Reference: Tree risk assessment and arboricultural recommendations for Tamahere Reserve.

Location: Tamahere Reserve, Tauwhare Road, Tamahere

Inspection date: 10/01/19

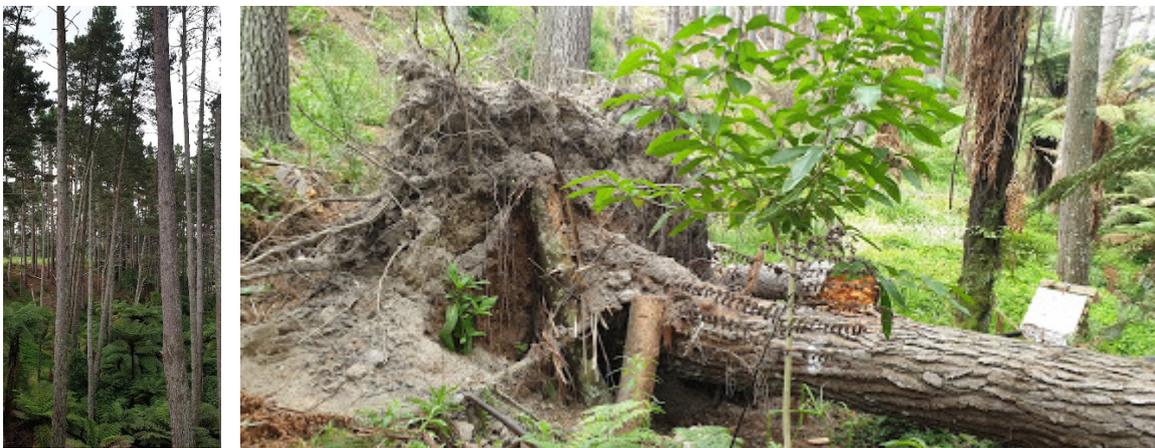
Tree Value: The majority of the pine trees at the reserve are classified as category A trees on the TreeAZ categorisation of trees system, see appendix 2. These are described as trees of moderate value which provide many eco-system services and functions. The predominant function of the trees at Tamahere Reserve is slope stabilisation and erosion reduction. Amongst these trees there are individual trees that are of a lesser value due to their defects, which are highlighted on the VALID risk assessments. There are also lower value trees within the reserve which are likely to fail due to their poor height diameter ratios and saturated rhizospheres. These are classified as category Z6 as they have little or no future potential, they are also less likely to be potential bat roosts due to their younger age and less inviting morphology like deadwood and crevices, see photographs 1 & 2.

Photograph 1 & 2, Category Z8 self-seeded and slender pines in water saturated rootzone.
