PRELIMINARY SITE INVESTIGATION (PSI)

231 TAHUNA ROAD & 52 LUMSDEN ROAD, OHINEWAI

Reference Number: REP-1352/PSI/JUN19

PREPARED FOR: AMBURY PROPERTIES LTD, C/- GAZE HOLDINGS LTD

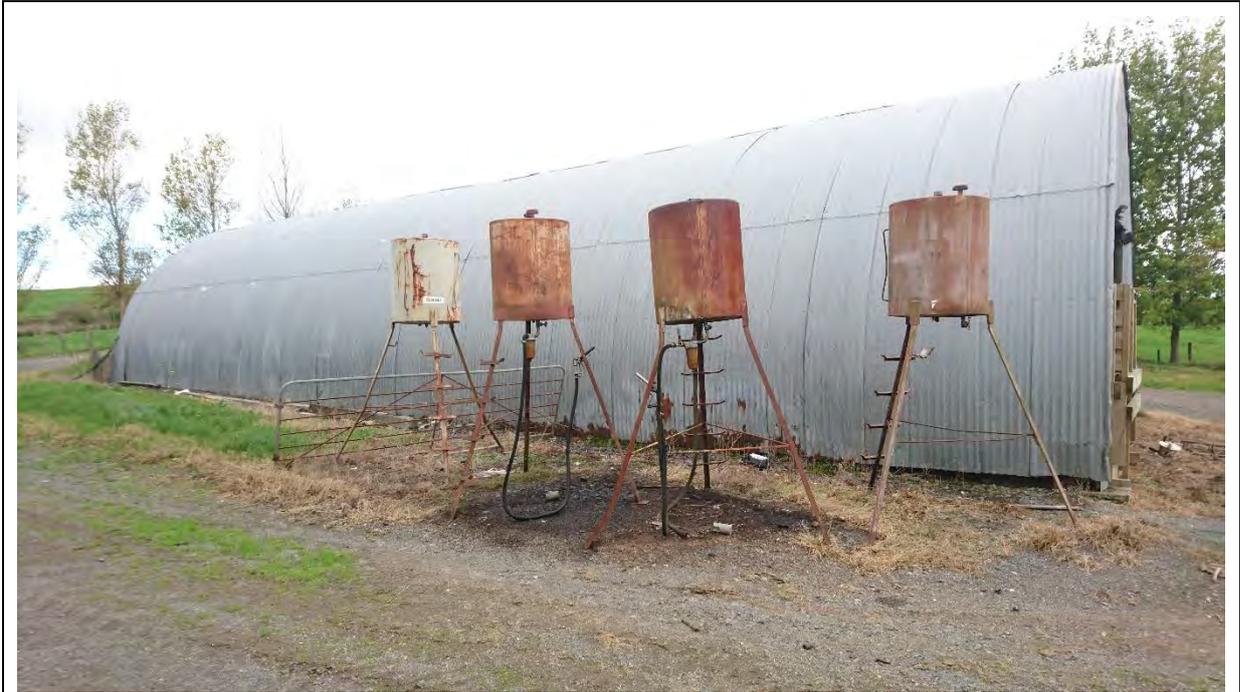
Four small, old above-ground diesel storage tanks with bowsers are located on the eastern side of the central barn structure, west of the milking shed; however, only the central two units appeared to still be in use, below which significant staining was visible. Whilst the units were not bunded, the staining was on the surface of compact hardstand material. No intrusive investigation was made into whether the staining may have penetrated the compact hardstand to the underlying soils.

PLATE 3: ABOVE GROUND DIESEL STORAGE TANKS WITH STAINS ON HARDSTAND SURFACE

- Appropriate validation soil sampling following decommissioning of the stock effluent dewatering ponds on Lot 1 and Lot 2, and the above ground fuel storage tanks at the milk shed on Lot 1 (including removal of the underlying hardstand gravel visibly stained by hydrocarbons).

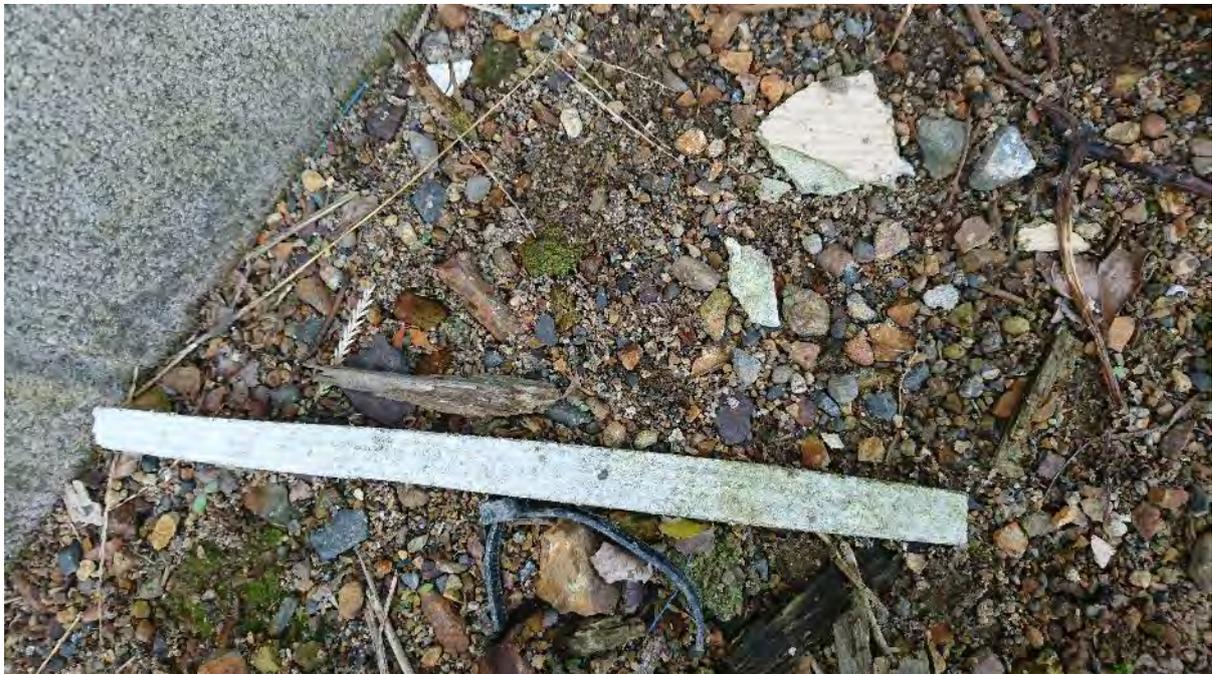
The milking shed on Lot 1 (Figure 4a) is still currently active, with a stock effluent dewatering pond and field east of the milking shed, and three barn structures containing stock pens on the shed's western side. The milking shed appeared to be clad in fibrous compressed cement weatherboard, suspected to contain asbestos. Several fragments of broken weatherboard were lying on the hardstand surface on the south western side of the building, where several panels had been damaged and subsequently replaced.

Potential contamination identified in this area therefore include localised hotspots of stored and spilled petroleum and polycyclic aromatic hydrocarbons (HAIL Item A.13), asbestos containing materials in a damaged and deteriorated condition (HAIL Item E.1), dumping of burnt refuse (HAIL Item I), and stock effluent dewatering ponds (HAIL Item G.6).

PLATE 4: DAMAGED AND DETERIORATED SUSPECTED ASBESTOS CONTAINING MATERIAL (ACM) AT LOT 1 MILKING SHED

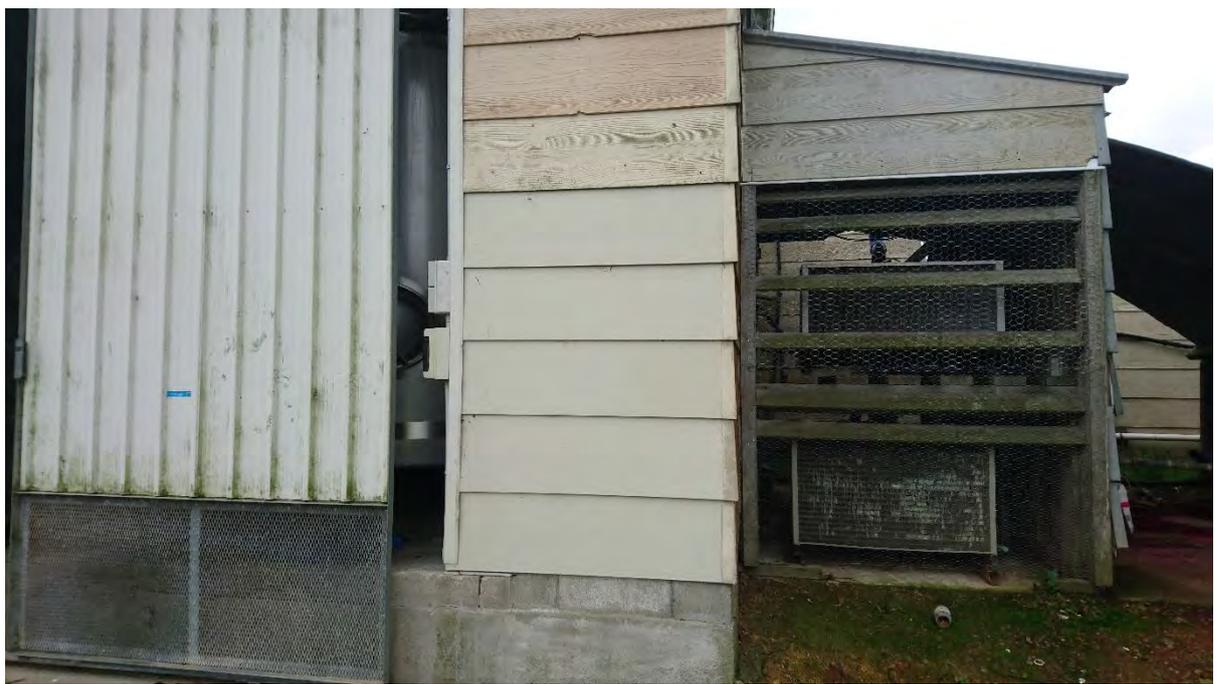
PLATE 5: REPLACED CLADDING PANELS ON LOT 1 MILKING SHED SOURCE OF SUSPECTED ACM FRAGMENTS

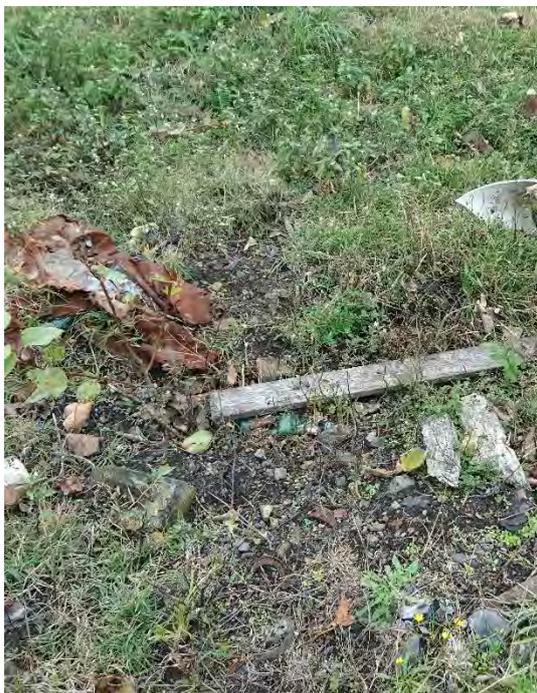
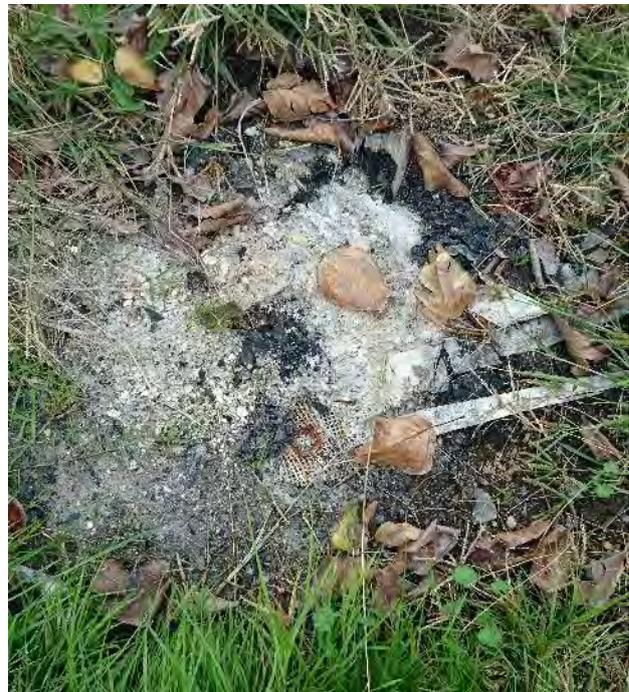
The three barn structures west of the milking shed were all of timber and unpainted corrugated iron construction and used for housing stock pens and storing some farming implements. Additional farming implements were stored in the grassed area on the western boundary of the yard, between the southern and northern barns. Multiple small areas of partially buried and overgrown refuse were noted in this area, including partially burnt materials such as timber, metal, glass, and plastic.

PLATE 6: EXAMPLE OF AREA OF DUMPED REFUSE AT LOT 1 MILKING SHED

- Test pit excavation within the area of buried metal on the western portion of Allot 405, and the area of burnt and buried material near the milking shed on Lot 1 to assess the nature of materials buried in these areas, including discrete soil sampling for analysis of potential contaminants based on the materials identified. Priority contaminants such as heavy metals, asbestos fibres, and polycyclic aromatic hydrocarbons (PAHs) may require laboratory analysis;

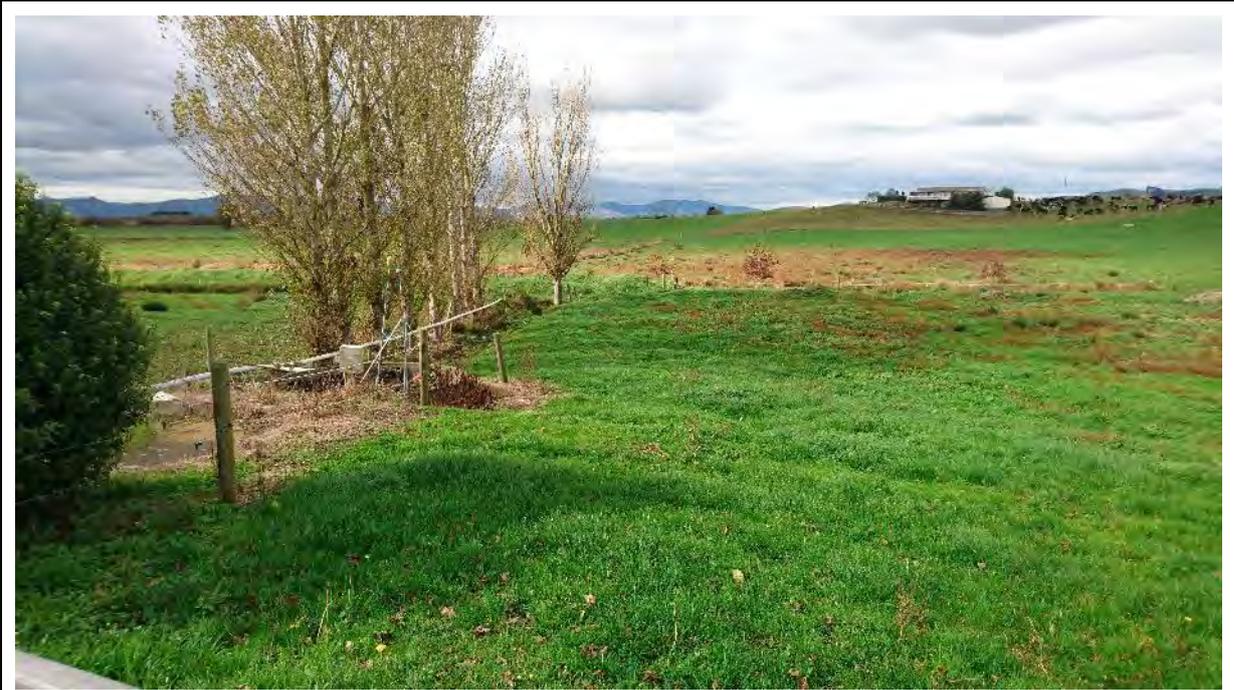
PLATE 7: VIEW EAST TOWARDS LOT 1 STOCK EFFLUENT DEWATERING POND

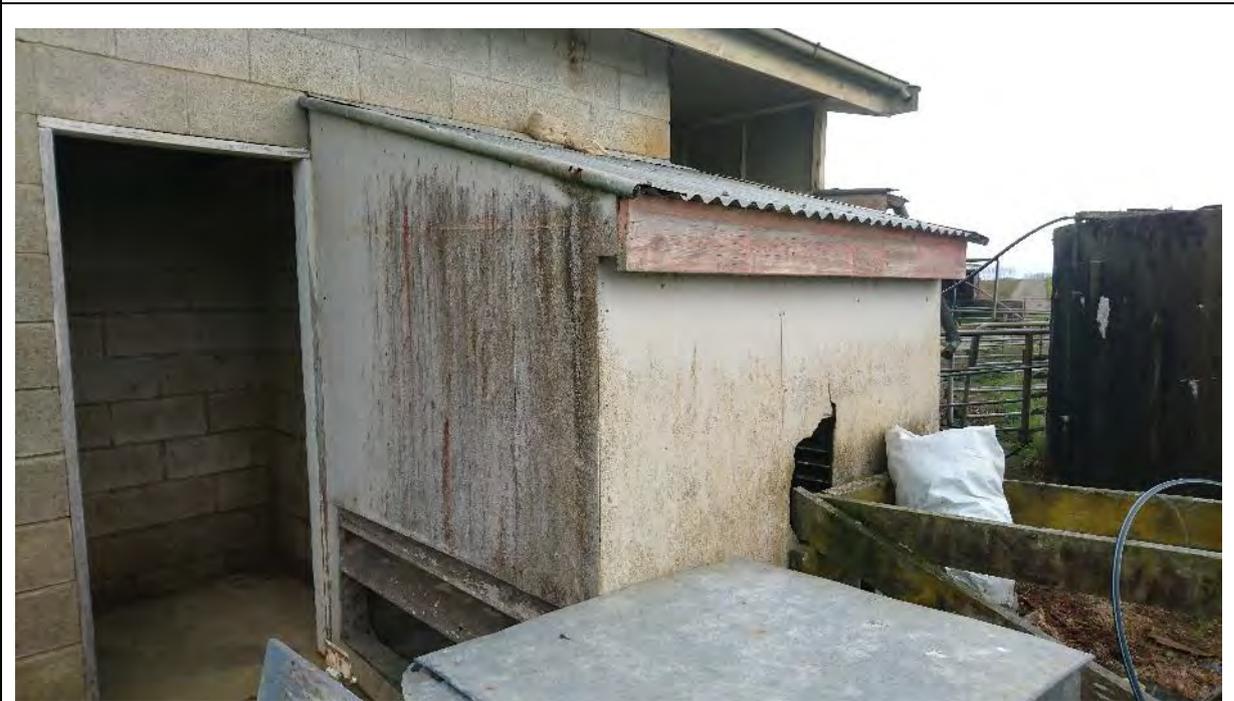
Potential contamination identified in this area therefore include localised hotspots of asbestos containing materials in damaged and deteriorated condition (HAIL Item E.1), bulk storage of fertiliser (HAIL Item A.6), discharge of lead to soil from lead-based paint on the former calf barn (HAIL Item I), discharge of potential contaminants from the incomplete combustion of refuse and building materials (HAIL Item I), and stock effluent dewatering ponds (HAIL Item G.6).

PLATE 8: DAMAGE AND DETERIORATED SUSPECTED ACM ON LOT 2 MILKING SHED

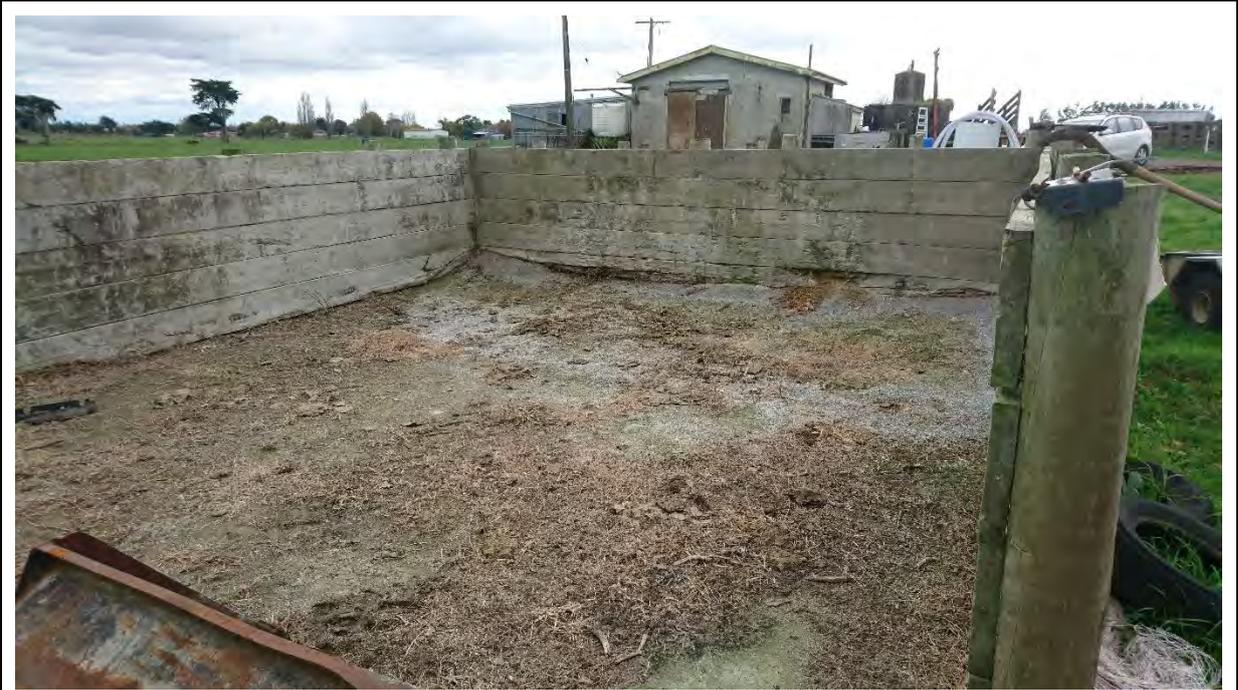
South of the milking shed, adjacent to the pile of burnt material, is a large timber fertiliser storage bunker. The bunker is essentially empty, with only small remnants of what appear to be ammonium phosphate granules. The floor of the bunker appears to be compacted but unlined clay.

PLATE 9: LOT 1 BULK FERTILISER STORAGE BUNKER WITH MILKING SHED IN BACKGROUND

- Discrete surface and depth soil samples in and around the fertiliser storage bunker near the milking shed on Lot 2;
- Analysis of soils where asbestos containing materials are positively identified and are in a broken or deteriorated condition;

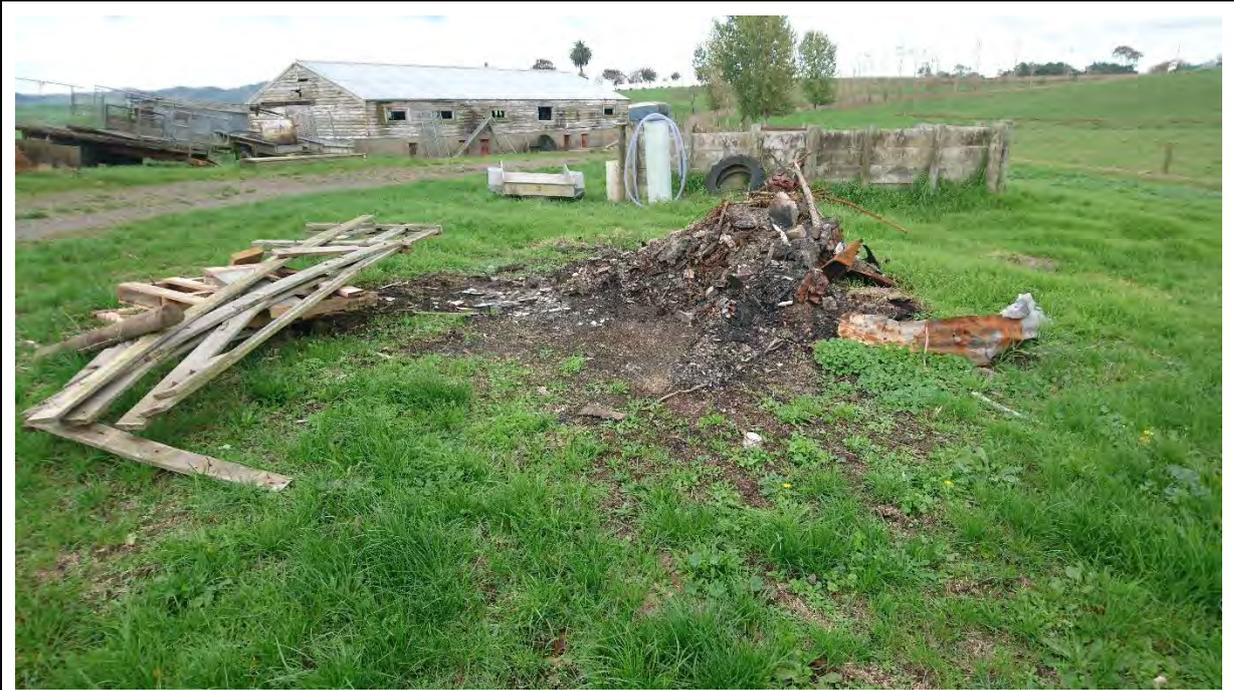
PLATE 11: BURN PILE NEAR LOT 1 MILKING SHED WITH CALF BARN AND FERTILISER BUNKER IN BACKGROUND

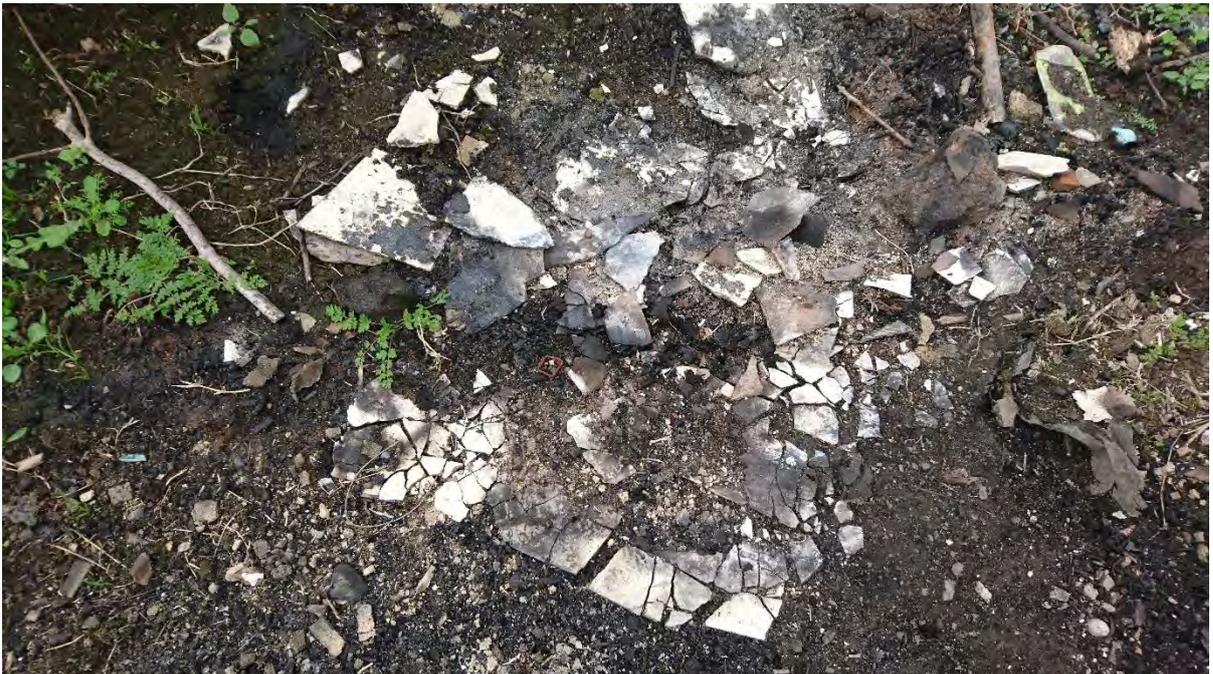
PLATE 12: DAMAGED AND DETERIORATED SUSPECTED ACM FRAGMENTS IN BURN PILE AT LOT 1 MILKING SHED

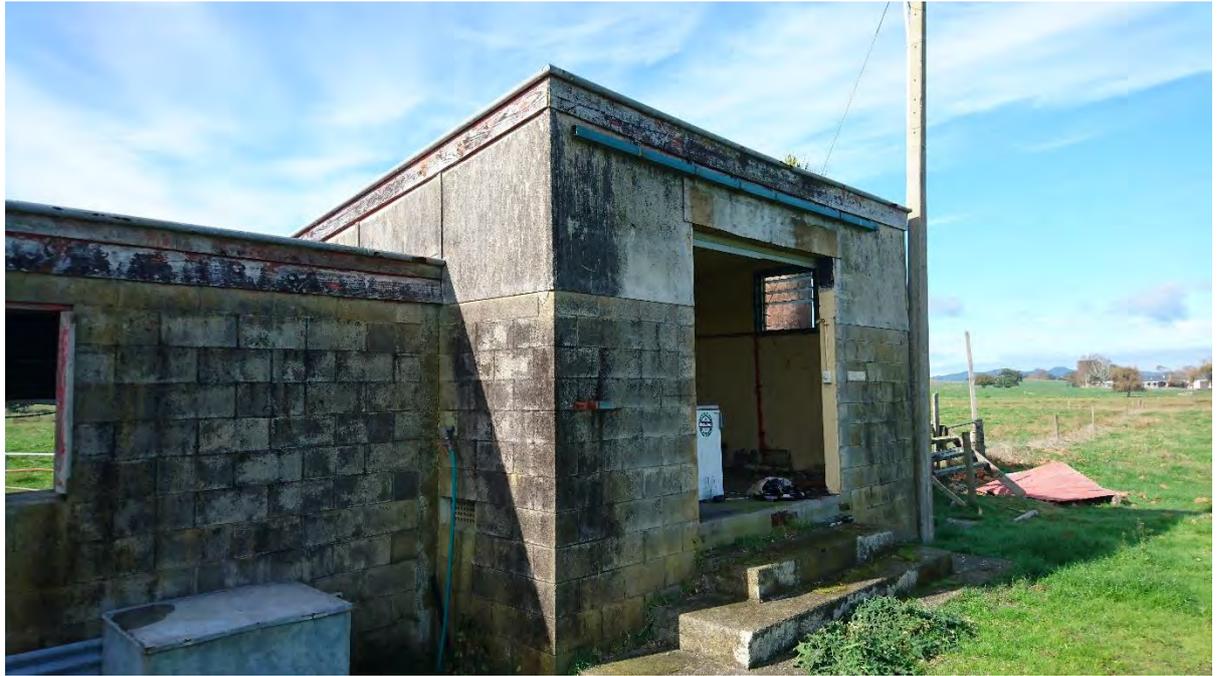
The milking shed on Allot 405 (Figure 4c) is currently inactive and partially dismantled. The building is constructed from unpainted concrete cinderblocks with a corrugated iron roof. However, some potential ACM panels are present at the southern end of the building and appear to be in weathered condition. The milking shed also contains a concrete water tank at its southern end, with the former stock effluent dewatering ponds further south east (decommissioned / fill in between August 2014 and March 2015).

Potential contamination in this area therefore includes possible asbestos containing material in deteriorated condition (HAIL Item E.1), potential waste disposal to land (HAIL Item G.5), and stock effluent dewatering ponds (HAIL Item G.6).

PLATE 13: DETERIORATED SUSPECTED ACM ON ALLOT 405 MILKING SHED

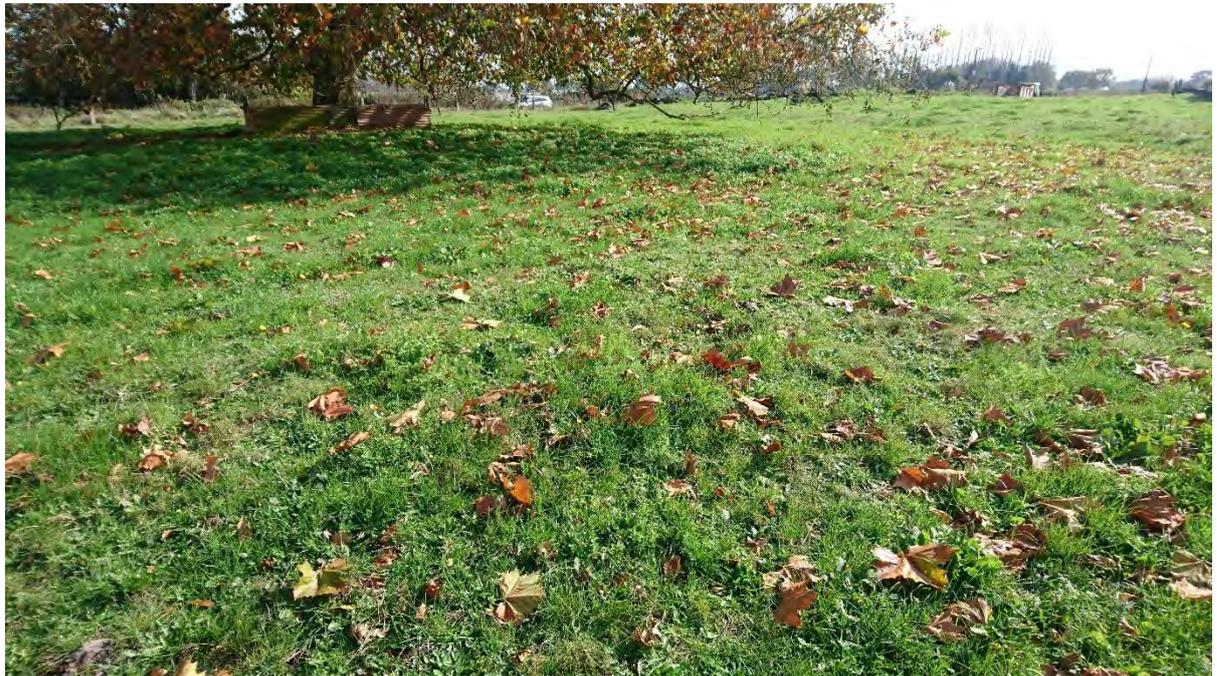
The surface of the area identified by the owner of Allot 405 as containing buried scrap metal was visually inspected; however, whilst minor surficial metal was noted, the overgrown nature of the area precluded a full assessment of the material.

PLATE 14: AREA OF SUSPECTED BURIED MATERIAL ON ALLOT 405

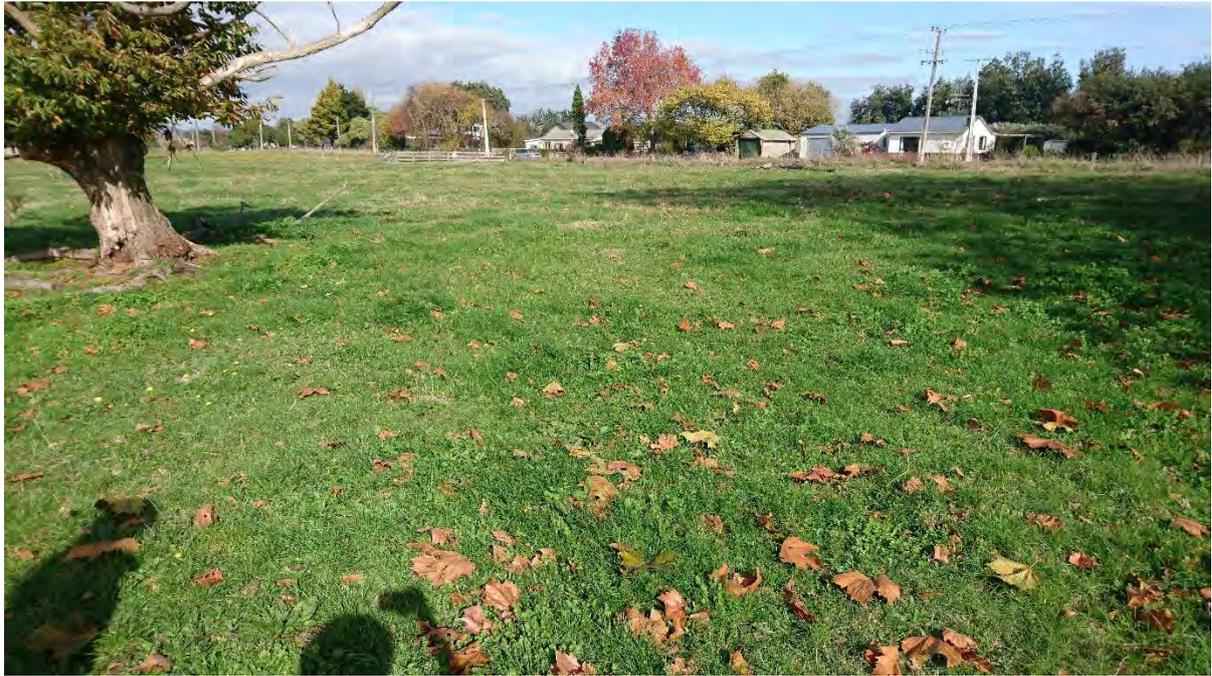
PLATE 15: AREA OF SUSPECTED BURIED MATERIAL ON ALLOT 405

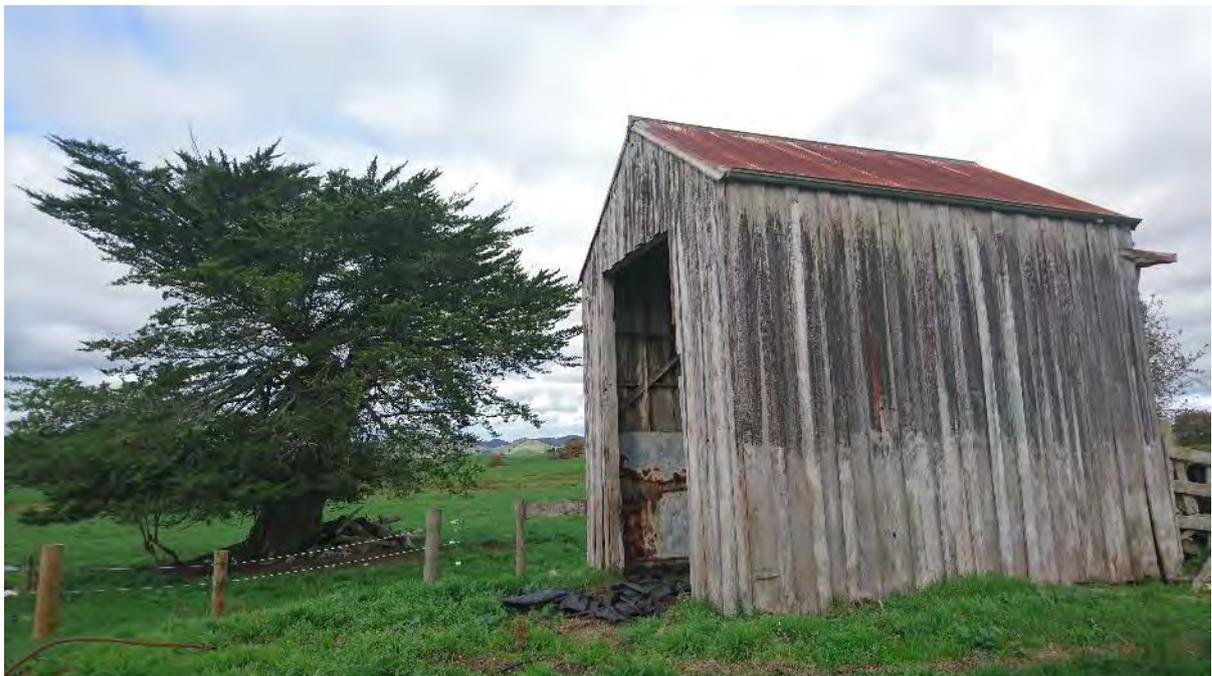
The timber shed formerly used as a slaughterhouse is still present on Lot 3. The timber structure, built prior to 1940, may have had a painted exterior; however, almost no paint remains on the exterior wooden cladding with only hints of red paint visible between the boards. Both the interior of the building and the corrugated iron roof appear to have been painted. Given the age of the building and condition of the painted surfaces, lead from lead-based paint is considered a potential contaminant in soils surrounding the building (HAIL Item I).

PLATE 16: HISTORIC TIMBER SHED (SLAUGHTERHOUSE) ON LOT 3
