**RE: Preliminary Geotechnical Appraisal Report for Graham Block, Hitchen Road, Pokeno**

client:	DFH JOINT VENTURE LIMITED
project:	GRAHAM BLOCK, HITCHEN ROAD, POKENO
title:	GEOMORPHOLOGY OVERVIEW
project no:	J00581
figure no:	01

client:	<b>DFH JOINT VENTURE LIMITED</b>		
					approved	sl		project:	<b>GRAHAM BLOCK, HITCHEN ROAD, POKENO</b>		
					date	24/02/17		title:	<b>GEOLOGY OVERVIEW</b>		
					scale	N.T.S.		project no:	<b>J00581</b>	figure no:	<b>02</b>
					original size	A3

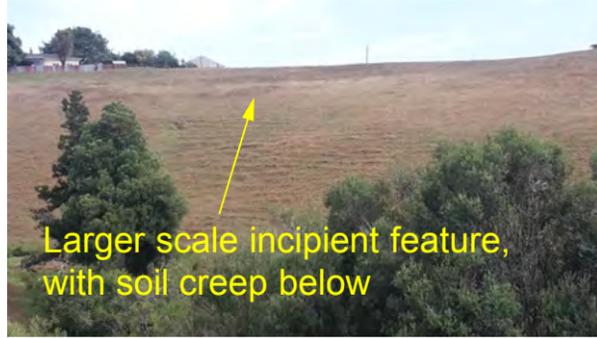
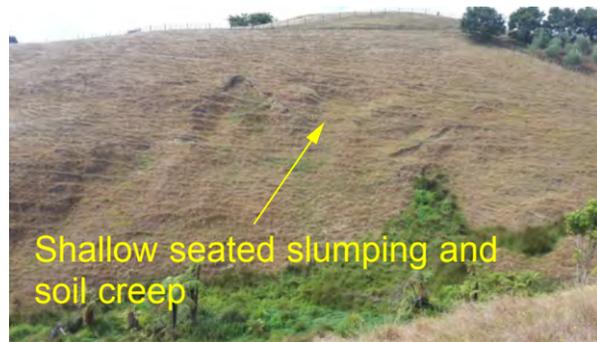
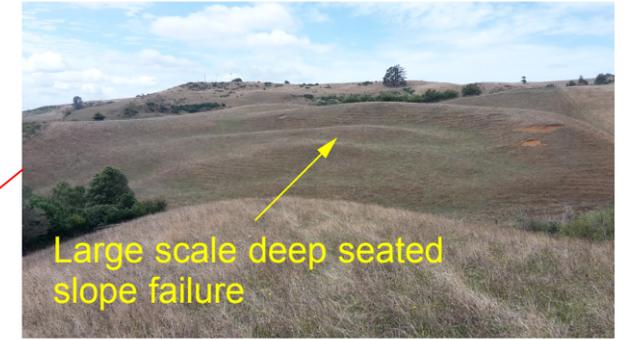
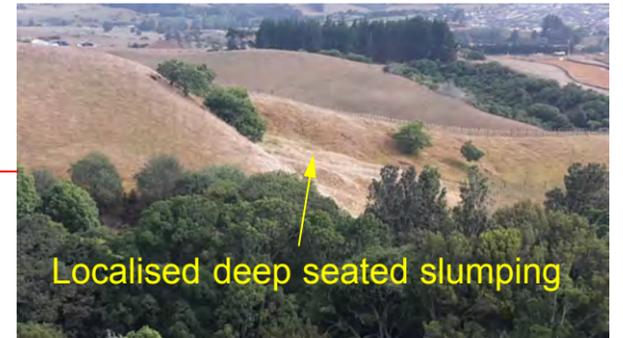
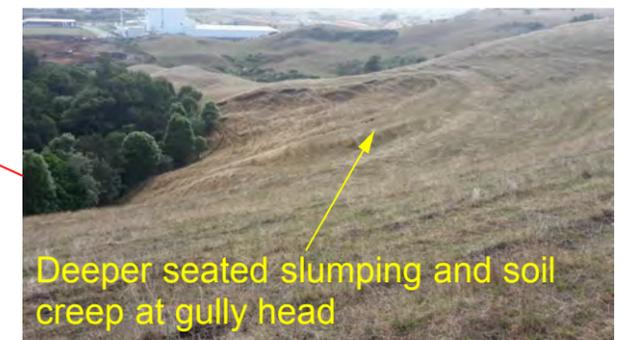
- shallow soil creep (i.e. sheep tracks / small terraces)
- isolated shallow slumping and erosional features
- subtle large scale incipient movement zones
- existing deeper seated slope failures

These are shown on the attached Figure 1 and the associated photographs illustrate the typical nature of these features.

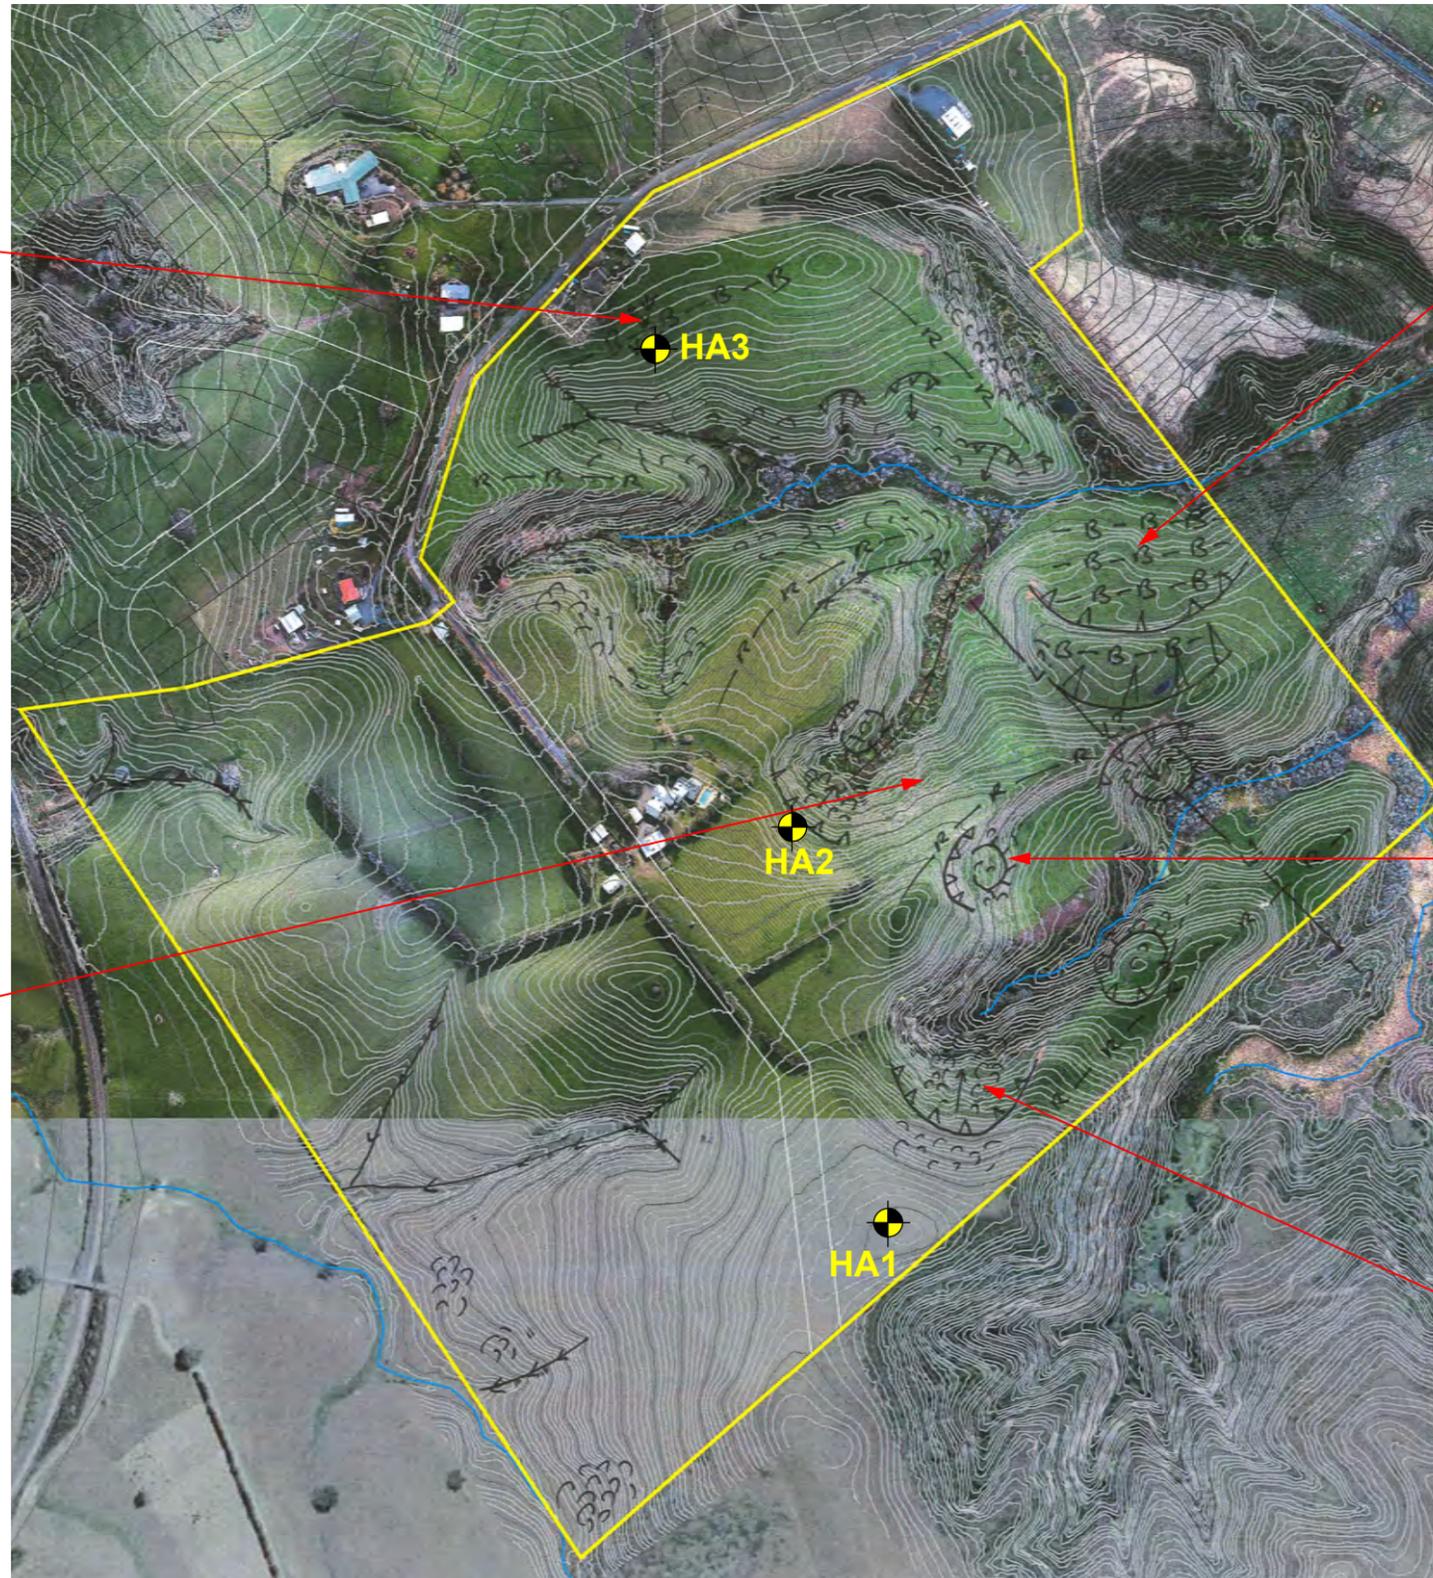
Geomorphic observations note both shallow and deep seated slope instability features associated with the moderate to steeply sloping ground flanking the various incised gullies (i.e. where slope gradients are generally steeper than 1(v) in 4(h)). They typically manifest as:

Significant portions of the site are steeply incised by gully features and display signs of shallow seated soil creep, slumping and large scale instability (refer Figure 1 attached for illustration of typical features and preliminary geomorphic mapping). Outside of such areas the land is generally undulating to rolling and shows no obvious geomorphic signs of ground instability.

- Consideration to development setbacks from incised gully flanks and areas displaying signs of slope instability will need to be assessed during detailed geotechnical site investigations of the land for Resource Consent.
- Where adequate setbacks cannot be achieved to mitigate slope instability risks, engineering intervention such as bulk earthworks (e.g. shear keys or buttress fills, and/ or remediation of slip areas), counterfort drains, palisade pile walls (i.e. in-ground retaining) can be designed and employed to mitigate slope instability. As already mentioned, engineering measures will be dependent on the findings of a detailed geotechnical site investigation that is commensurate with the subdivision scheme and earthworks proposals.

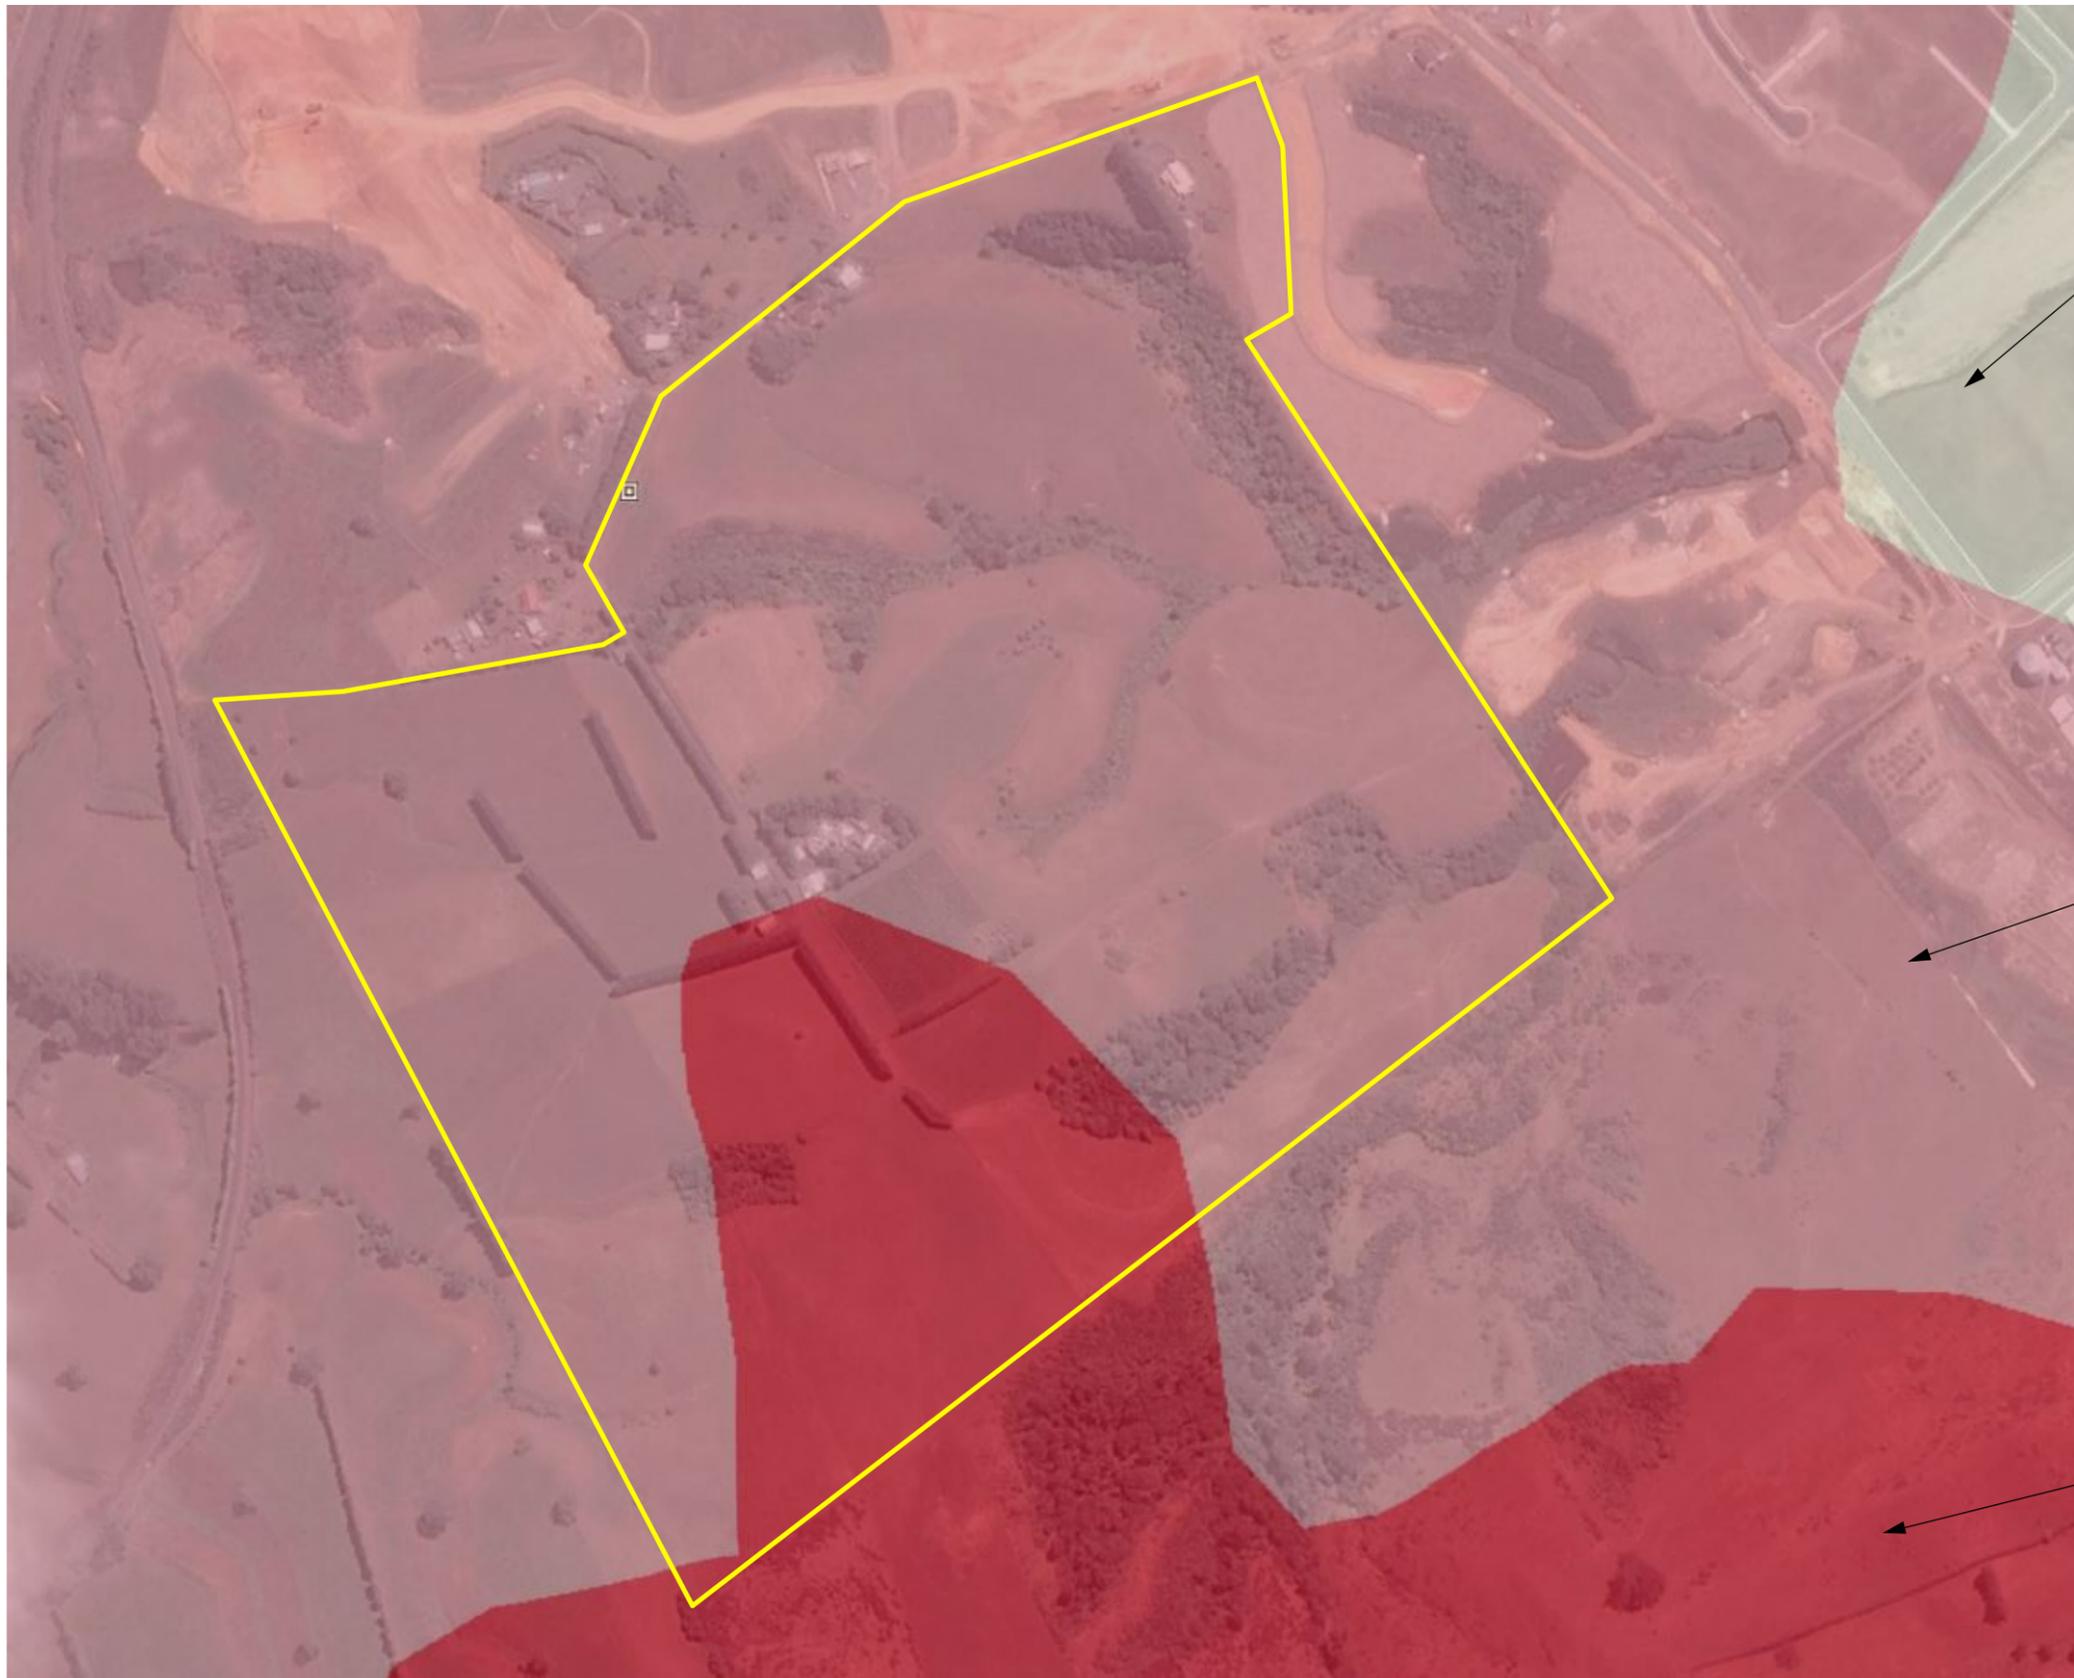
Figure 2 attached provides an overview of geology within the site. These are described as follows:

A large proportion of the site is depicted as containing ash, lapilli and lithic tuff deposits of the South Auckland Volcanic Field. Unconsolidated ash, lapilli and lithic tuff are described as soft, sensitive materials, prone to slumping on steep slopes (which is evident in Section 3.1 above).

Figure 2 shows these deposits east of the site, and they comprise sedimentary infill (pumice sands, silts and gravels) of the Taupo Pumice Alluvium. There may also be organic materials. Although not shown on the published geological map, sedimentary infill (e.g. gully mullock) will also be present in the base of the various incised gullies throughout the site, together with colluvium associated with existing landslide features on the flanks of the existing slopes.

Basalt rock weathers to fertile clayey/silty soils, while unweathered rock is generally strong and hard. No basalt rock outcrops were observed within the site.
