Lakeside Te Kauwhata

Ecological Restoration Plan
Prepared for Lakeside Developments 2017 Ltd

15 March 2017

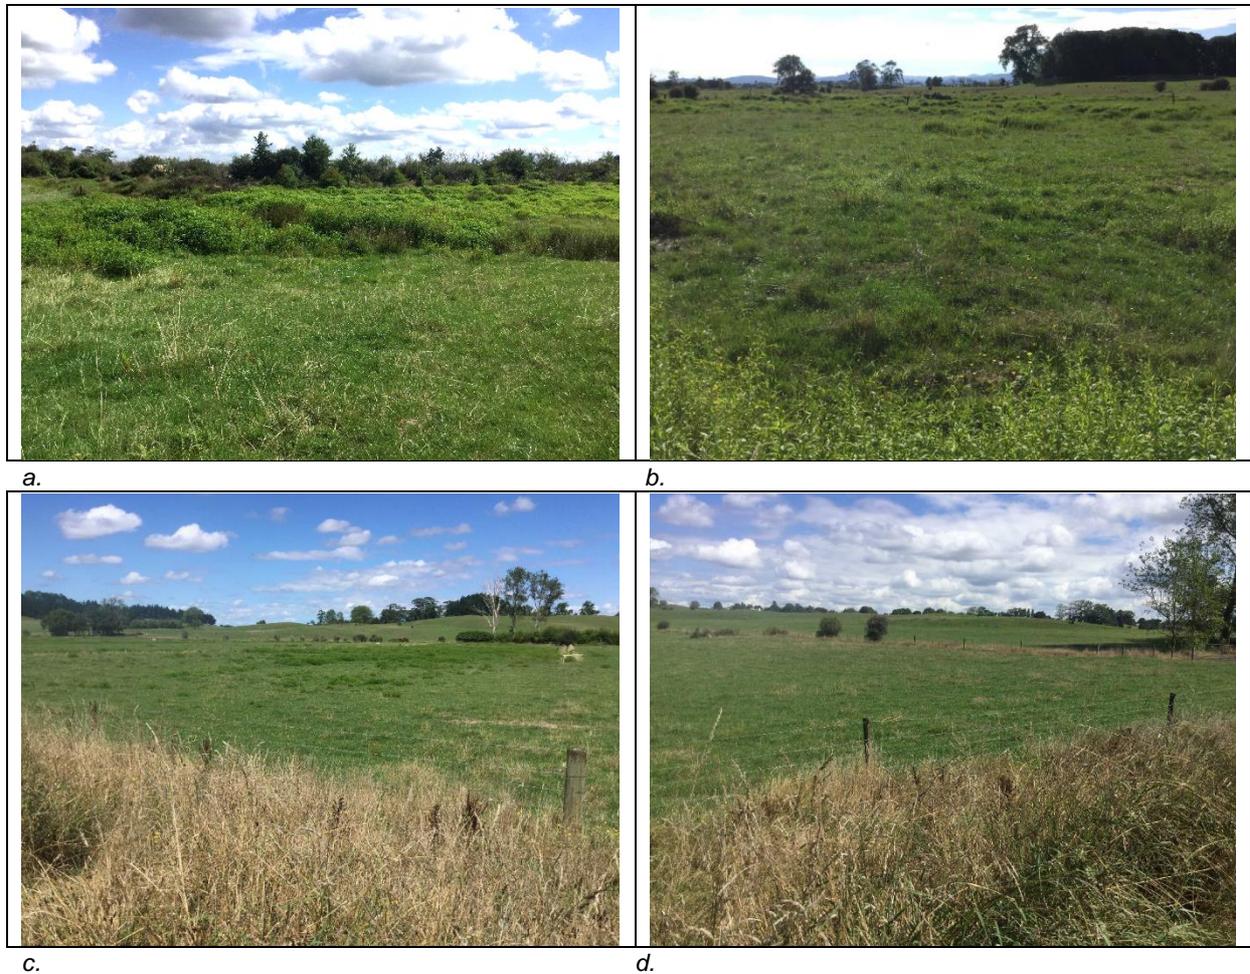
Plate 1: Pastureland with variable cover of water pepper (scattered hedgerows and shade trees also evident).

Water pepper covers large portions of low-lying paddocks close to the lake margin, indicating that these areas tend to be waterlogged much of the time (Plate 1). A few of these low-lying paddocks also contain abundant brassicas and nightshade, which may be the result of cultivation for cropping.

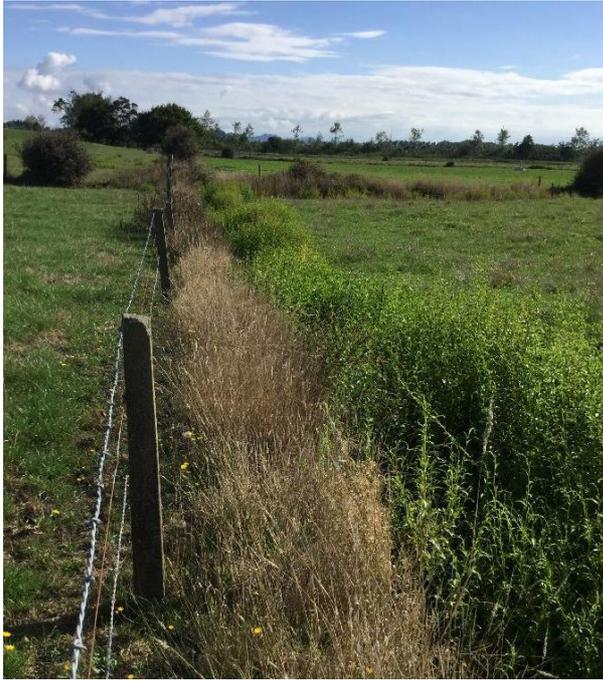
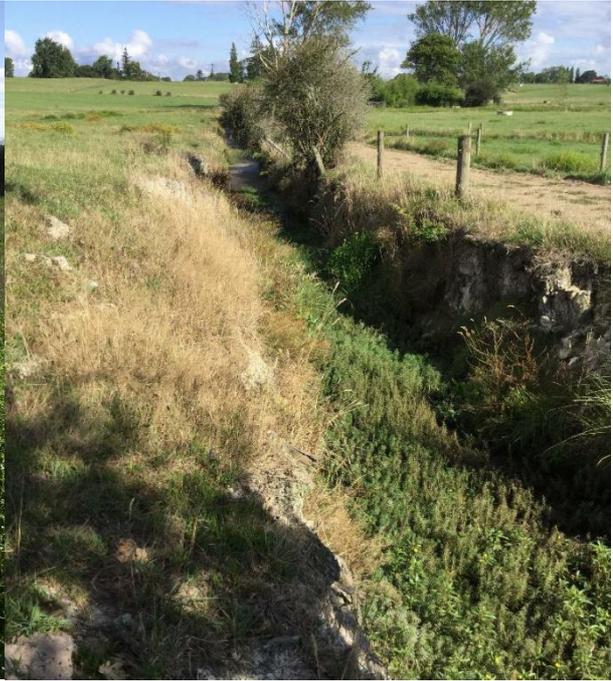
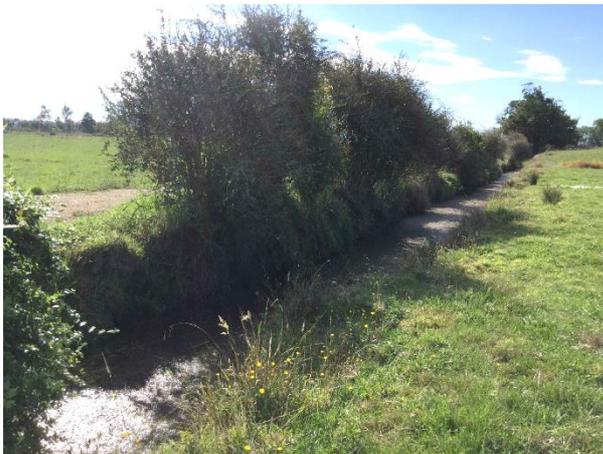
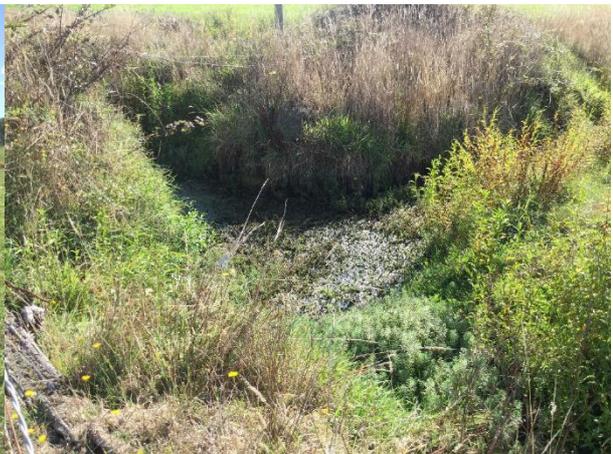
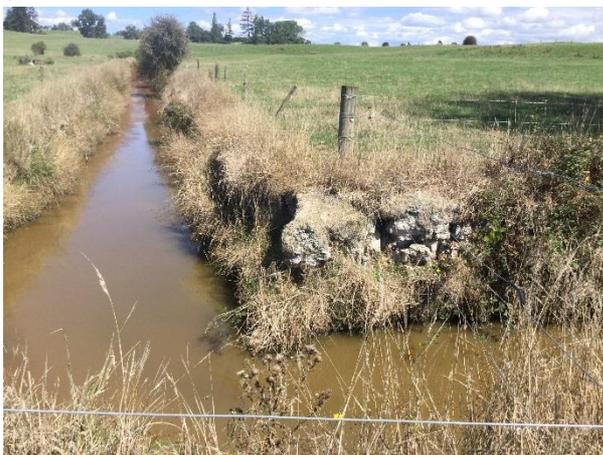
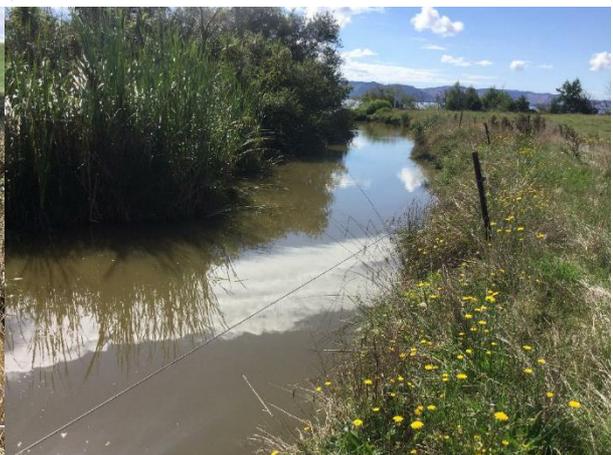
Plate 2: Examples of drainage channels that intersect the proposed restoration area.

Numerous drainage channels intersect the pasture land throughout the proposed restoration area (Figure 1), at approximately 50m spacings in the most low-lying parts. Channel depths range between approximately 1 – 2m deep. At approximately 200m or more from the lake margin, water levels in channels were generally very low, and extensive growths of aquatic macrophytes (water pepper, parrot's feather, ludwigia) were present (Plates 2a & b). Nearer to the lake margin, water covered the channels and was generally greater than 15 cm deep, though often stagnant (Plates 2c-f).

Surface drains will be recontoured to create graded margins, to enable establishment of permanent and intermittent wetland zones. Recontouring of drains to make them somewhat wider and shallower will enable establishment of a continuous cover of rush and sedge vegetation over the wetted part of the channel and a surrounding cover of sedgeland beneath an emergent canopy of manuka. Planting 'zones' and associated species are summarized in Table 1. Broadly, *Machaerina* species and manuka will be planted in intermittently wet zones, while sections of channel that permanently contain standing water will be revegetated in Raupo and *Bolboschoenus fluviatilis*. Figure 1 shows approximately 7 ha of drainage channel wetlands, at a nominal width of 20 m wide in total (though in practice the margins would be undulating and sinuous).

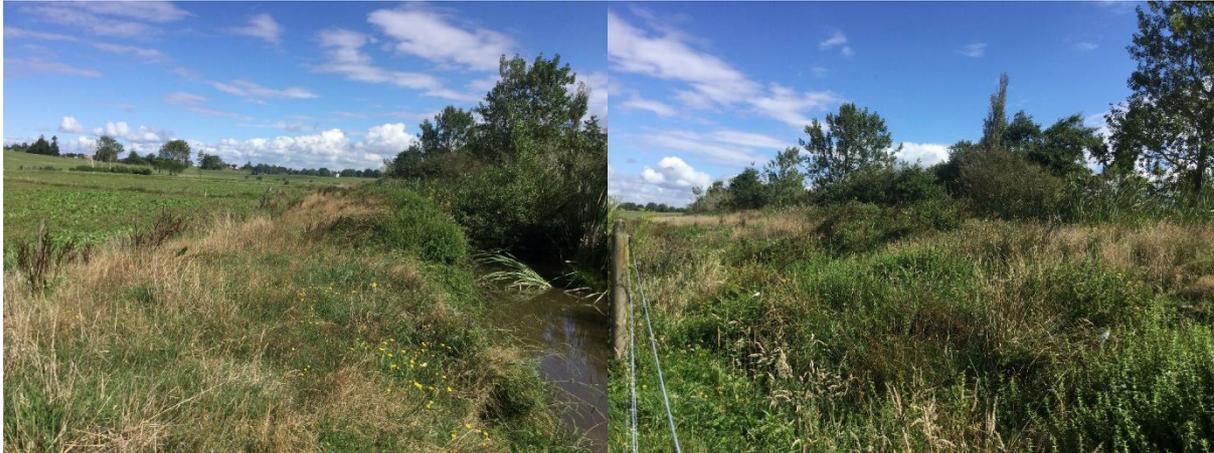
Plate 3: Bund along Lake Waikare margin.

An earth bund has been formed around the margin of Lake Waikare (Plate 3) and fenced off from stock, separating paddocks from the open water and the wetland fringe that surrounds the lake. Rank grass and pasture herbs cover the bund, with local patches of blackberry and occasional woody weeds (gorse, cotoneaster, Chinese privet, etc). Swards of water pepper frequently grow around the toe of the bund.

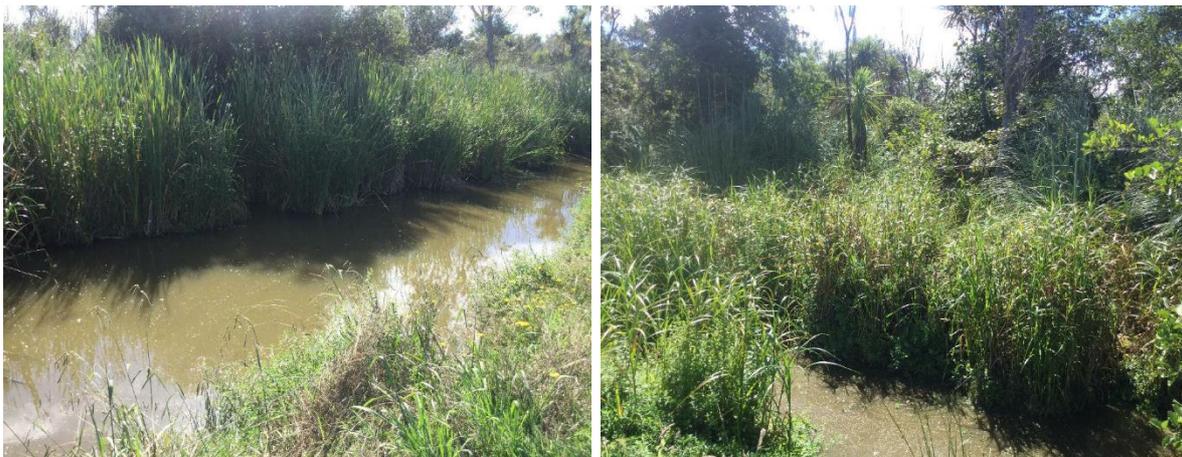
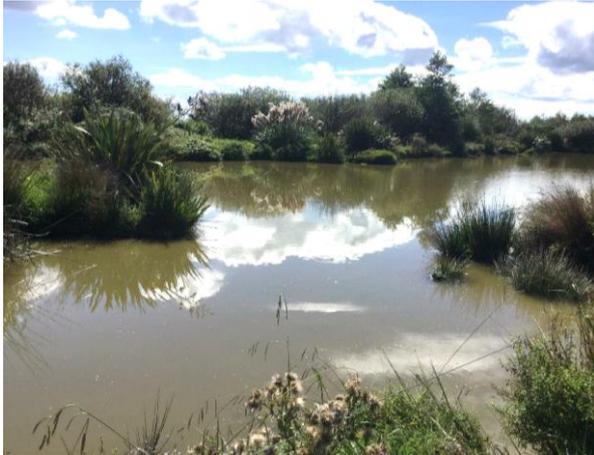
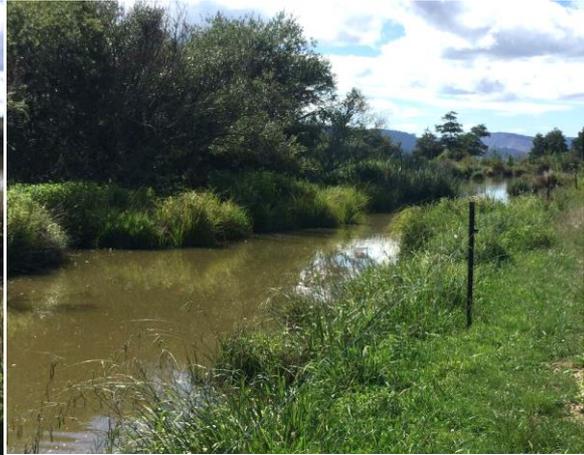
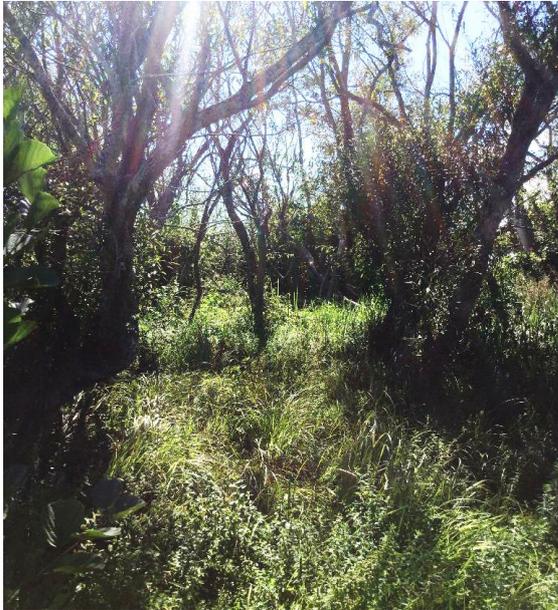
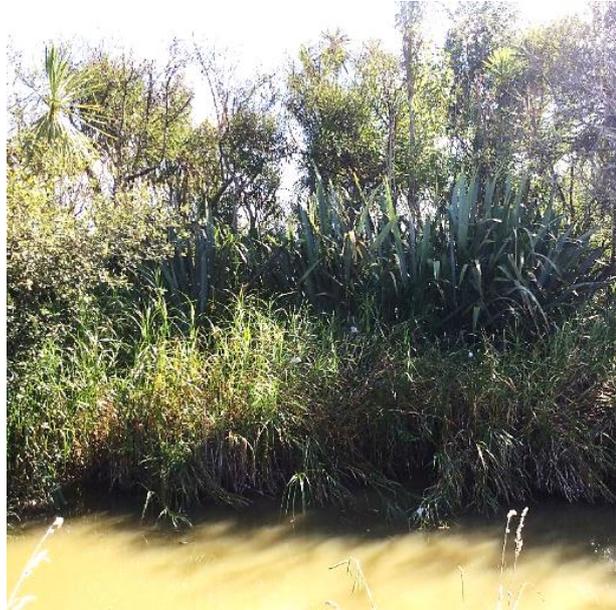
Plate 4: Examples of wetland vegetation along Lake Waikare fringe.

Wetland vegetation forms a near-continuous fringe around the lake margin (Plate 4), generally outside the property boundary and separated from the bund by a wide channel filled with murky water containing abundant koi carp. The composition of the wetland fringe is varied, with a patchy canopy of crack and grey willow interspersed with cabbage trees, above dense swards of raupo and *Bolboschoenus fluviatilis*, with local patches of *Carex secta*, *Carex geminata* and flax. A variety of other native sedges are also present and locally common, including *Machaerina articulata*, *Machaerina teretifolia*, *Elaeocharis sphacelata* and *Schoenoplectus tabernaemontanii*. In a few places along the lake margin the channel between the bund and the wetland fringe widens to form a pond-like feature, with a large expanse of open water surrounded by willows, flax, sedges and rank grass (with occasional pampas).

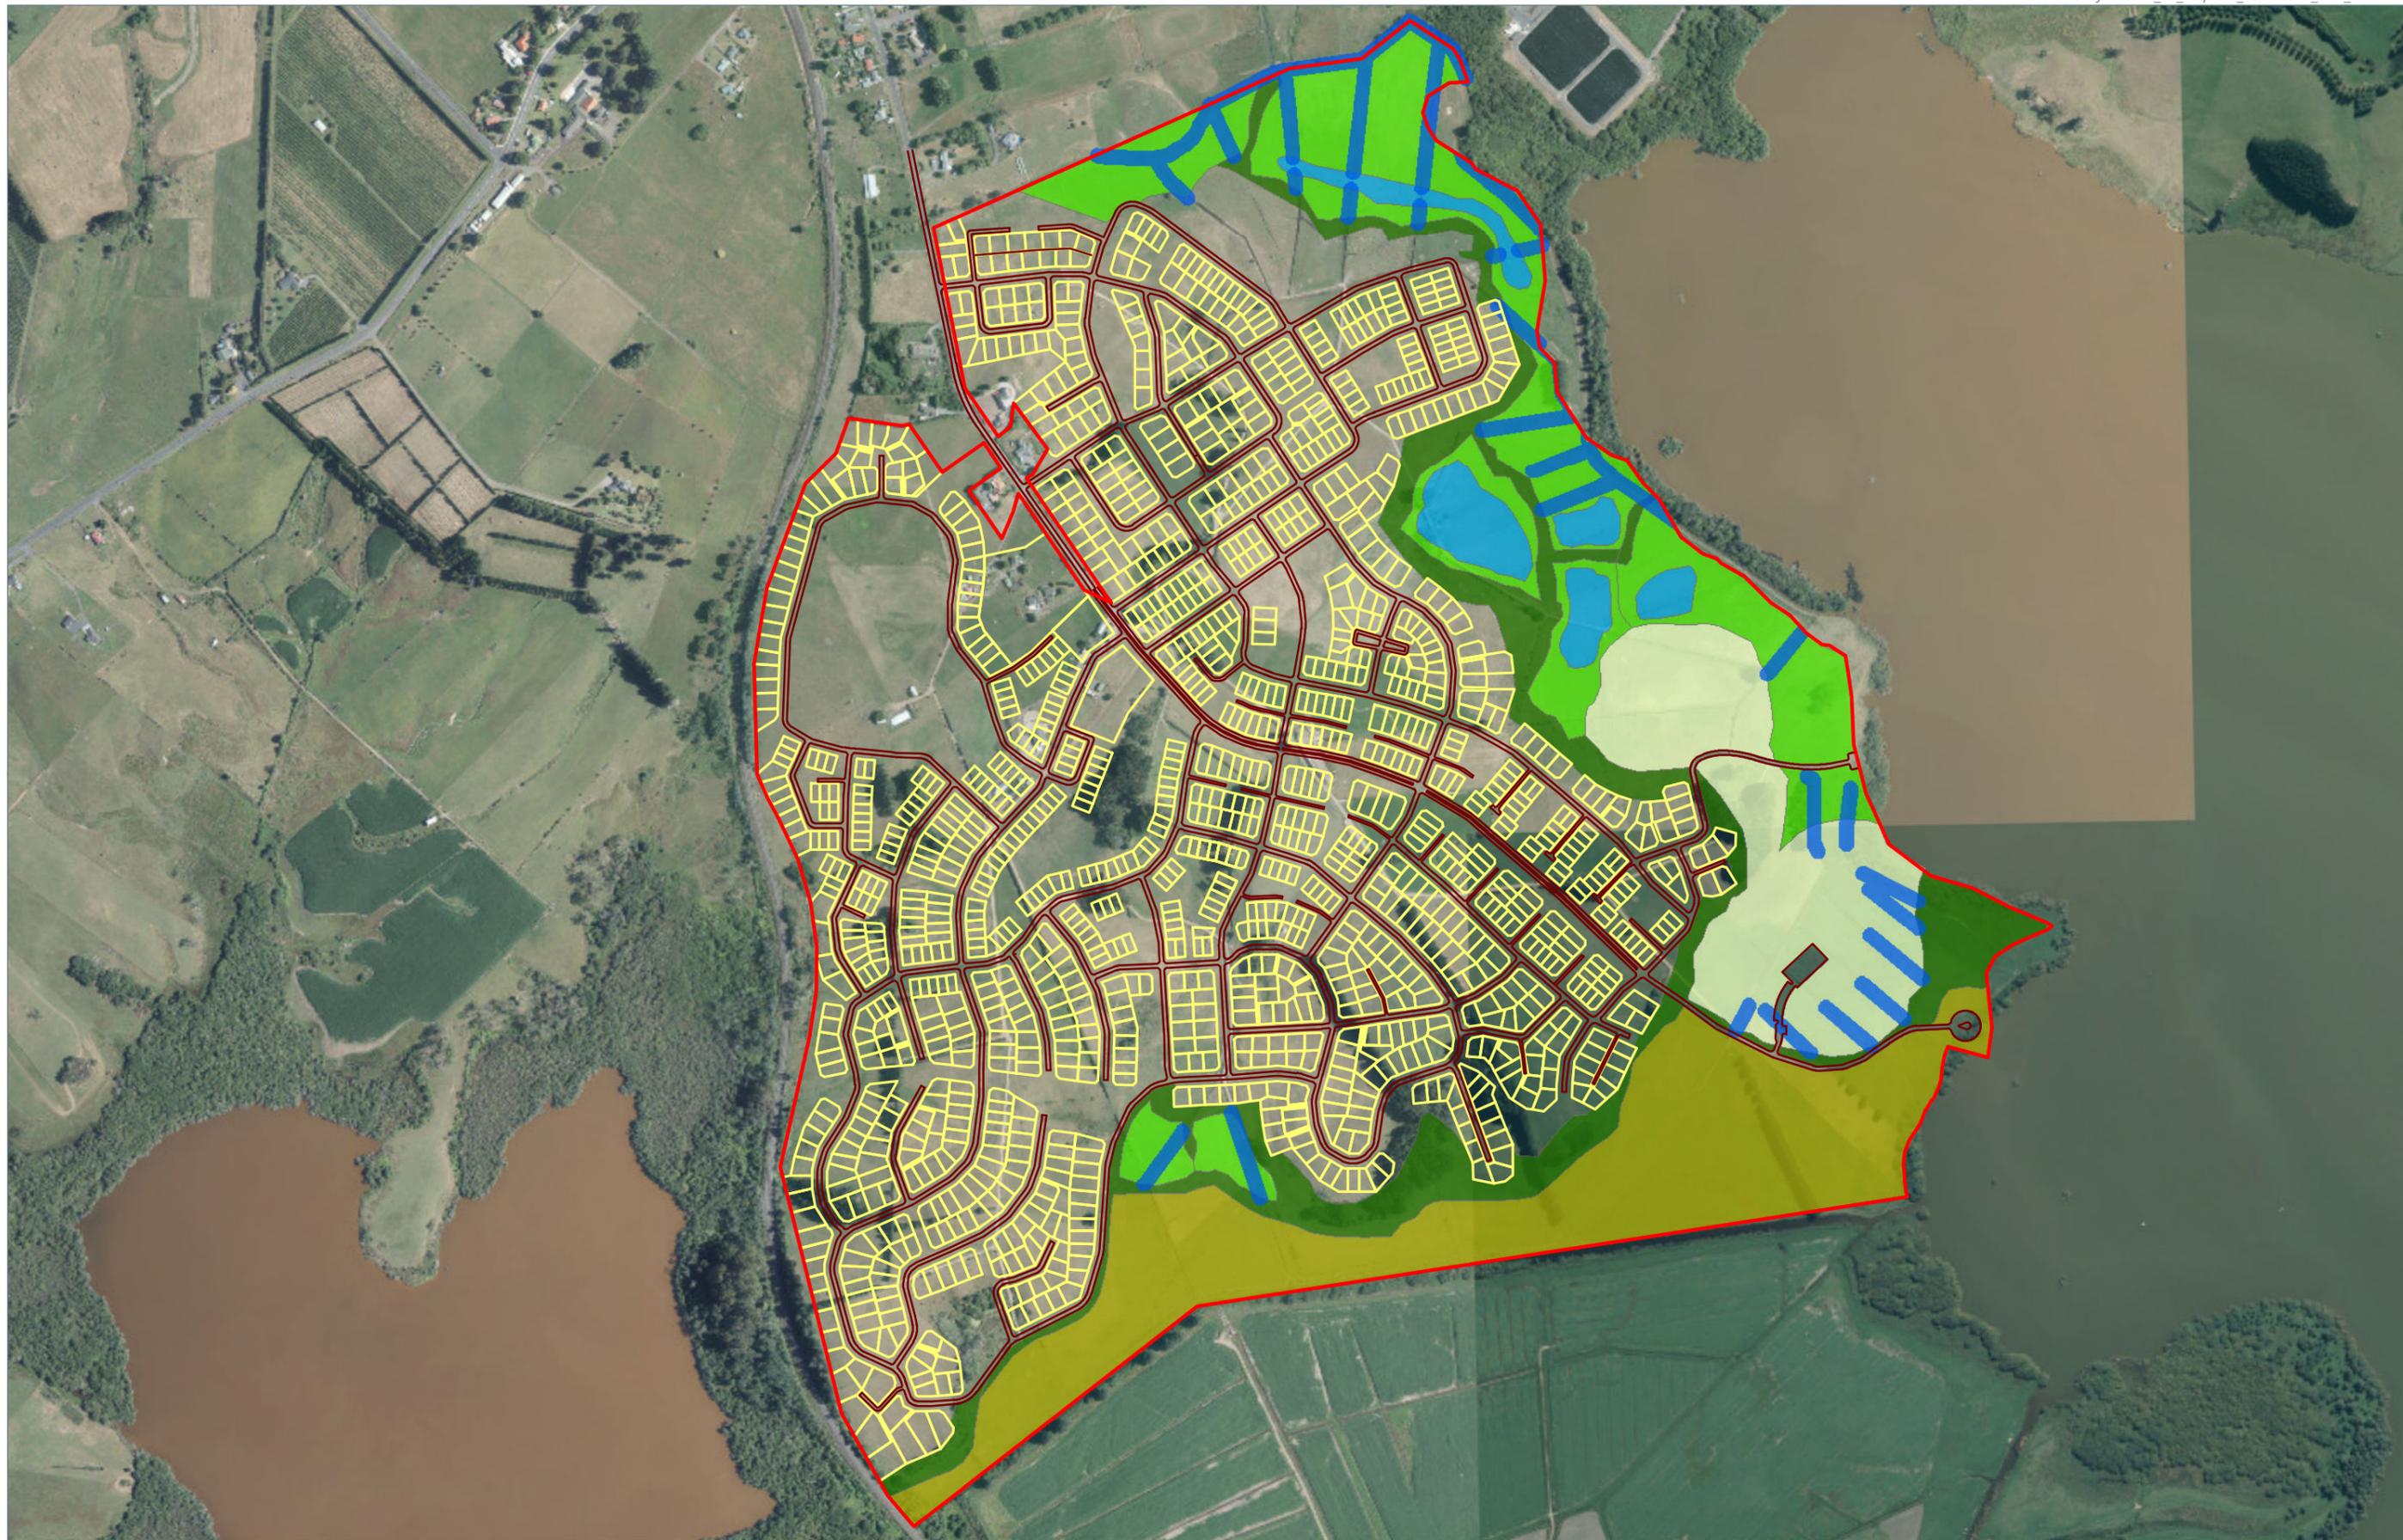
Each of these treatments is described below, and indicatively mapped in Figure 1 (note that the precise extent and specific locations of the above treatments are yet to be determined).

Raised bunds will be created through parts of the restoration area and around its landward perimeter in order to create walking trails (refer Figure 1). These bunds will close off portions of drainage channels and create impounded areas of standing water. Restoration of these areas will entail excavating out a continuous, gently contoured depression to reinstate groundwater-fed wetland systems that would once have been a feature of the area. A similar treatment will be applied to boggy depressions and highly flood-prone land in low-lying paddocks close to the lake margin where water tables are persistently near the soil surface. Fig. 1 shows approximately 7 ha of excavated wetland.

Walking tracks (as shown on Figure 1) will be established on existing accessways and bunds where these exist while new bunds will be constructed as required to provide connectivity and ensure paths are not inundated. Walkway margins will be revegetated in order to minimise maintenance requirements and improve amenity, while also providing a buffer to minimise disturbance to wildlife within restored wetlands as a result of human activity. The plant selection for land surrounding walkways is chosen to complement both the site's overall ecological context and habitat value, and for aesthetic reasons.
