PRELIMINARY SITE INVESTIGATION (PSI)

231 TAHUNA ROAD & 52 LUMSDEN ROAD, OHINEWAI

Reference Number: REP-1352/PSI/JUN19

PREPARED FOR: AMBURY PROPERTIES LTD, C/- GAZE HOLDINGS LTD

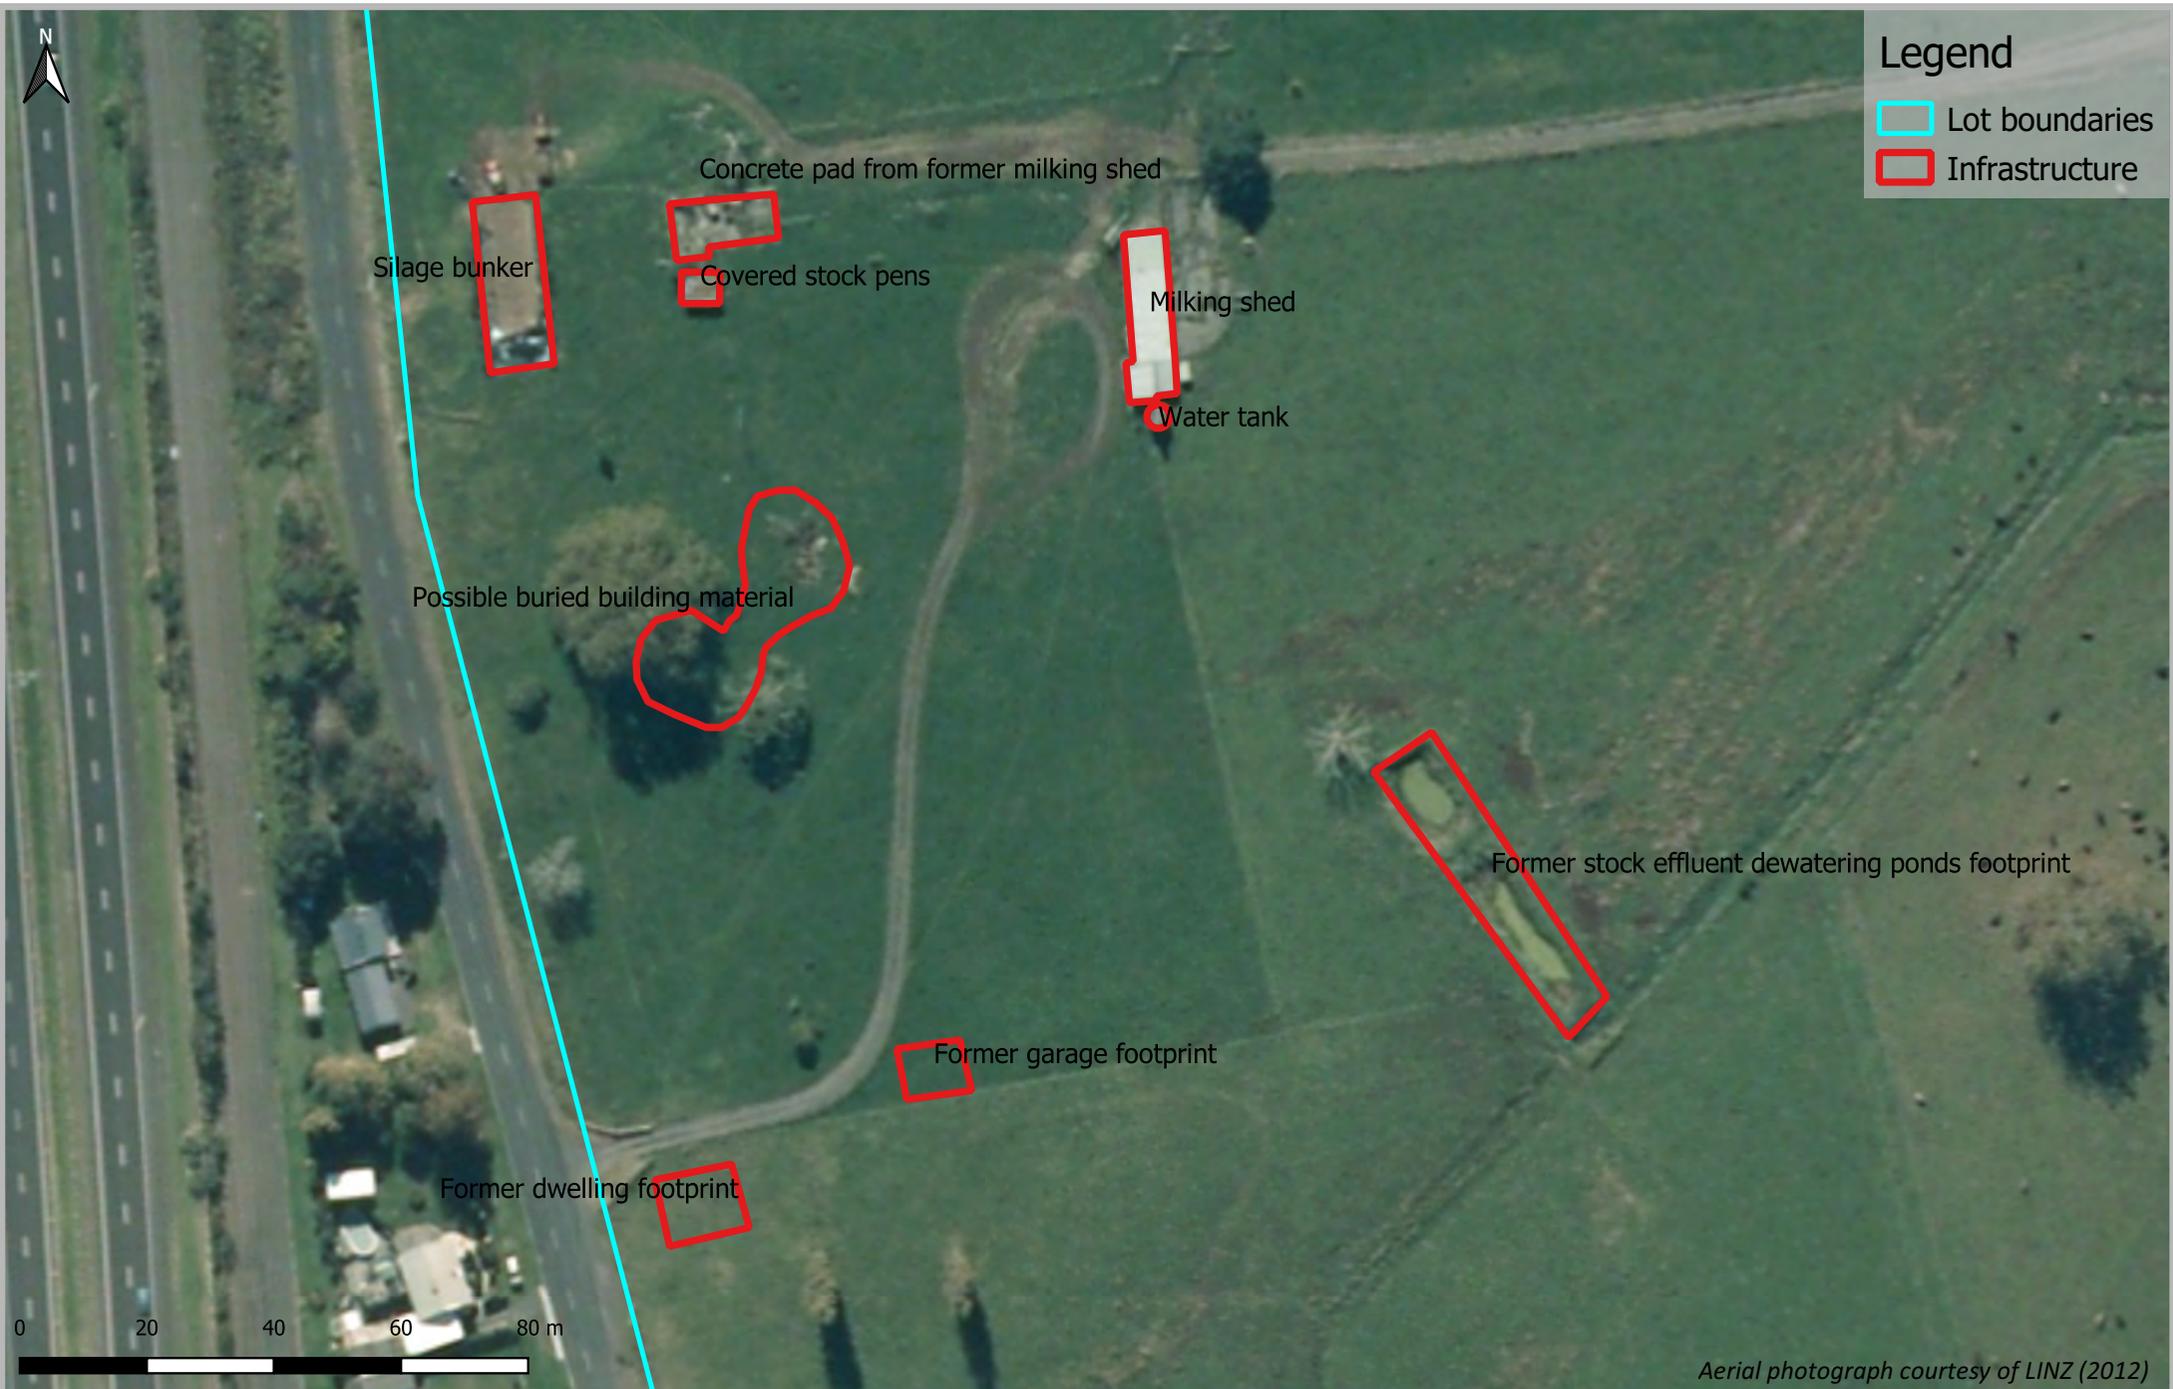
Figure 4c - Allot 405 Milking Shed and surrounds
231 Tahuna Road and 52 Lumsden Road, Ohinewai, Waikato

The milking shed on Allot 405 (Figure 4c) is currently inactive and partially dismantled. The building is constructed from unpainted concrete cinderblocks with a corrugated iron roof. However, some potential ACM panels are present at the southern end of the building and appear to be in weathered condition. The milking shed also contains a concrete water tank at its southern end, with the former stock effluent dewatering ponds further south east (decommissioned / fill in between August 2014 and March 2015).

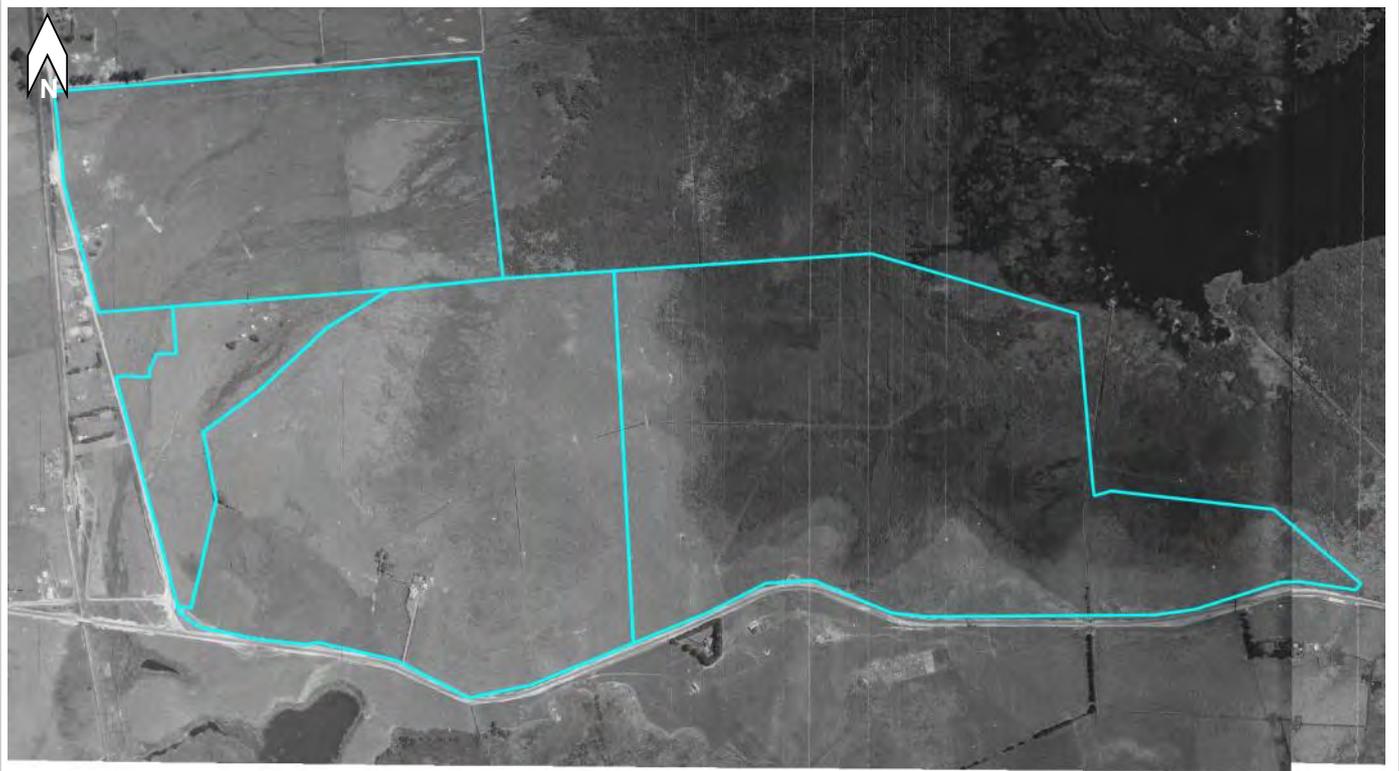
1942 The 1942 image is of poorer quality than the 1940 image but covers the full extent of the site. At this time, the entirety of the site appears to be under rough bush and pasture. An additional building is visible to the north of those noted on Allot 405, however no other buildings are visible beyond those noted in the 1942 image.

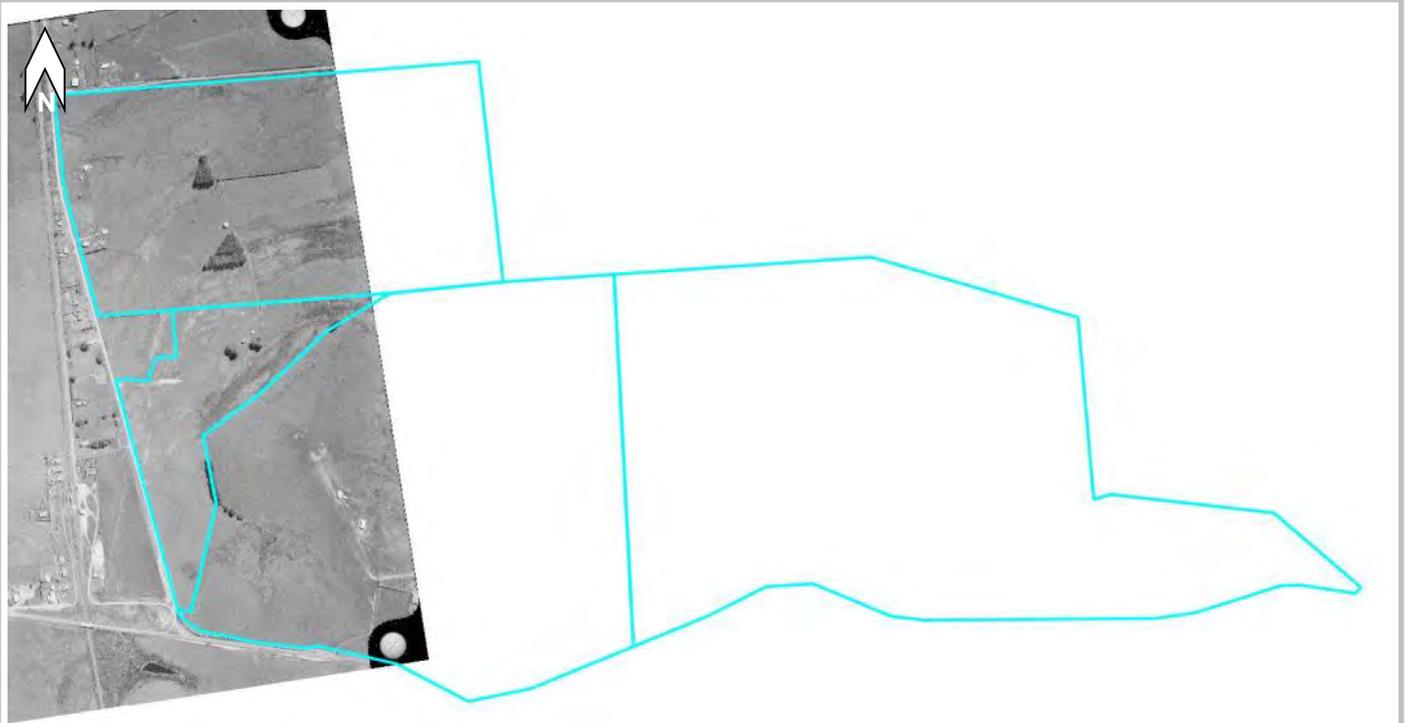
1961 The 1961 image is of the same limited extent as the 1942 image, showing only the south-western portion of the site but is of better quality. The buildings noted on Allot 405 adjacent to the western boundary appear to be a residential dwelling (formerly 82 Lumsden Road) with a nearby garage / shed and a domestic vegetable garden. The structures to the north have been expanded and appear to be a small milking shed with attached stock holding pens. A hay barn has also been constructed in the pasture directly east of the residential dwelling.

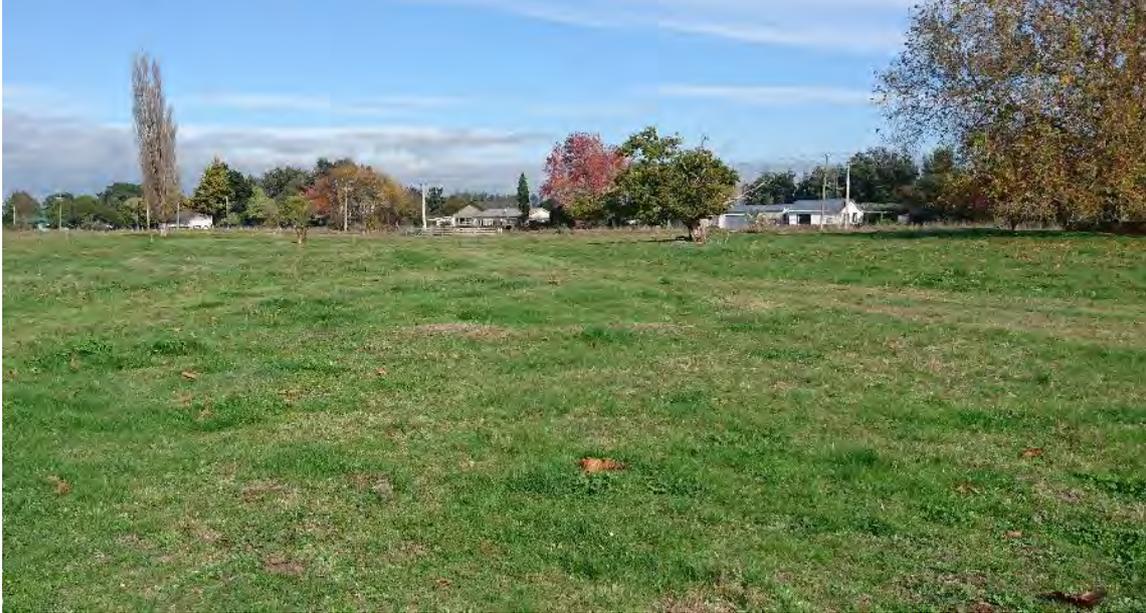
PLATE 1: VIEW SOUTHWEST TOWARDS FOOTPRINT OF FORMER BUILDINGS AT ENTRANCE TO ALLOT 405 FROM LUMSDEN ROAD

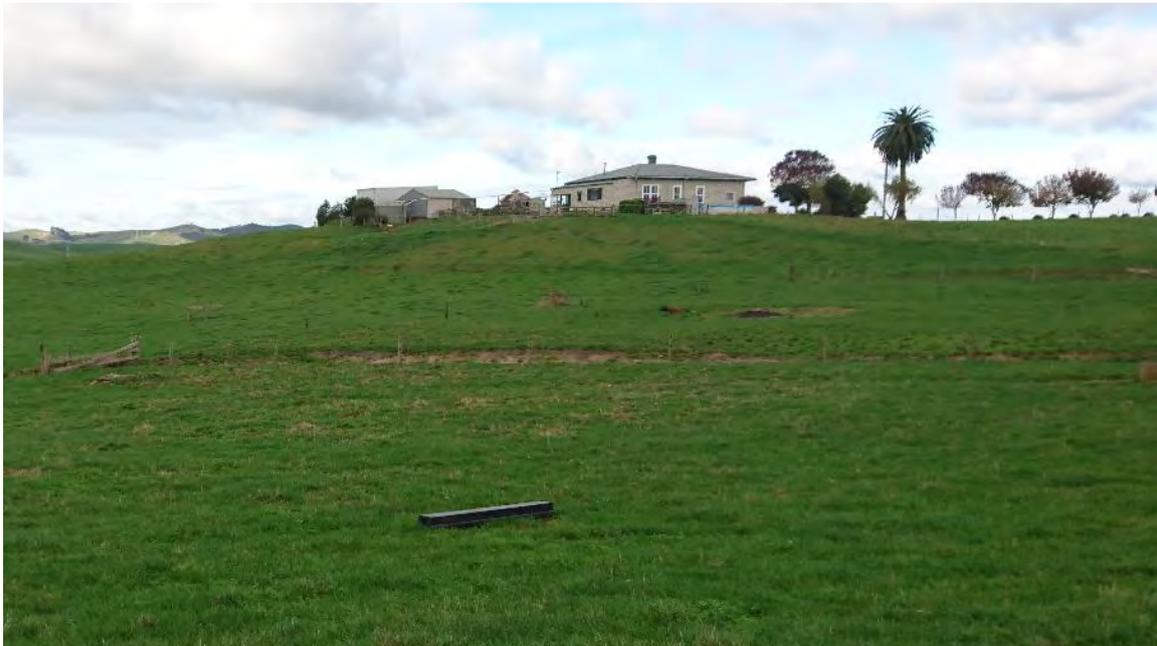
PLATE 2: VIEW SOUTHEAST TOWARDS FARMSTEAD AT 109 TAHUNA ROAD

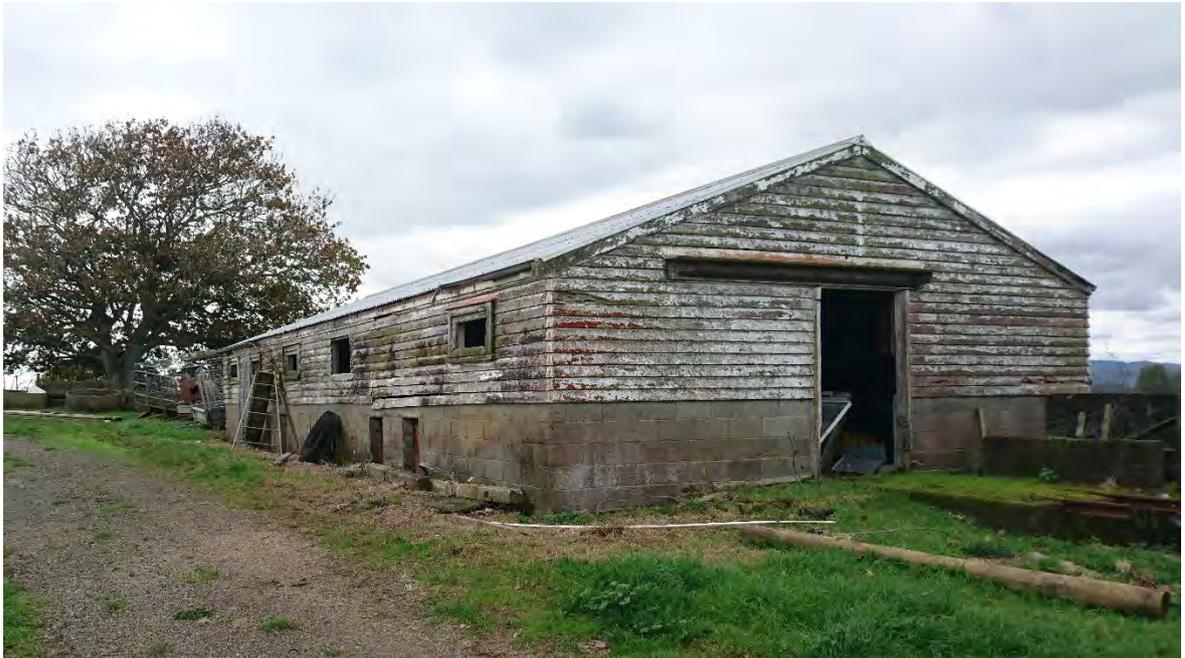
PLATE 10: LOT 1 CALF BARN
