WAIKATO DISTRICT COUNCIL COASTAL HAZARDS

Waikato District Coastal Hazard Assessment

**PREPARED FOR WAIKATO DISTRICT COUNCIL
BY MEMBERS OF FOCUS RESOURCE MANAGEMENT GROUP:**

FOCUS, 2019: Waikato District Coastal Hazard Assessment. Prepared for Waikato District Council by the Focus Resource Management Group. Focus Report No. 19/130.

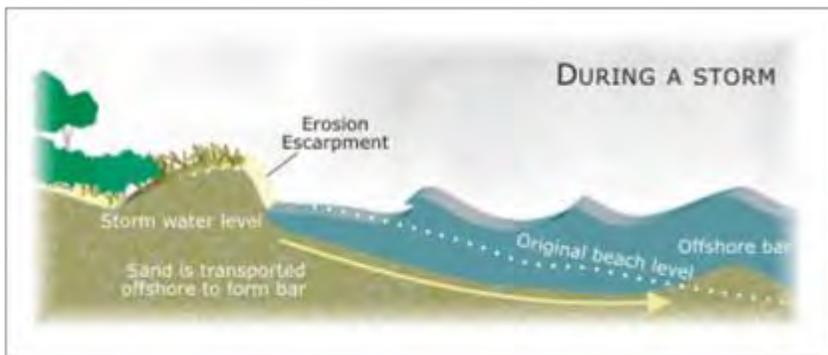
Figure 4: During storms, sand is eroded from the dune and forms bars offshore that absorb wave energy.

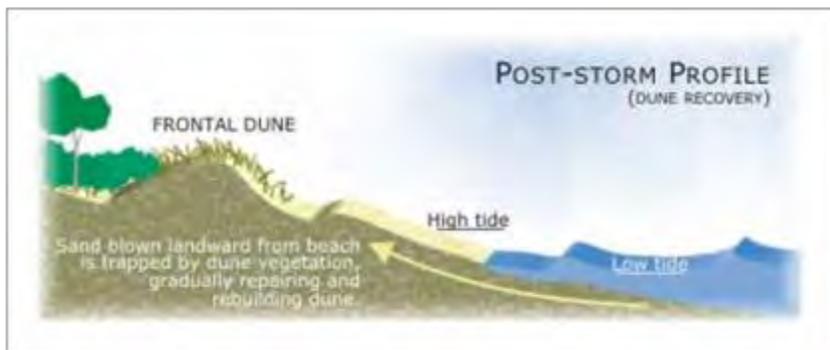
Figure 5: During calmer wave conditions, sand from the offshore bars makes its way to the beach and over time the dunes rebuild (source: Waikato Regional Council, 2011)

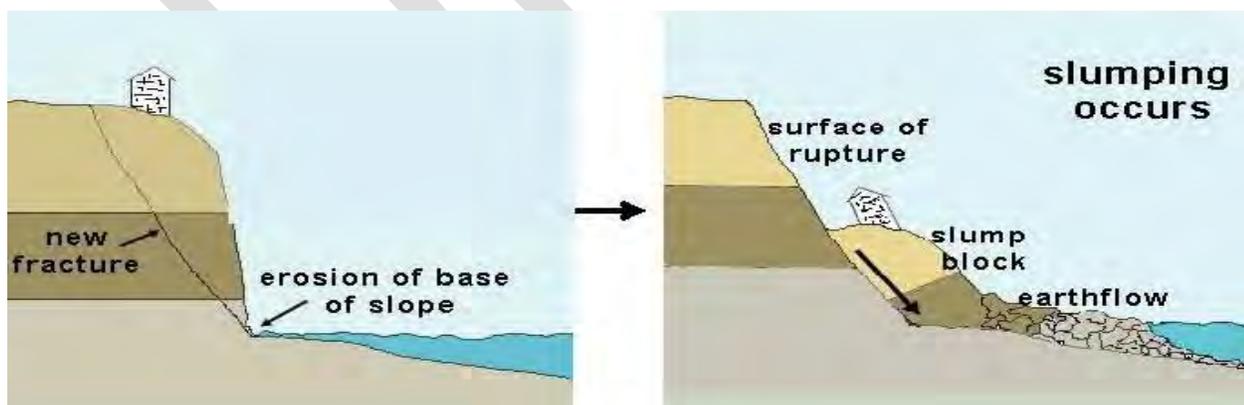
Figure 6: Processes of cliff erosion.

There are many cliff shorelines in the Waikato District, including much of the open ocean coastline, and a large proportion of the Raglan Township shoreline. The mechanisms of slope failure and potential for erosion vary greatly depending on cliff geology, height and physical setting.

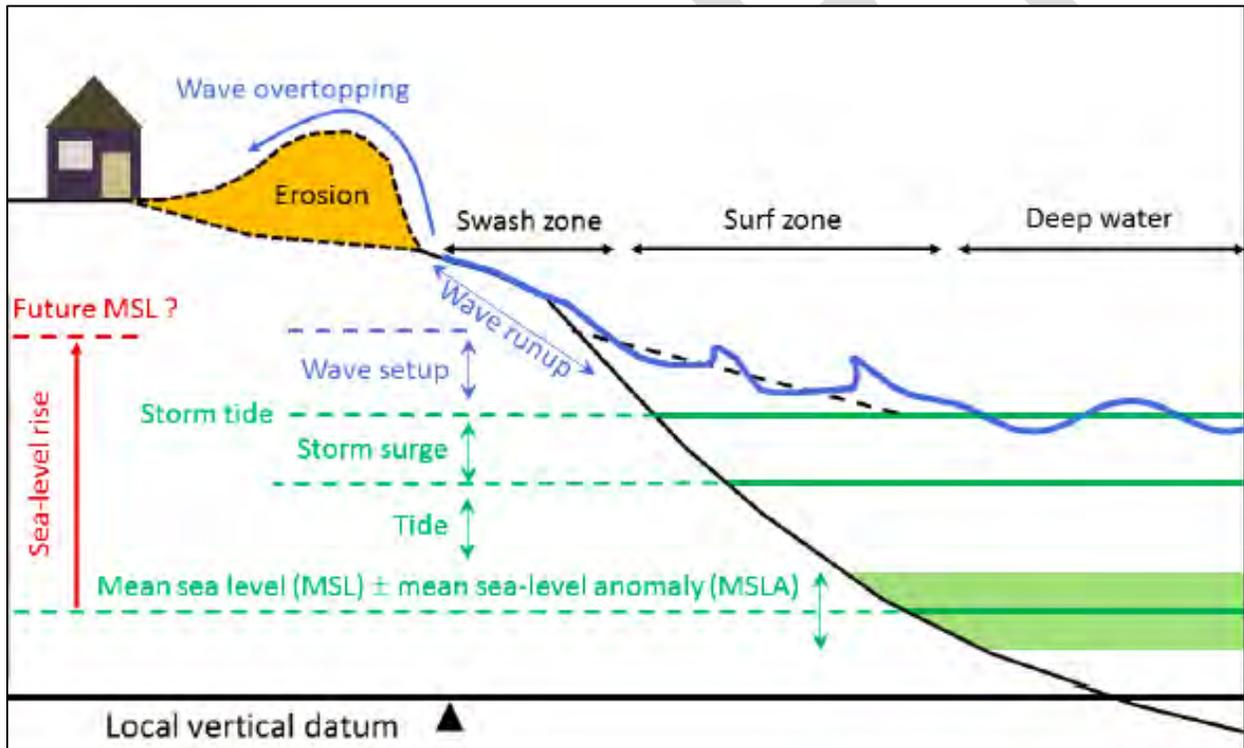
Figure 7: Summary diagram showing the various components that contribute to coastal storm inundation (source: Figure 30 from MfE, 2017)

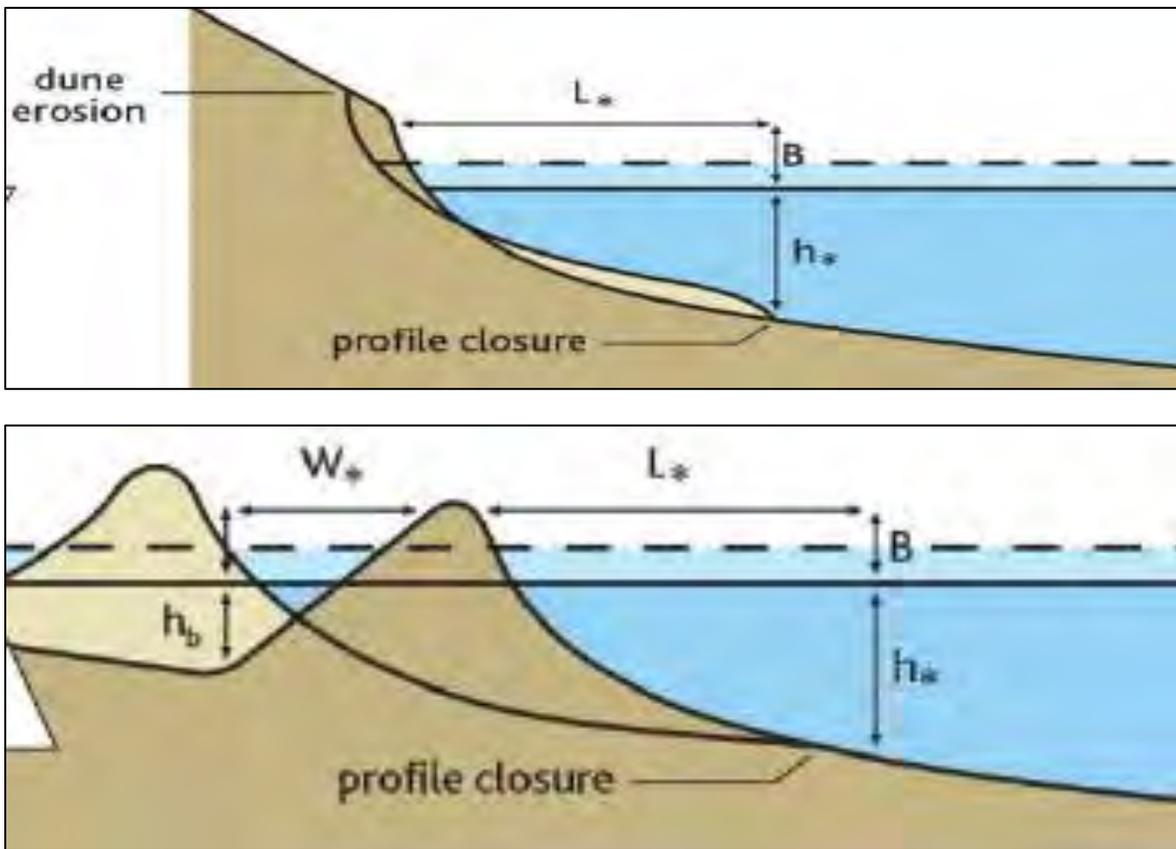
Figure 8: Schematic diagrams showing the standard Bruun Rule (top) and the generalised Bruun Rule (bottom) (Modified from Figure 1 in Shand et al. 2013).

These simple two-dimensional geometric models assume that neither the cross-shore shape of the beach profile nor the plan shape of the beach system are otherwise significantly modified; as might occur if climate change affects other key drivers additional (e.g. wave climate; sediment supply/budget). Obviously, this is an area of considerable uncertainty, one of many relating to potential climate change effects. It is our view that any such changes on the Waikato coast are more likely to aggravate rather than offset or mitigate erosion. We therefore believe that the use of these simple geometric models to provide indicative estimates of erosion is not likely to significantly overestimate future erosional response. It is important to appreciate that (regardless of the assessment model used), estimates of shoreline response to sea level rise are always indicative rather than being accurate predictions. Future monitoring and the use of adaptable management approaches are therefore critical to successful long-term management.

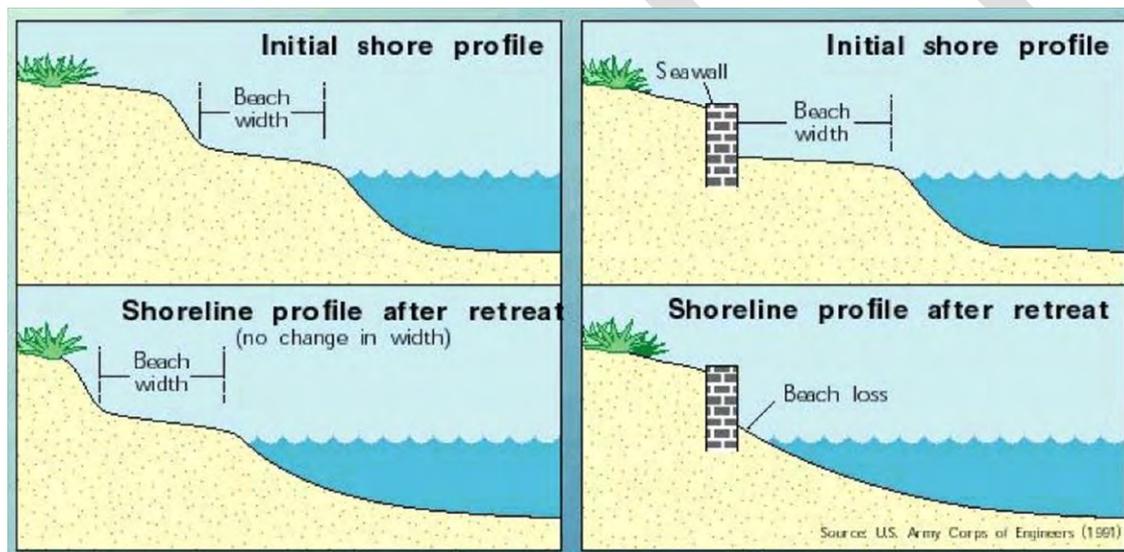
As the beach level drops in front of the seawall, wave and tidal impacts on the seawall also increase. Larger waves can impact the structure, requiring more robust engineering to avoid wall failure. Beach lowering can also expose seawall foundations, or cause slumping of sloping rock structures. Seawalls often also cause increased “end effect” erosion of unprotected shorelines nearby.

A seawall separates the beach from the dune and interrupts the natural processes of beach recovery. Without a functioning dune, it is more difficult for the shoreline to recover from short term erosion. Loss of beach impacts on the recreational value of the beach as well as on natural character and ecological values.

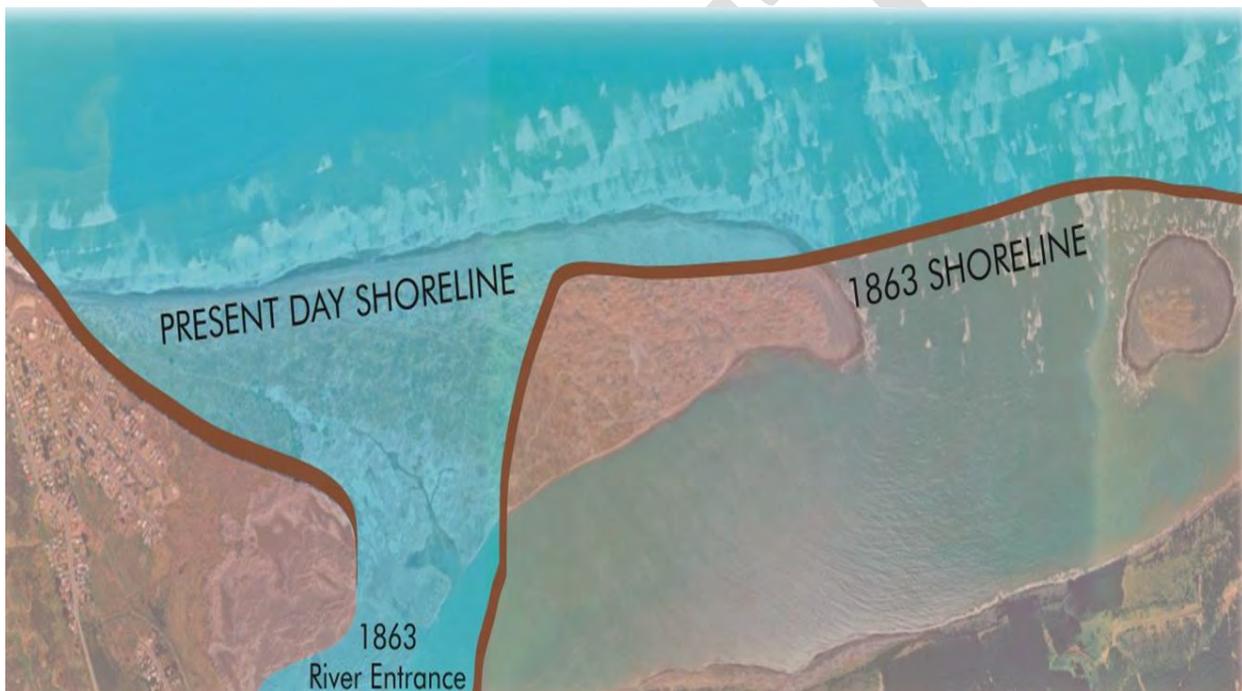
Figure 11: Overlay of the 1863 and a relatively recent (1990s) shoreline. Note the severe erosion of the 1863 shoreline that has accompanied the northward growth of the spit. Source – Waikato Regional Council

The Port Waikato sand spit is known to be a very dynamic feature and has extended northwards considerably since the earliest available survey of 1863 (Dahm, 1999; Earthtech, 2006; Tonkin and Taylor, 2007 & 2009; ASR, 2007). The present main river entrance is located over 3,200 m north of the entrance position surveyed in 1863 (Figure 11). There is also evidence of significant earlier changes. For instance, Smith (1878) reports being informed by local Maori that the coastline between Manukau Heads and Port Waikato once extended much further seaward, projecting in a curved line and composed of low sand country with numerous sand dunes, freshwater lakes and clumps of tall manuka. There is also evidence that the river entrance channel was once hard against the hills on the southern side of the township, field inspections indicating wetlands and low-lying areas that appear to have been a former channel. Similar evidence was noted by ASR (2007).

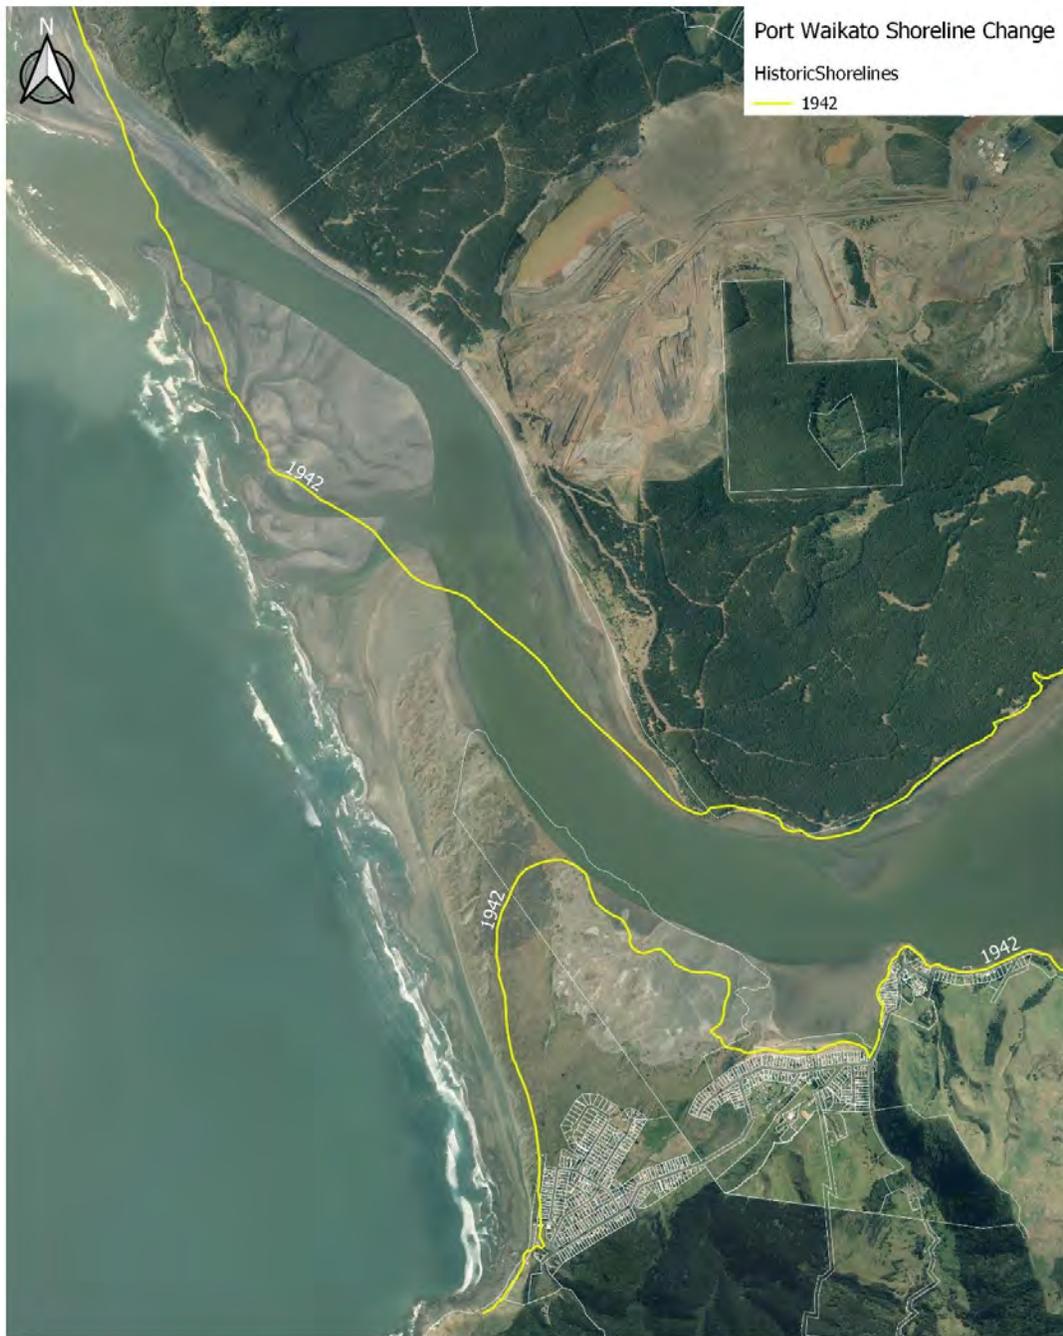
Figure 12: Recent aerial photograph of Port Waikato Township and spit. The yellow line illustrates the position of the shoreline in 1942. The scale of shoreline change over many decades is clearly evident.

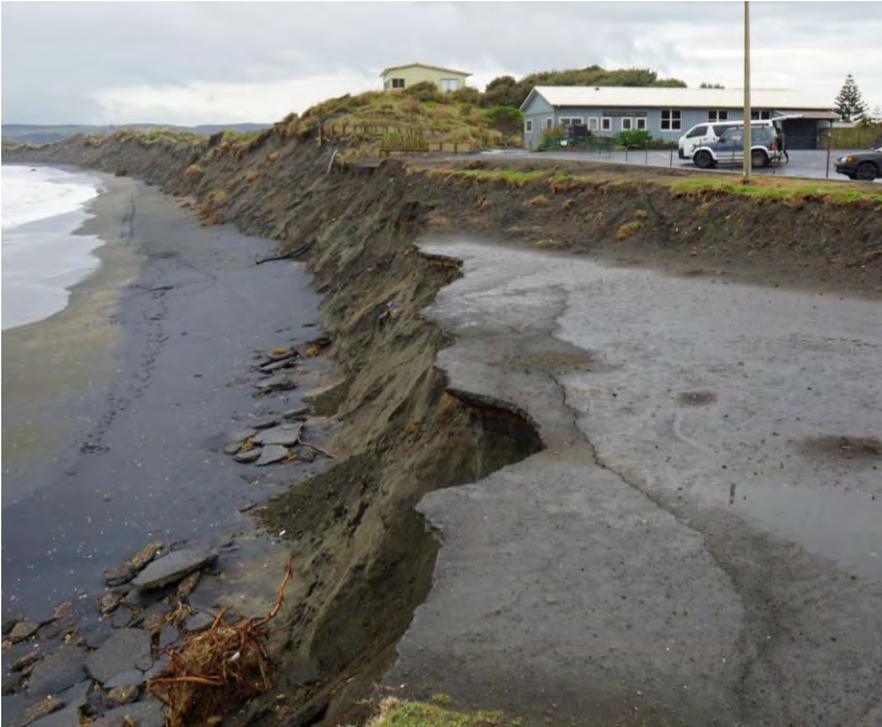
Figure 13: Erosion fronting the car park and private properties at the southern end of Sunset Beach.

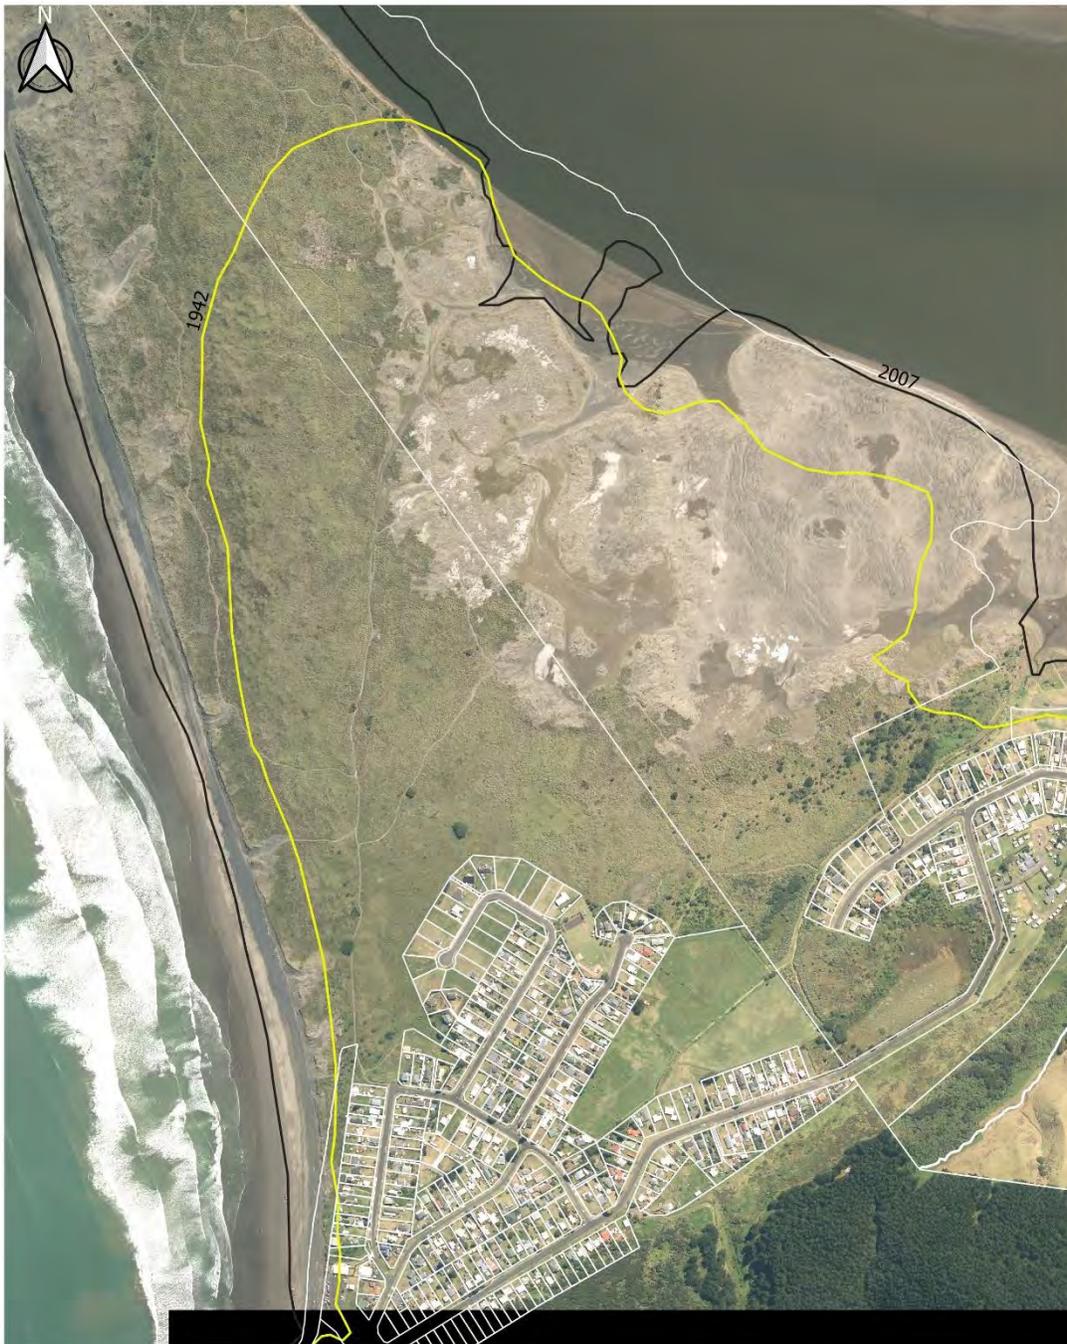
Figure 14: Shoreline change at Port Waikato Township. The current shoreline is still seaward of the 1942 shoreline location.

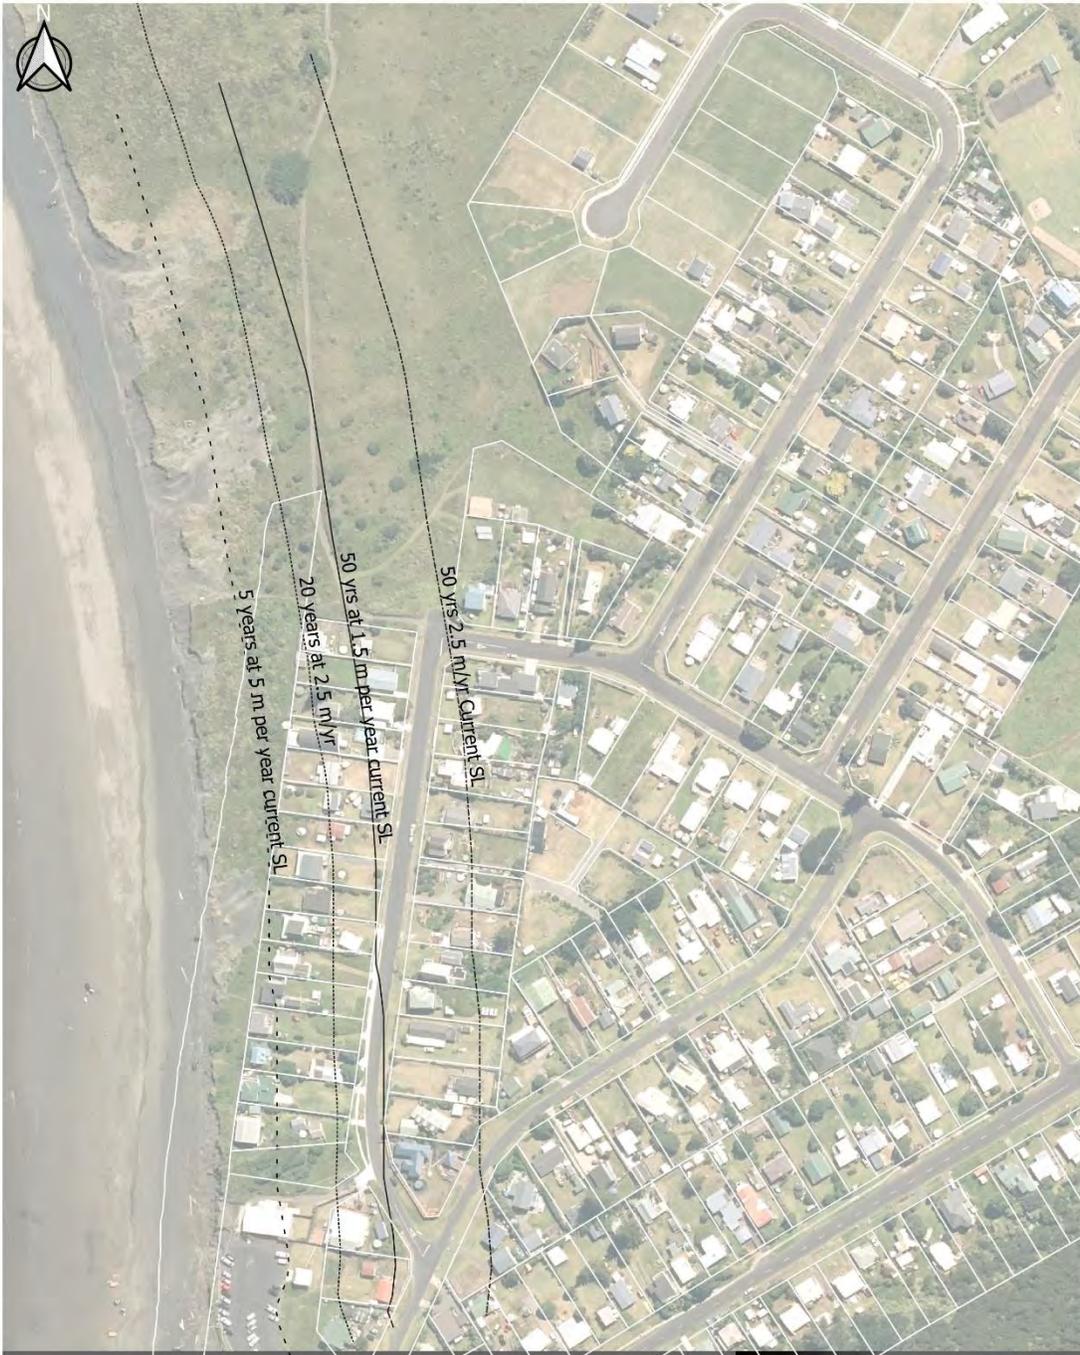
Port Waikato Shoreline Change Scenarios
 Prepared by Focus Resource Management Group
 © Waikato Regional Council 2018. Aerial Photography -
 Historic Aerial Photographs Data Sourced from <http://retrolens.nz> and licensed by LINZ CC-BY 3.0

The uncertainty in regard to future erosion is illustrated in Figure 15 which shows (by way of example only) various potential future scenarios with different erosion rates and timeframes. It can be seen that even with average erosion rates as low as 1.5 metres per year, erosion could extend considerably landward into the township over the next century. Obviously, if the much higher erosion rate experienced over the last decade (5 m/yr) were to persist longer term, much more severe erosion would be experienced. Equally, if the erosion is simply part of a multi-decadal shoreline fluctuation, much lesser erosion might occur and eventually some recovery.

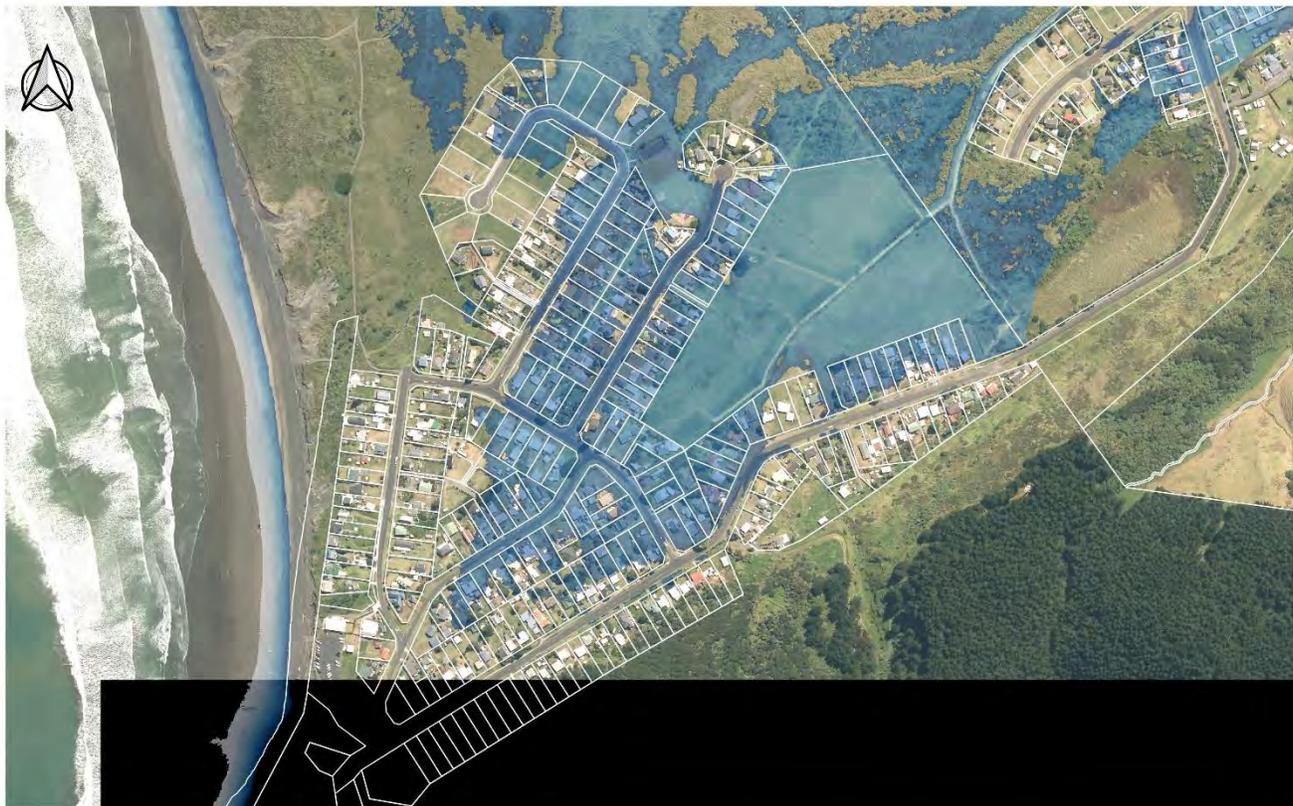
Waikato District Coastal Hazards - Coastal Inundation 1%AEP with Current Sea Level
Prepared by Focus Resource Management Group
© Waikato Regional Council 2018. Aerial Photography - Historic Aerial Photographs Data
Sourced from <http://retrolens.nz> and licensed by LINZ CC-BY 3.0

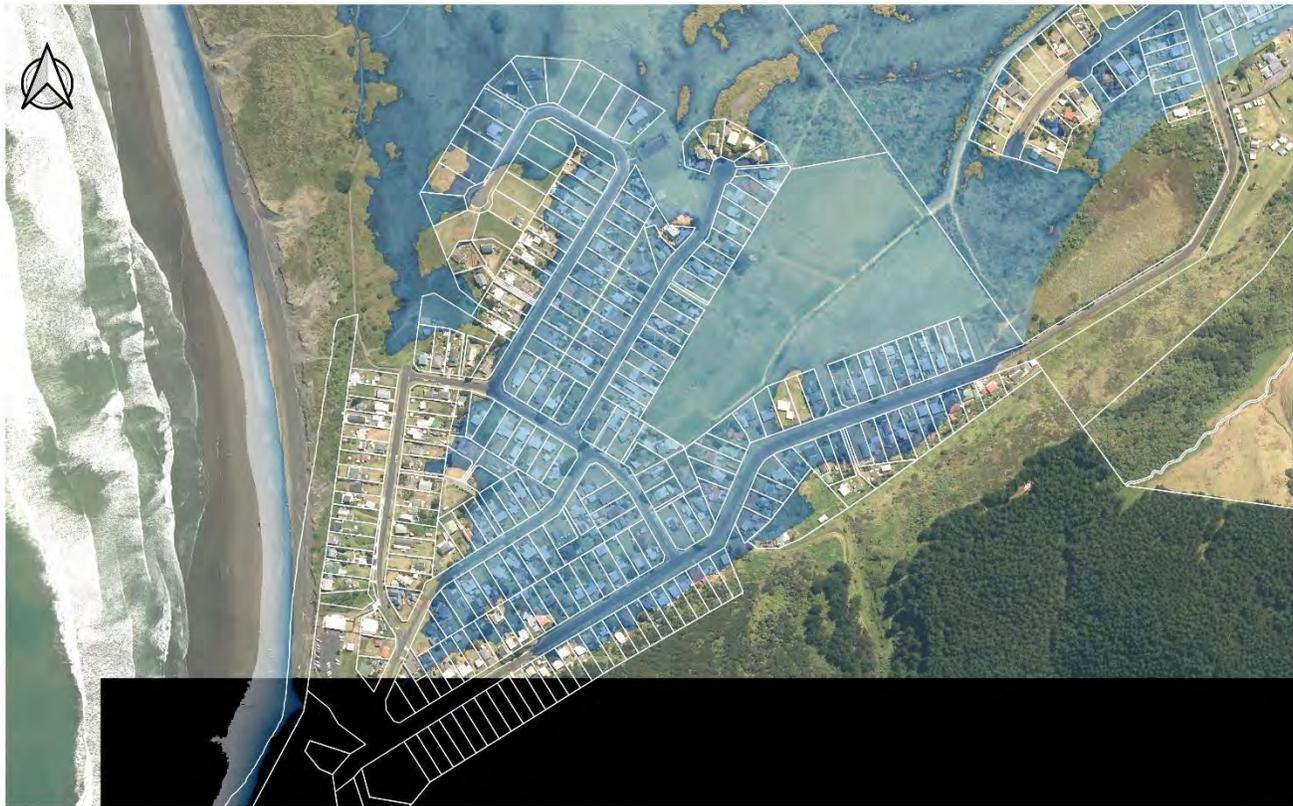
Waikato District Coastal Hazards - Coastal Inundation 1%AEP with 1.0 m Sea Level Rise
 Prepared by Focus Resource Management Group
 © Waikato Regional Council 2018. Aerial Photography - Historic Aerial Photographs Data
 Sourced from <http://retrolens.nz> and licensed by LINZ CC-BY 3.0

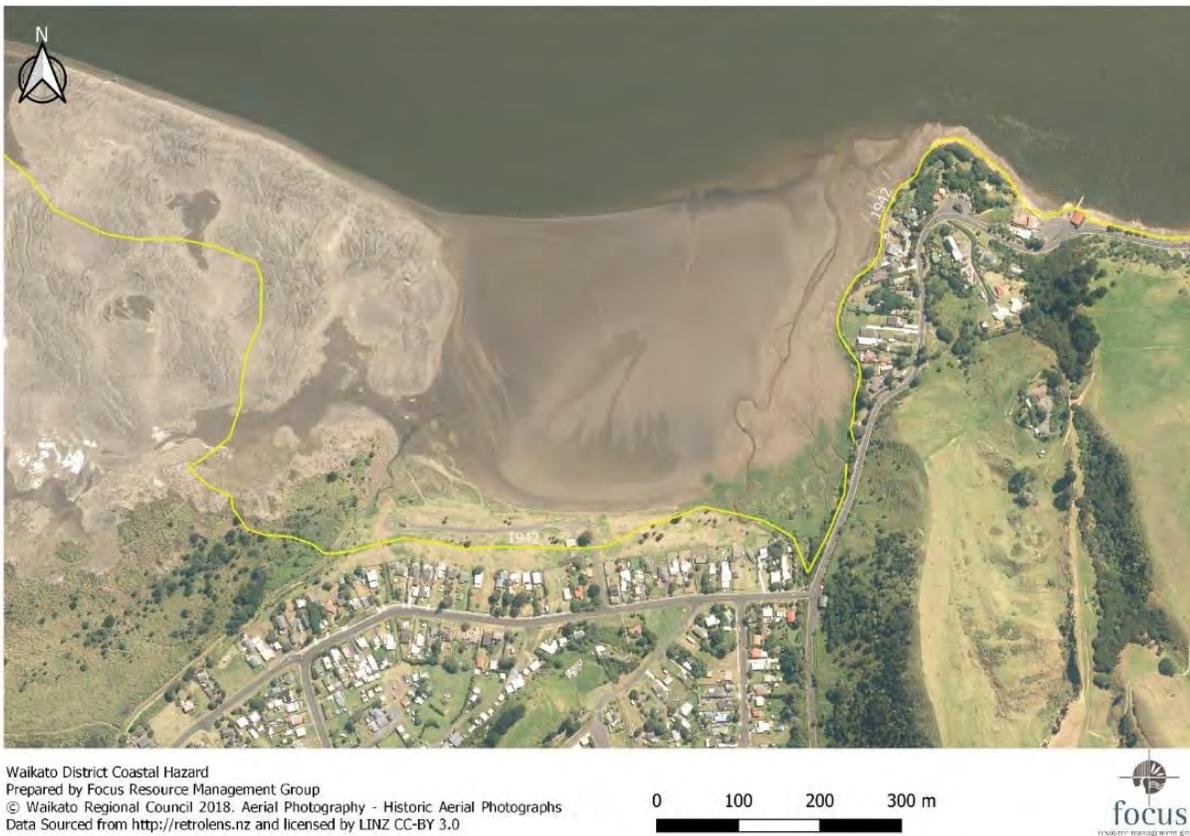
Figure 18: Maraetai Bay at Port Waikato. The yellow line indicates the location of the shoreline in 1942.

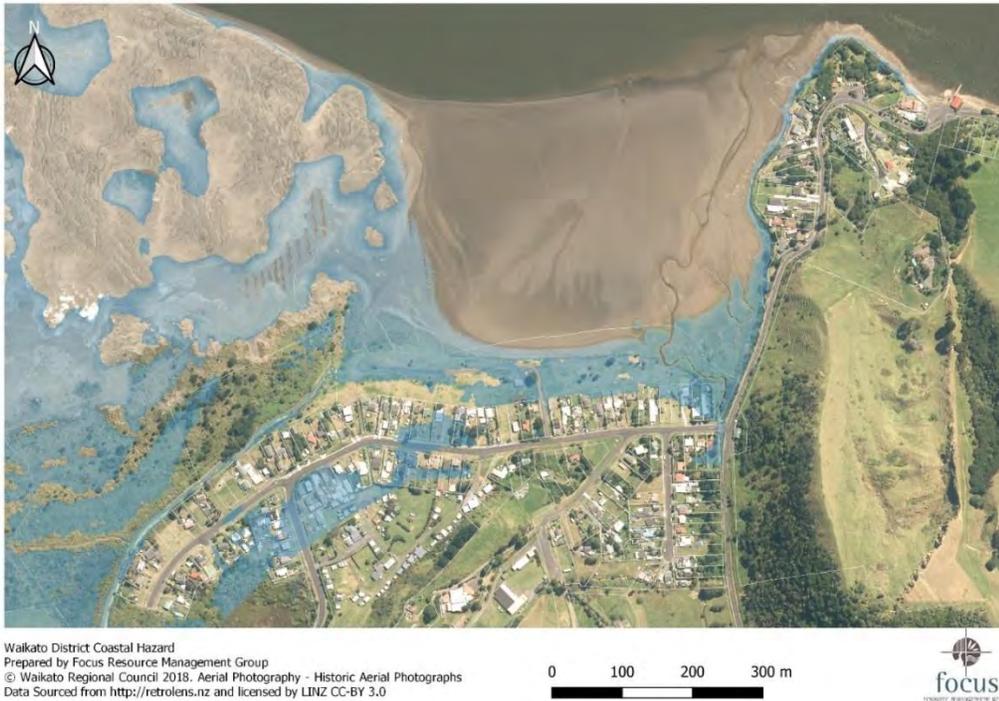
Figure 19: Broad area currently at risk from coastal inundation with a 1%AEP extreme event (for levels see Section 4.2). Source: Waikato Regional Council Coastal Inundation Tool <http://coastalinundation.waikatoregion.govt.nz/>.

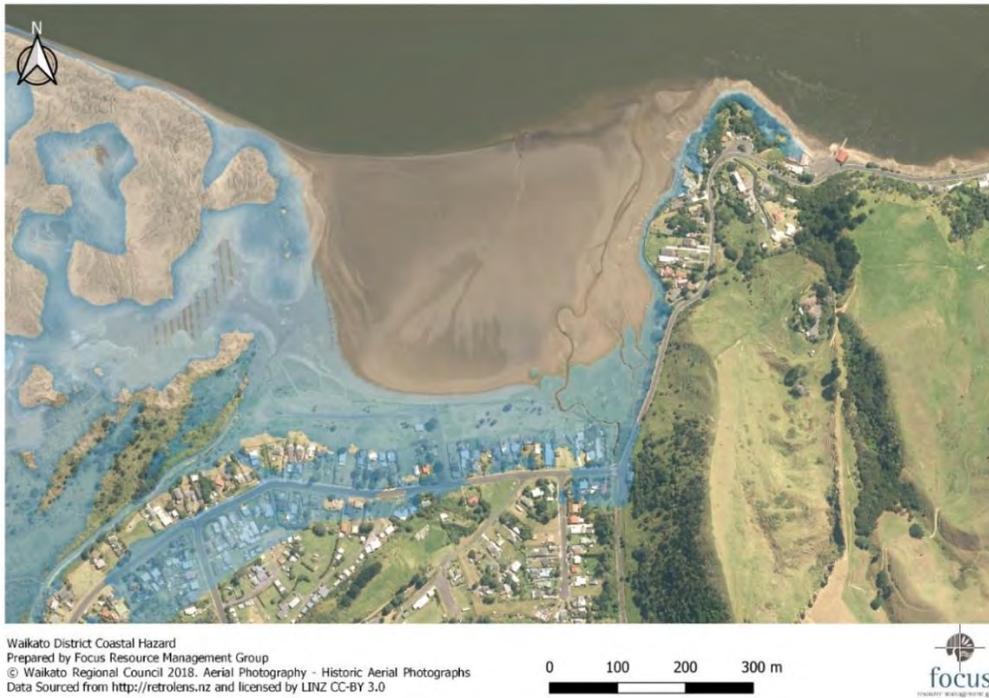
Figure 20: Area likely to be at risk from coastal inundation in a 1%AEP extreme event with 1.0 m of sea level rise (for levels see Section 4.2). Source: Waikato Regional Council Coastal Inundation Tool <http://coastalinundation.waikatoregion.govt.nz/>.

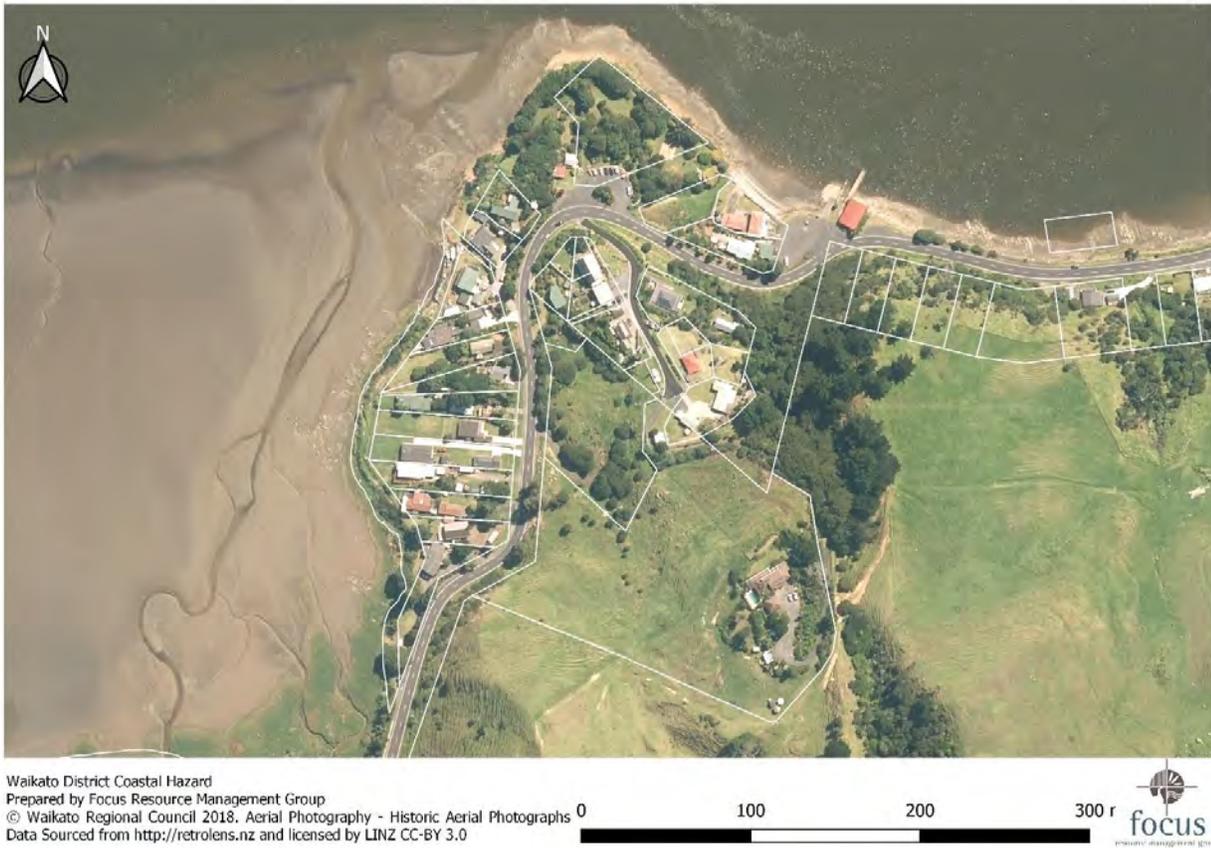
Figure 22: Aerial view of the Putataka Headland with property boundaries overlaid. The Cobourne Reserve occupies the entire seaward end of the headland and there is a wide public reserve around the entire coastal margin.

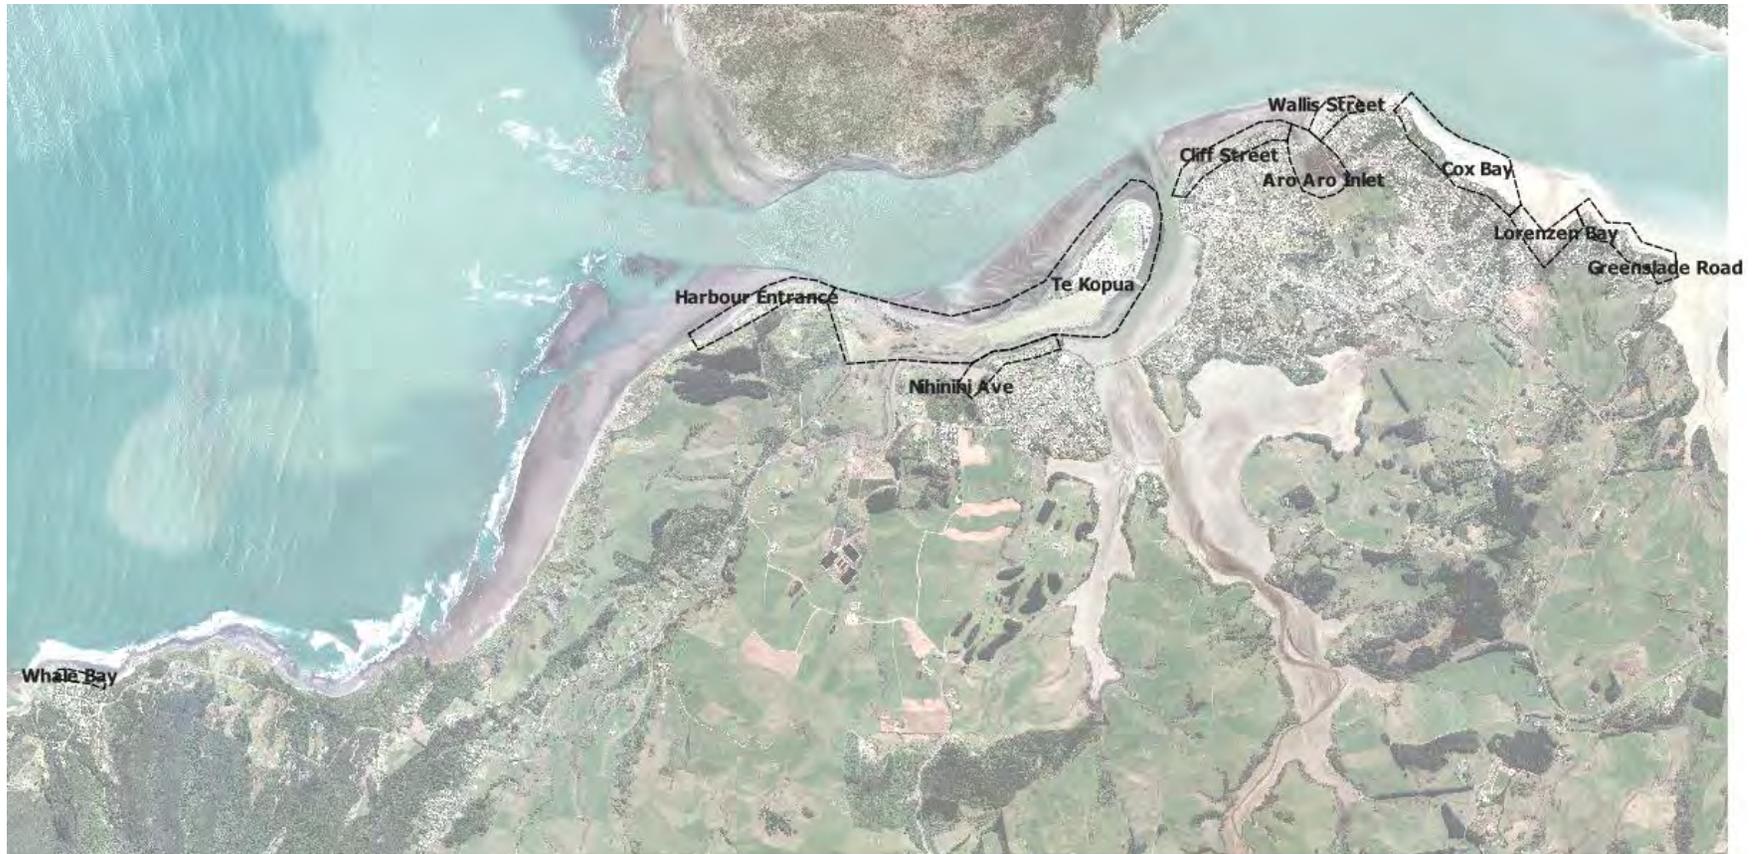
Figure 23: Priority coastal management areas at Raglan as numbered above. © Waikato District Council. Aerial Photography - Historic Aerial Photographs Data LICENSE: Creative Commons Attribution 4.0 International. <https://data.linz.govt.nz/license/attribution-4-0-international/>

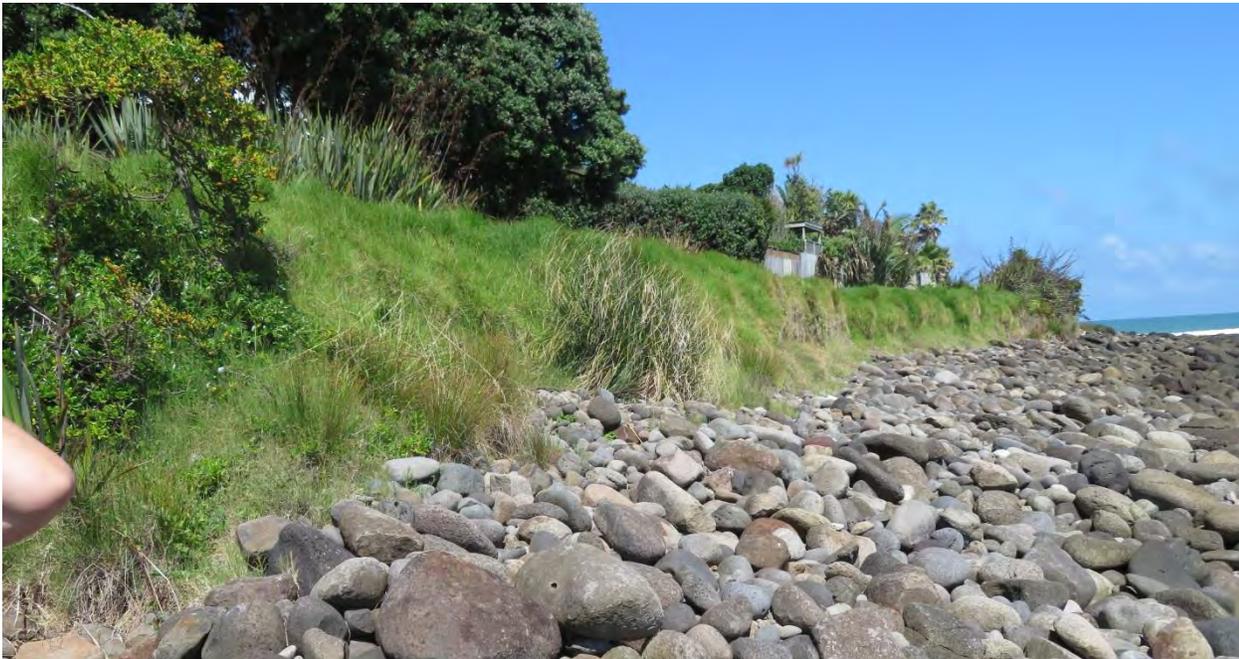
Figure 24: View of vegetated erosion scarp fronting the grassed reserve in Whale Bay township

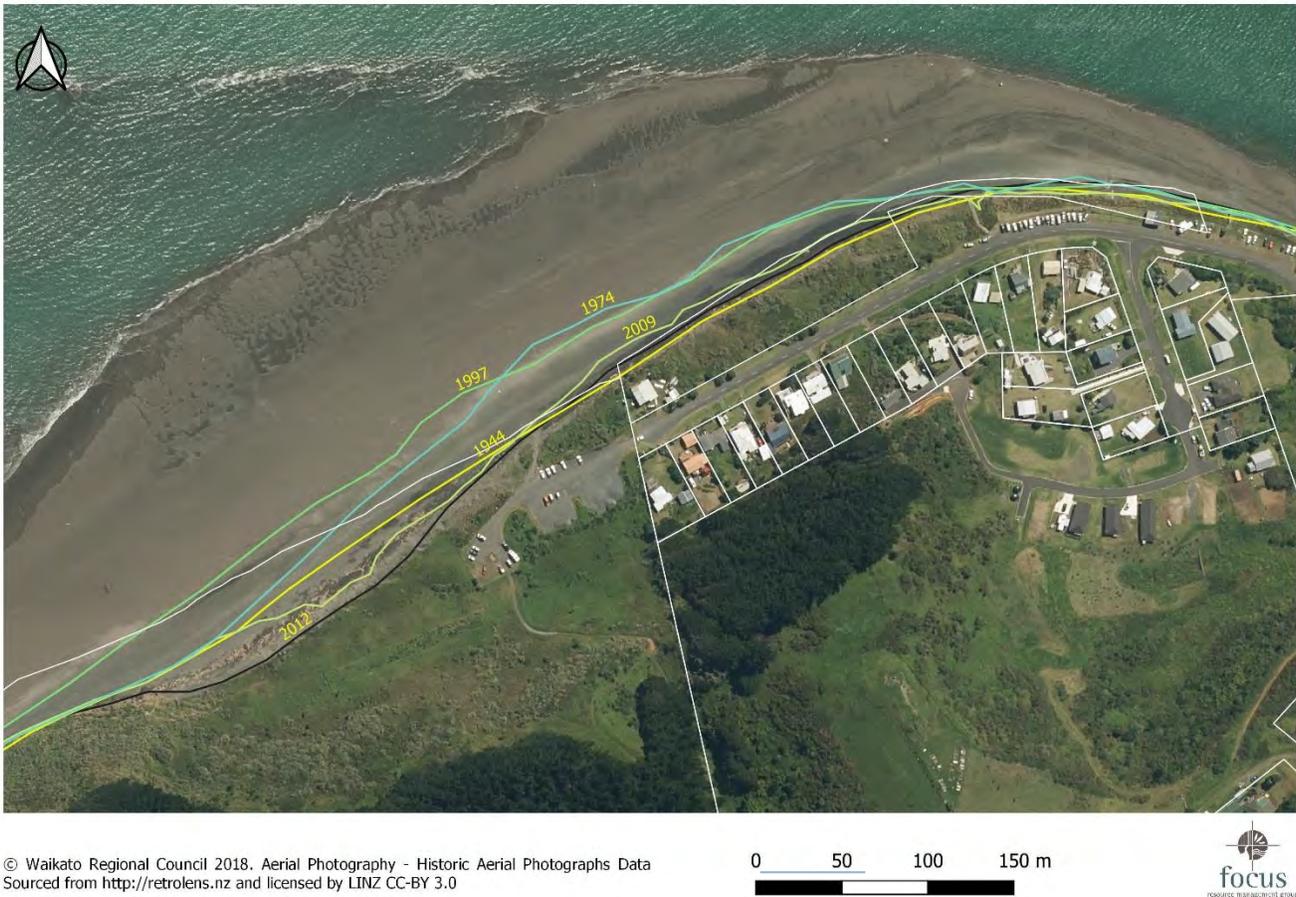
Figure 25: Shoreline change at the Raglan Harbour Entrance.

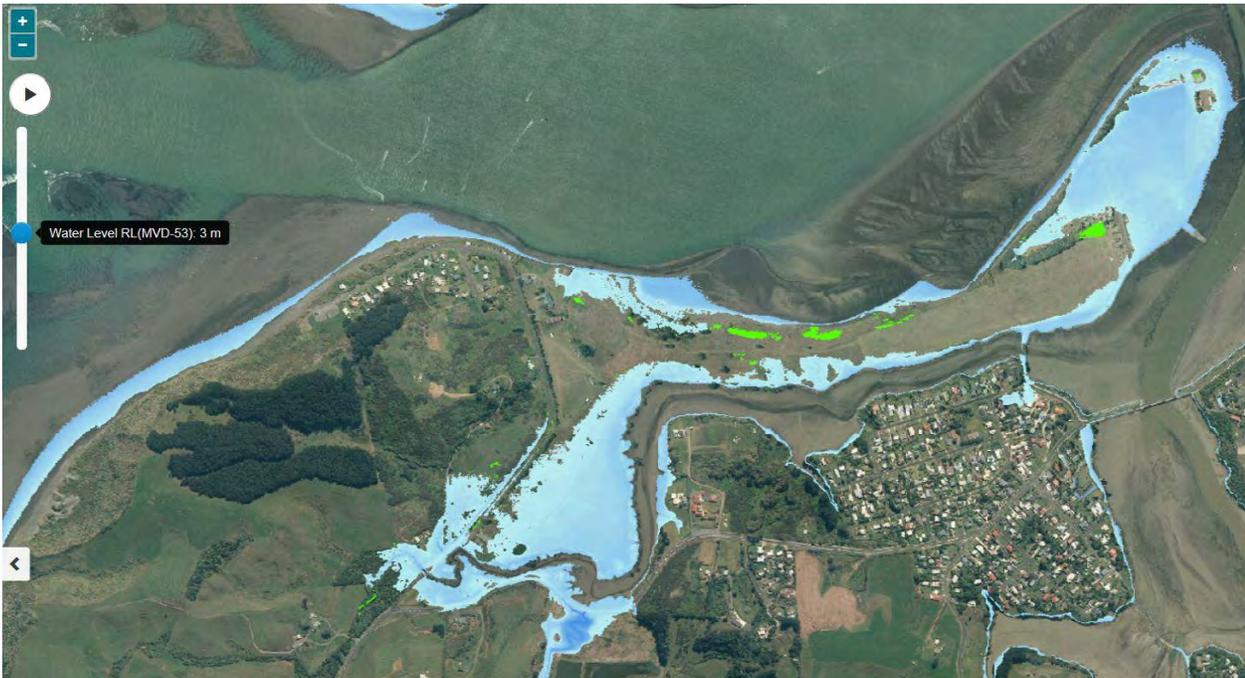
Figure 28: Illustration of the areas likely to be inundated (coloured) in a severe storm. Waikato Regional Council Coastal Inundation Tool <http://coastalinundation.waikatoregion.govt.nz/>.

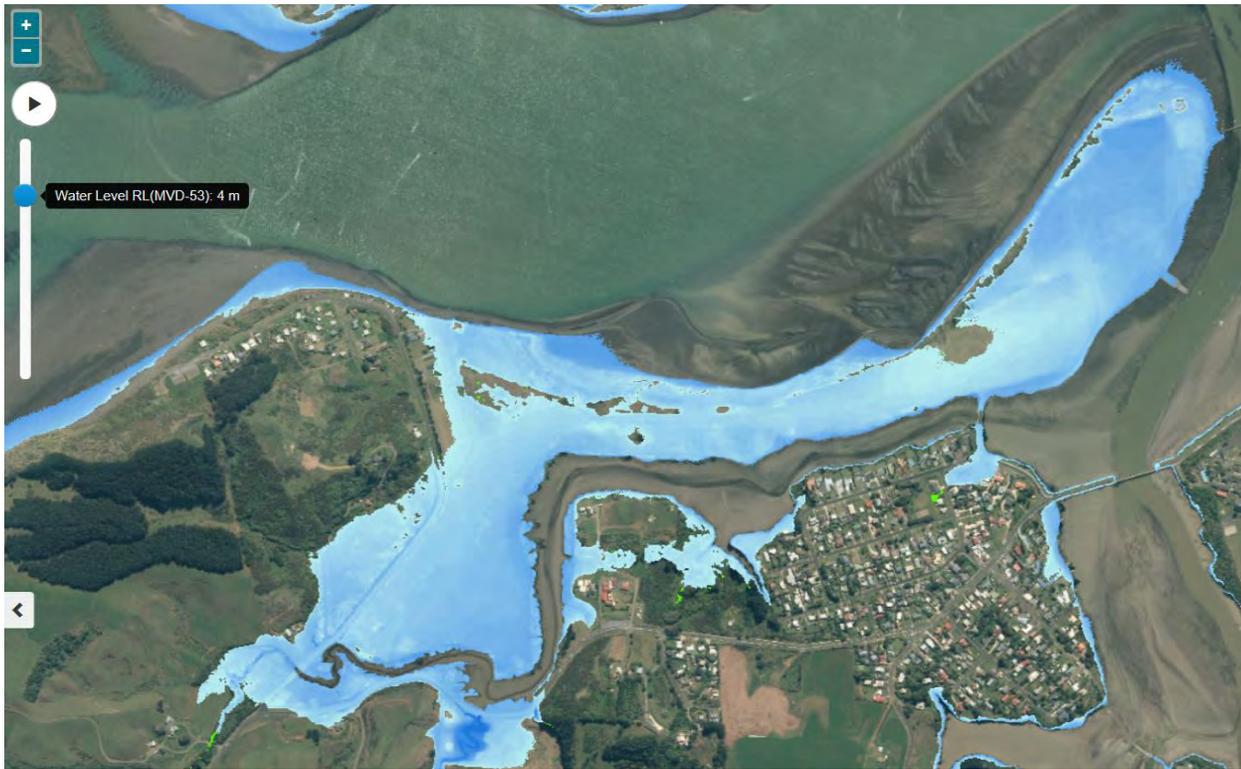
Figure 29: Broad area potentially at risk from coastal inundation in a 1%AEP extreme event after 1.0 m of sea level rise. Waikato Regional Council Coastal Inundation Tool <http://coastalinundation.waikatoregion.govt.nz/>.
