WAIKATO DISTRICT COUNCIL COASTAL HAZARDS

Waikato District Coastal Hazard Assessment

**PREPARED FOR WAIKATO DISTRICT COUNCIL
BY MEMBERS OF FOCUS RESOURCE MANAGEMENT GROUP:**

FOCUS, 2019: Waikato District Coastal Hazard Assessment. Prepared for Waikato District Council by the Focus Resource Management Group. Focus Report No. 19/130.

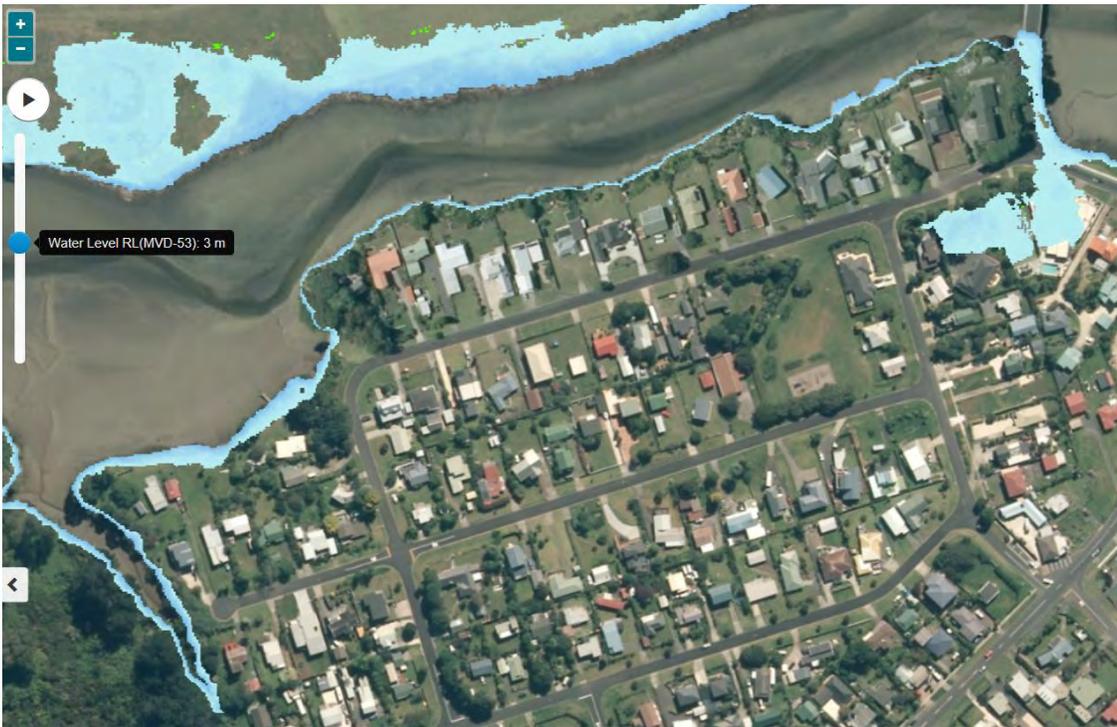
Figure 31: Broad area currently at risk from coastal inundation in extreme events. Waikato Regional Council Coastal Inundation Tool <http://coastalinundation.waikatoregion.govt.nz/>.

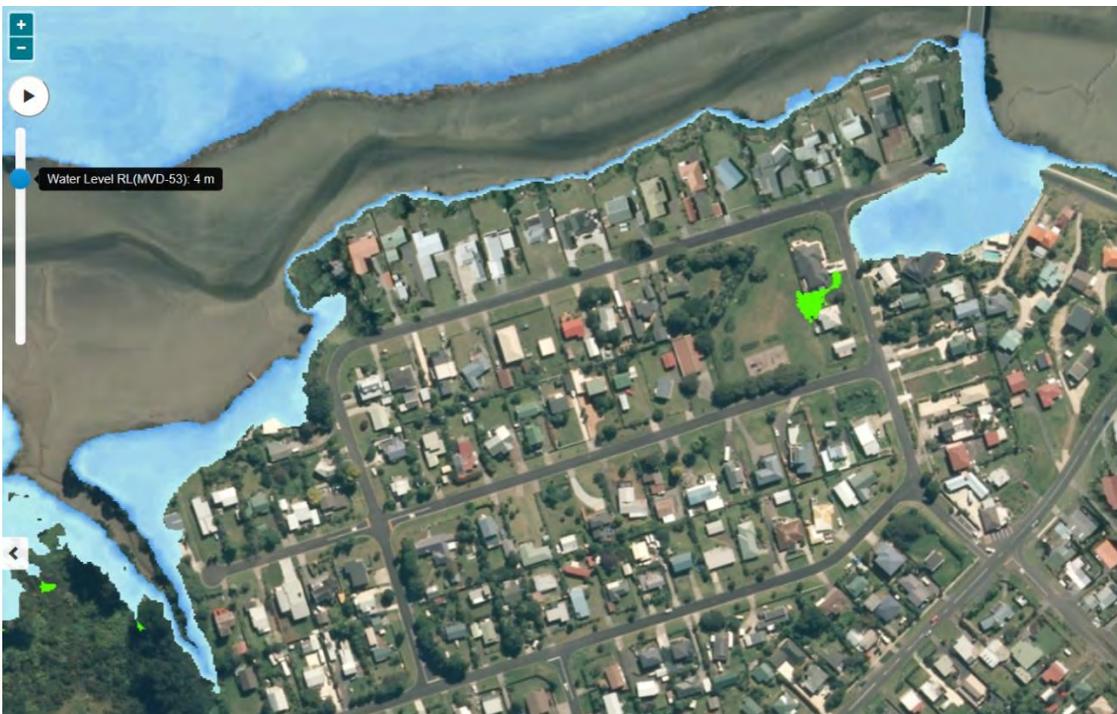
Figure 32: Broad area currently at risk from coastal inundation in extreme events. Waikato Regional Council Coastal Inundation Tool <http://coastalinundation.waikatoregion.govt.nz/>.

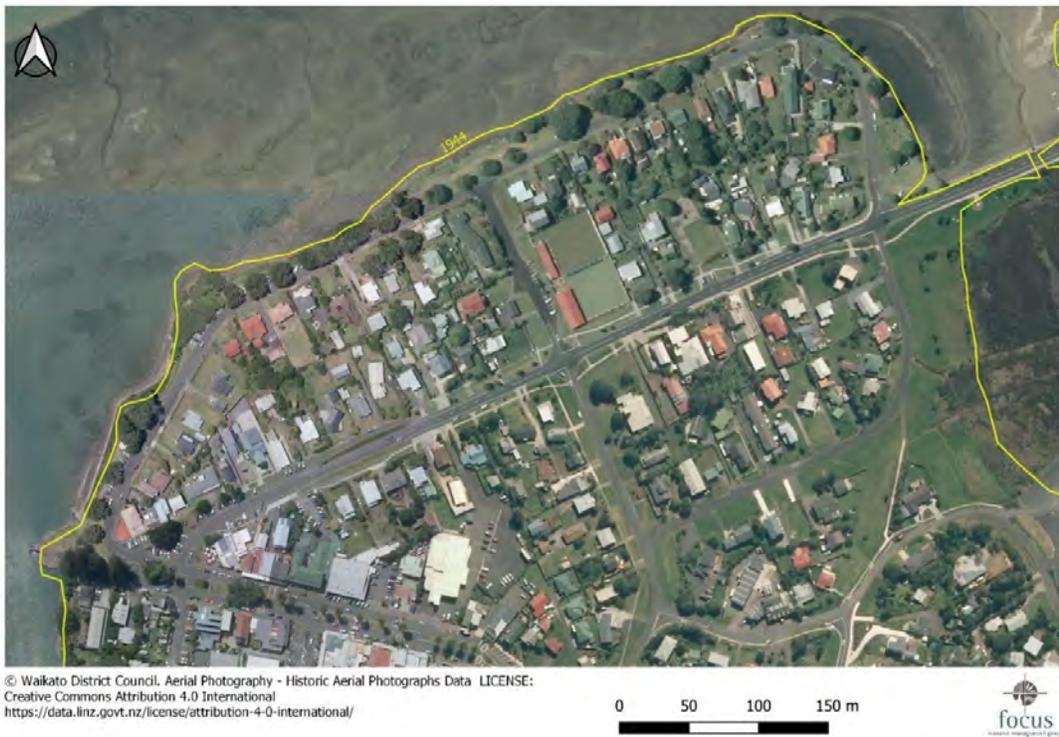
Figure 33: Cliff Street showing 1944 shoreline (yellow) over a modern photograph.

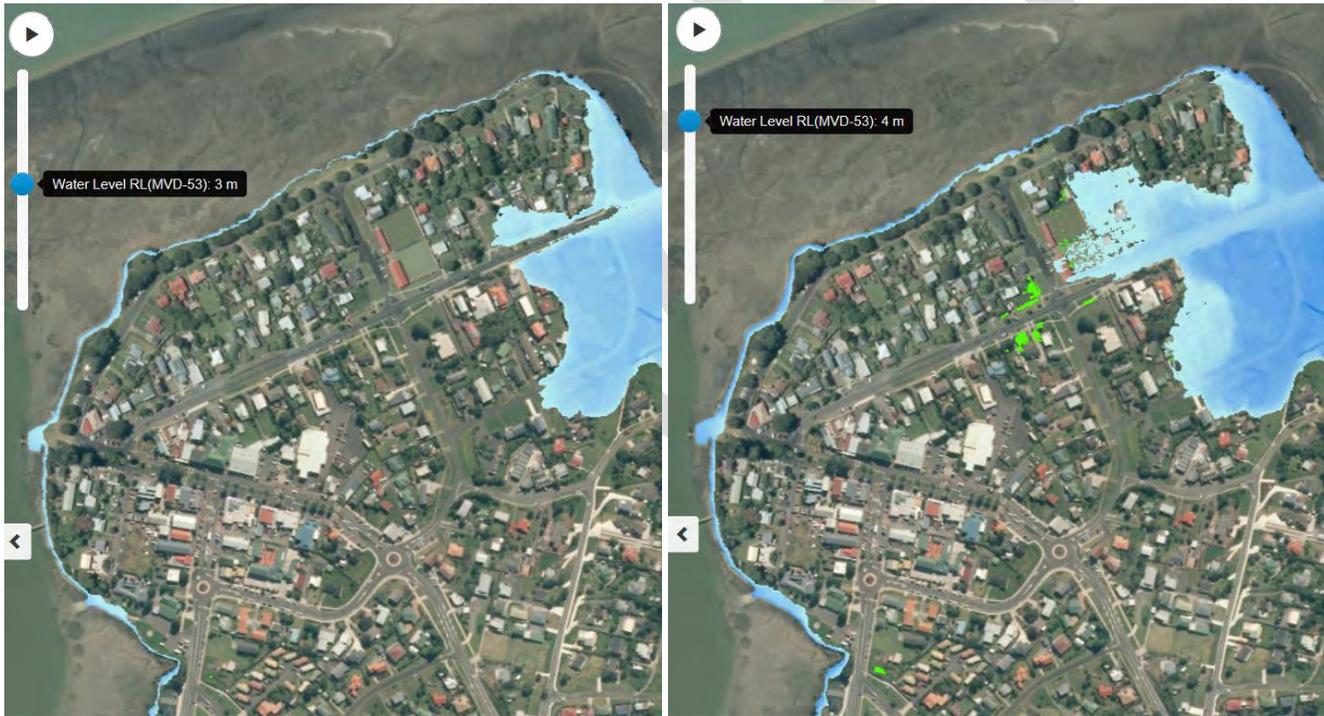
Figure 35: Broad area at risk from coastal inundation with current sea level (left) and with 1.0 m of sea level rise (right). Waikato Regional Council Coastal Inundation Tool (<http://coastalinundation.waikatoregion.govt.nz/>).

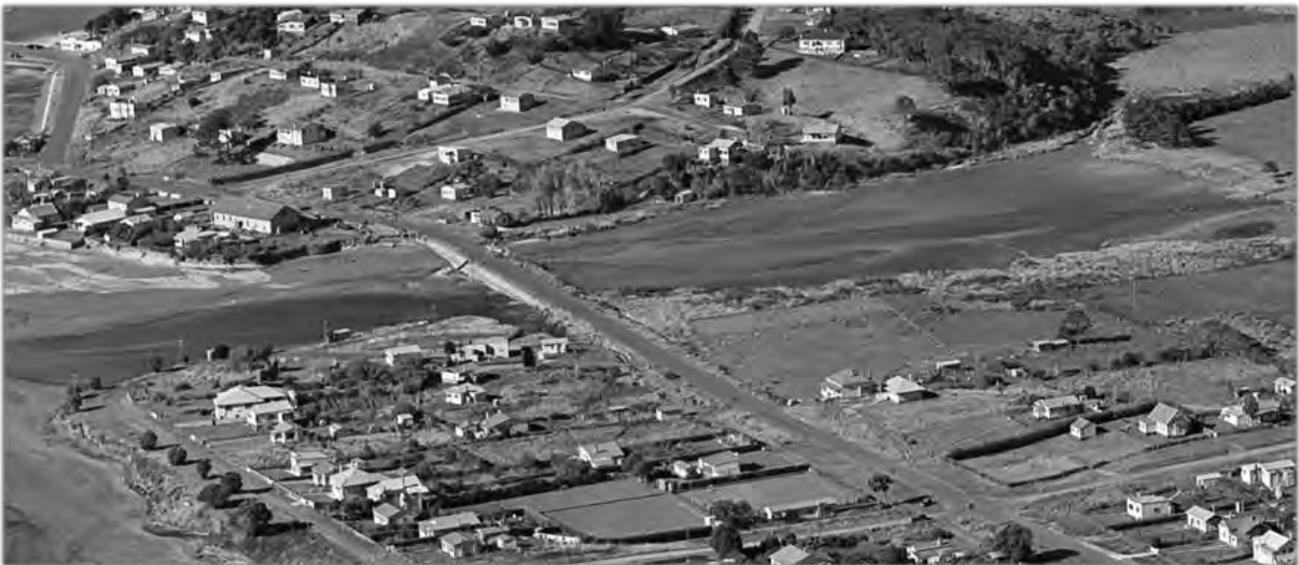
Figure 36: Aro Aro Inlet in 1951. Whites Aviation Collection, Alexander Turnbull Library. Attribution 4.0 International (CC BY 4.0). The upper reaches of the estuarine arm (not shown) had already been reclaimed from the sea at this time.

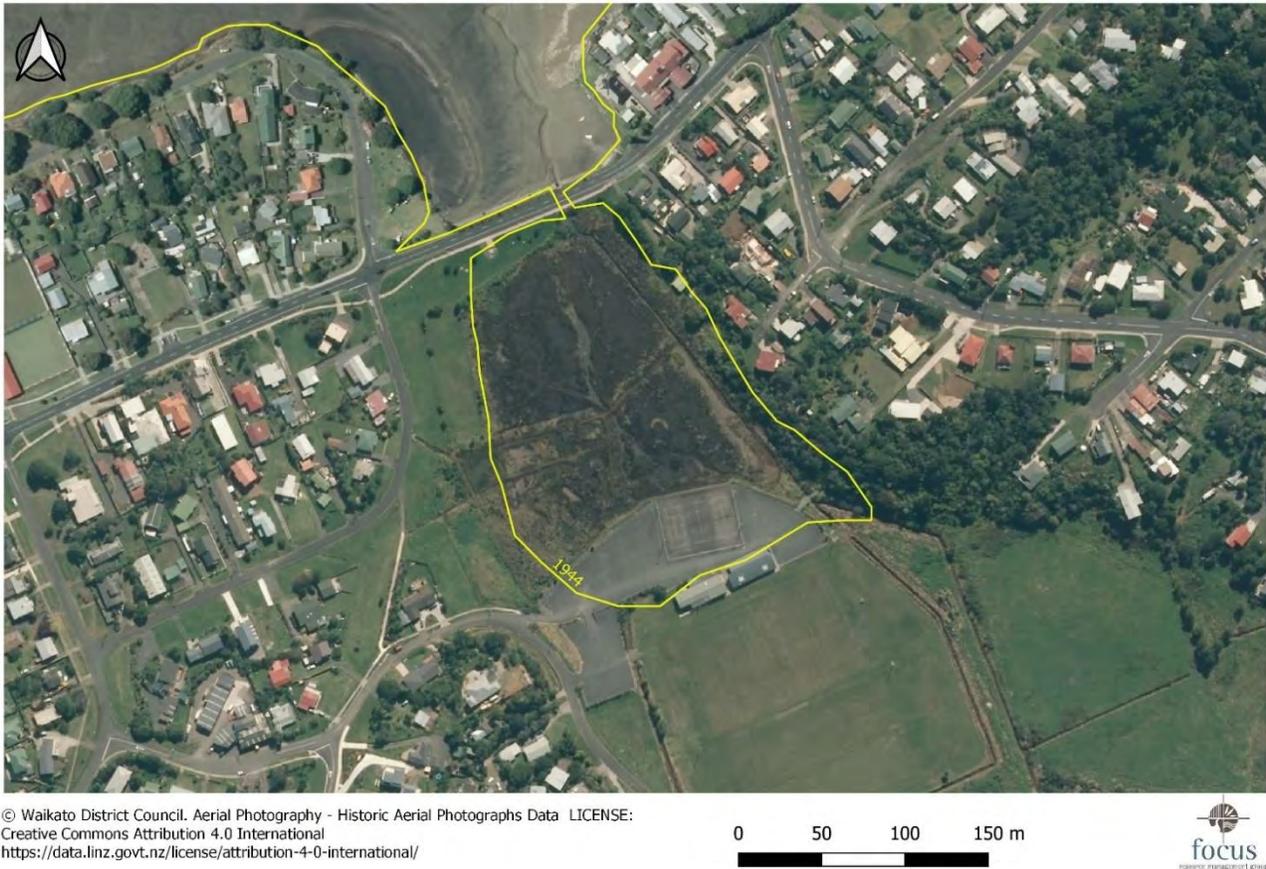
Figure 37: Aro Aro Inlet showing 1944 shoreline (white), clearly illustrating the extent of drainage and reclamation.

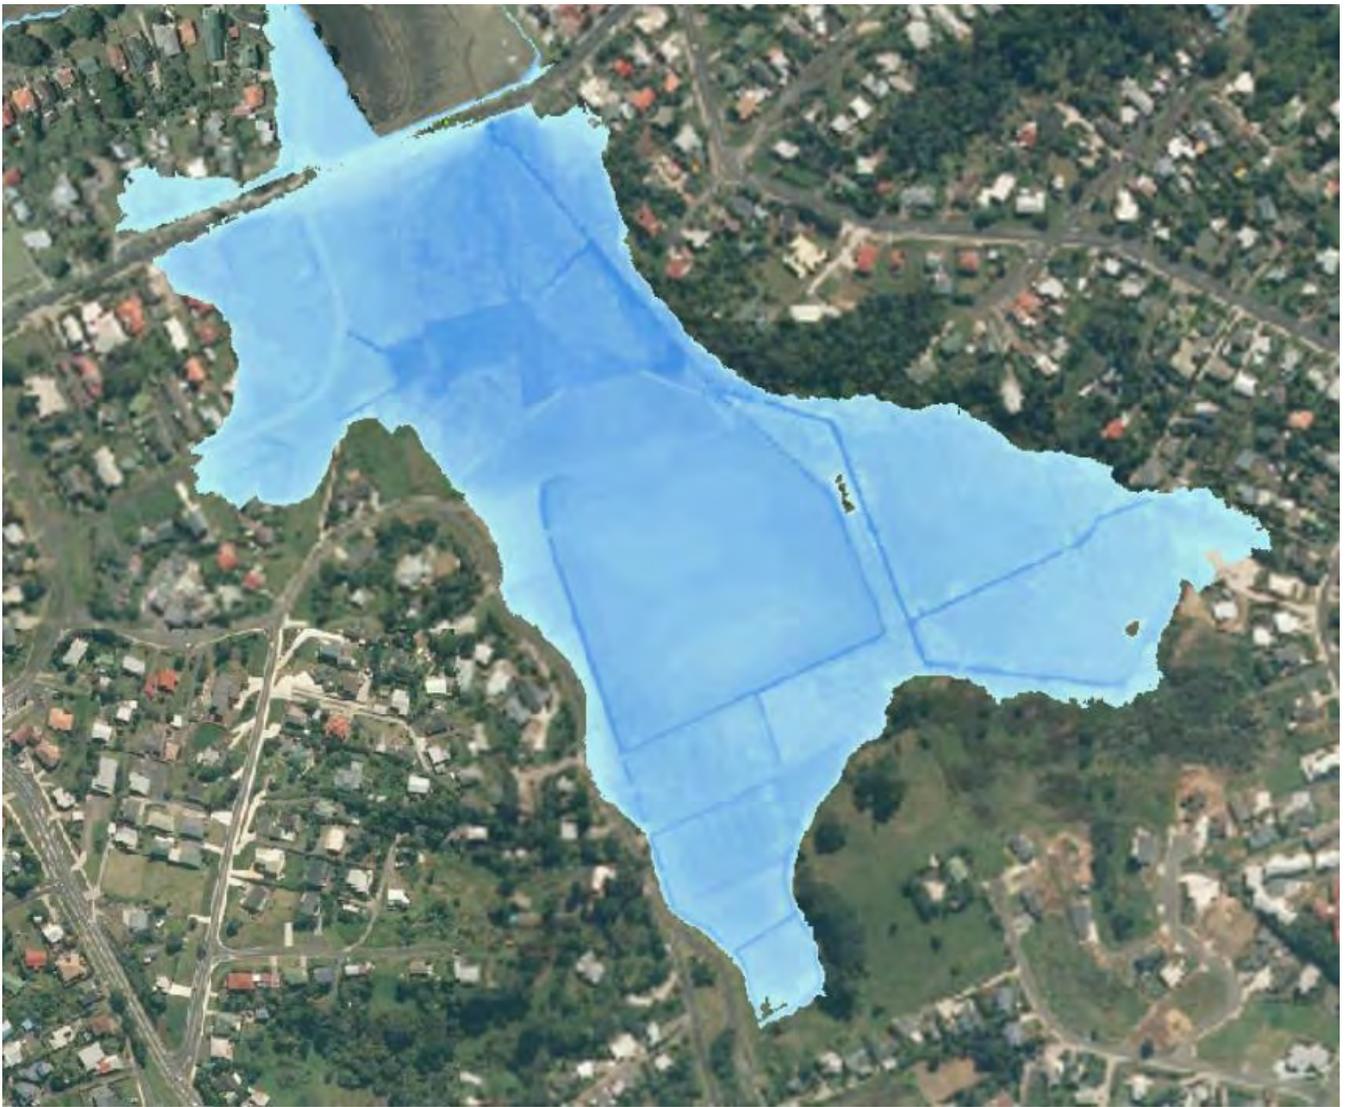
Figure 38: Broad area currently at risk from coastal inundation in extreme events (Waikato Regional Council Coastal inundation tool, <http://coastalinundation.waikatoregion.govt.nz/>).

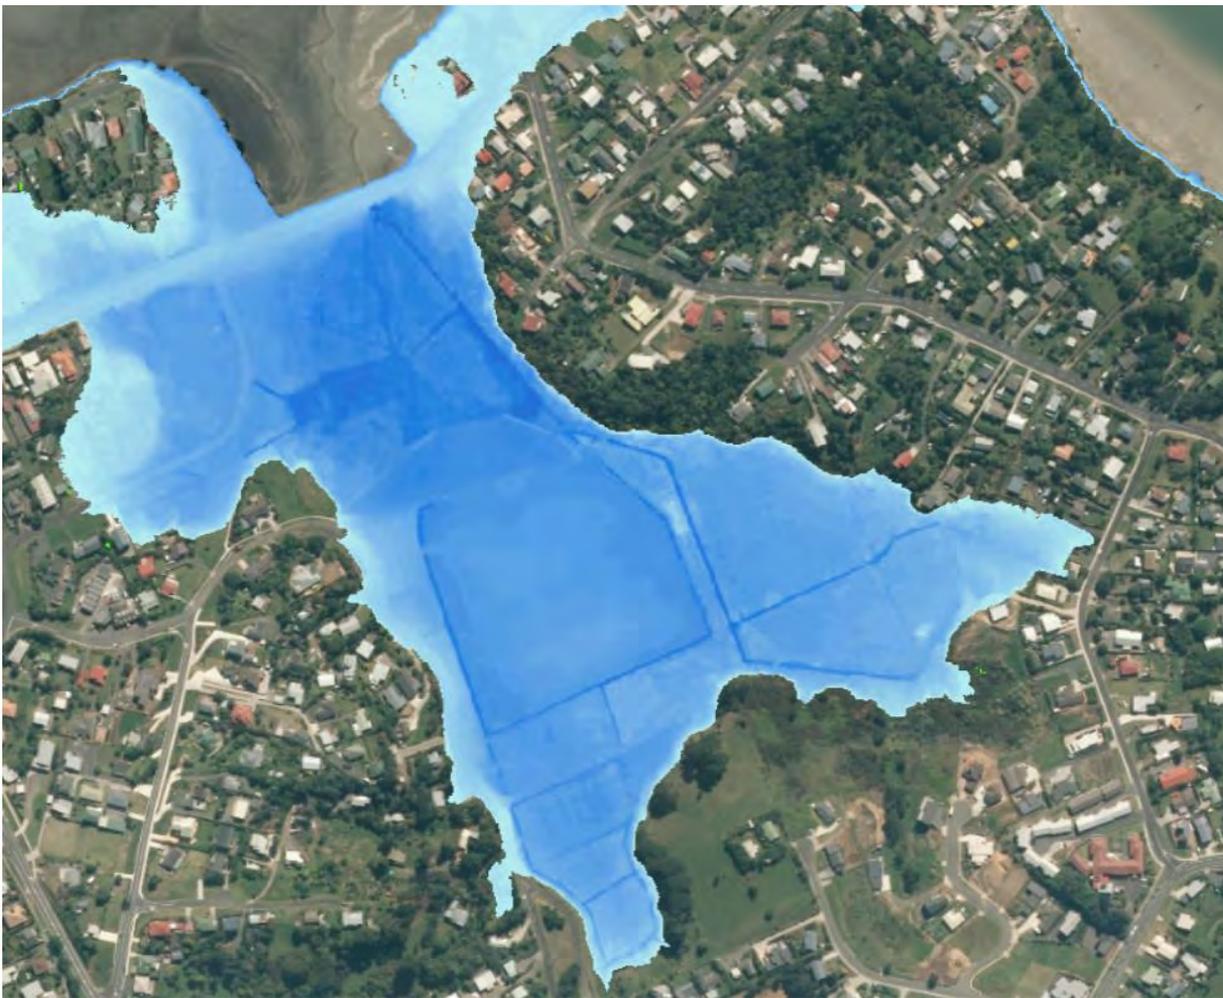
Figure 39: Broad area currently at risk from coastal inundation in extreme events following 1.0 m of sea level rise (Waikato Regional Council Coastal inundation tool, <http://coastalinundation.waikatoregion.govt.nz/>).

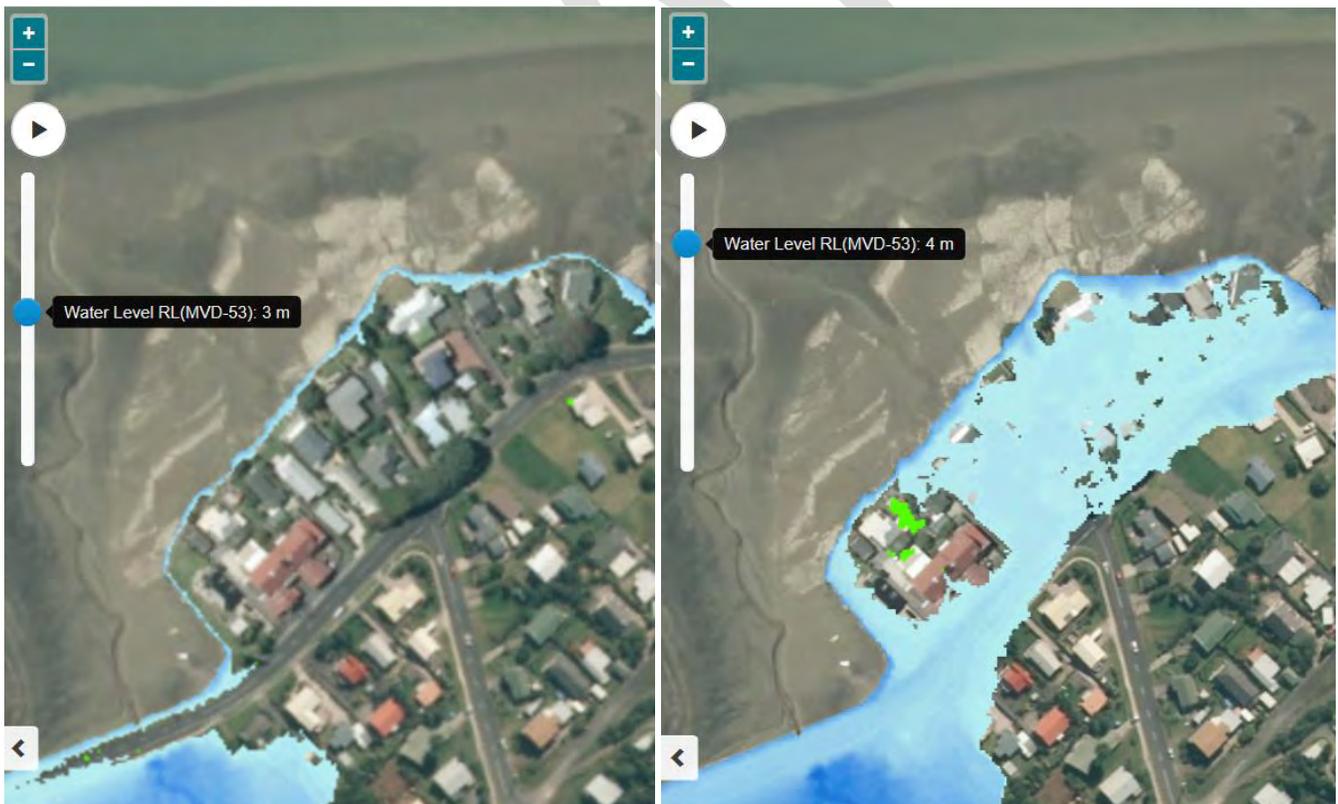
Figure 41: Broad area at risk from coastal inundation with current sea level (left) and with 1.0 m of sea level rise (right). Waikato Regional Council Coastal Inundation Tool (<http://coastalinundation.waikatoregion.govt.nz/>).

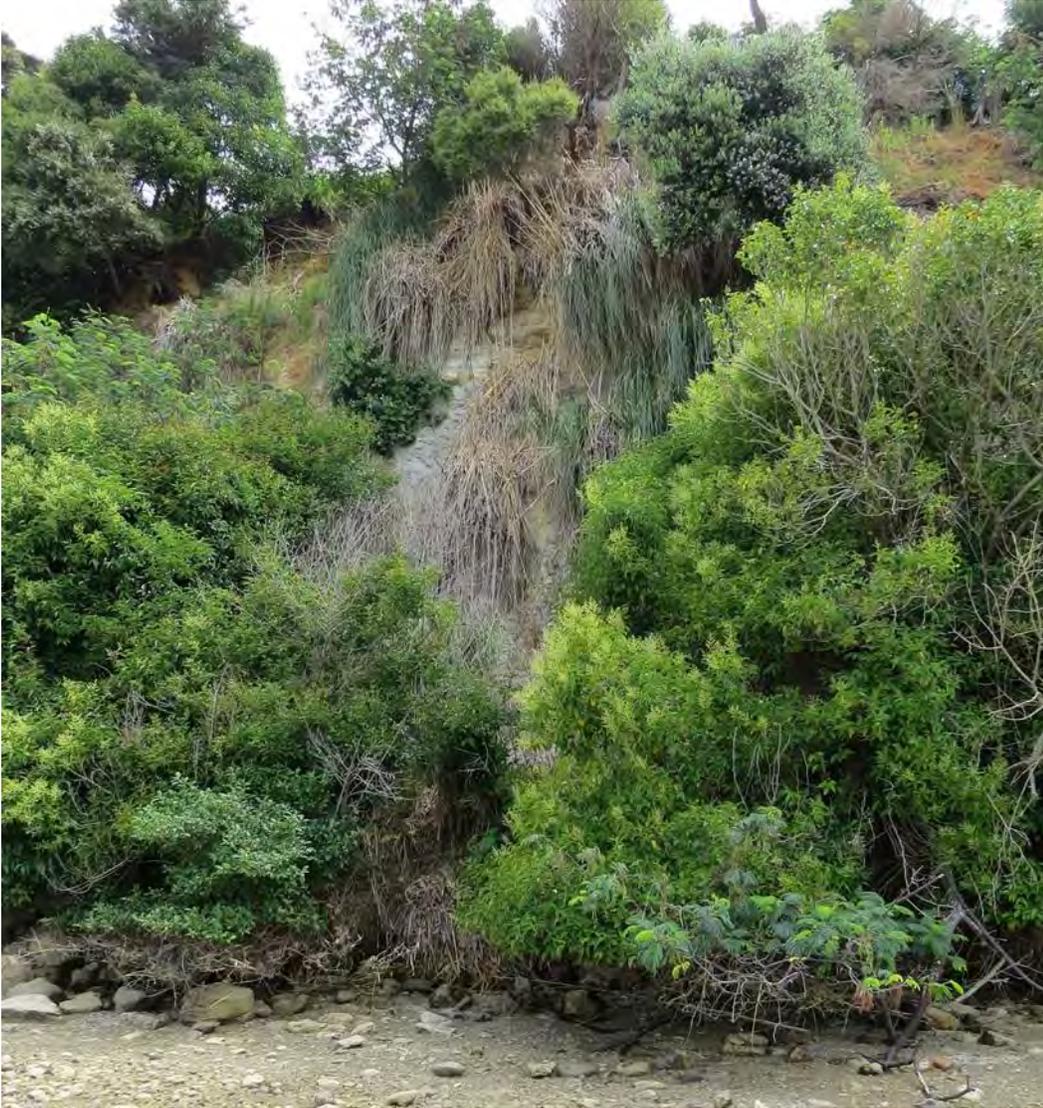
Figure 42: Cliffed shoreline at Cox Bay.

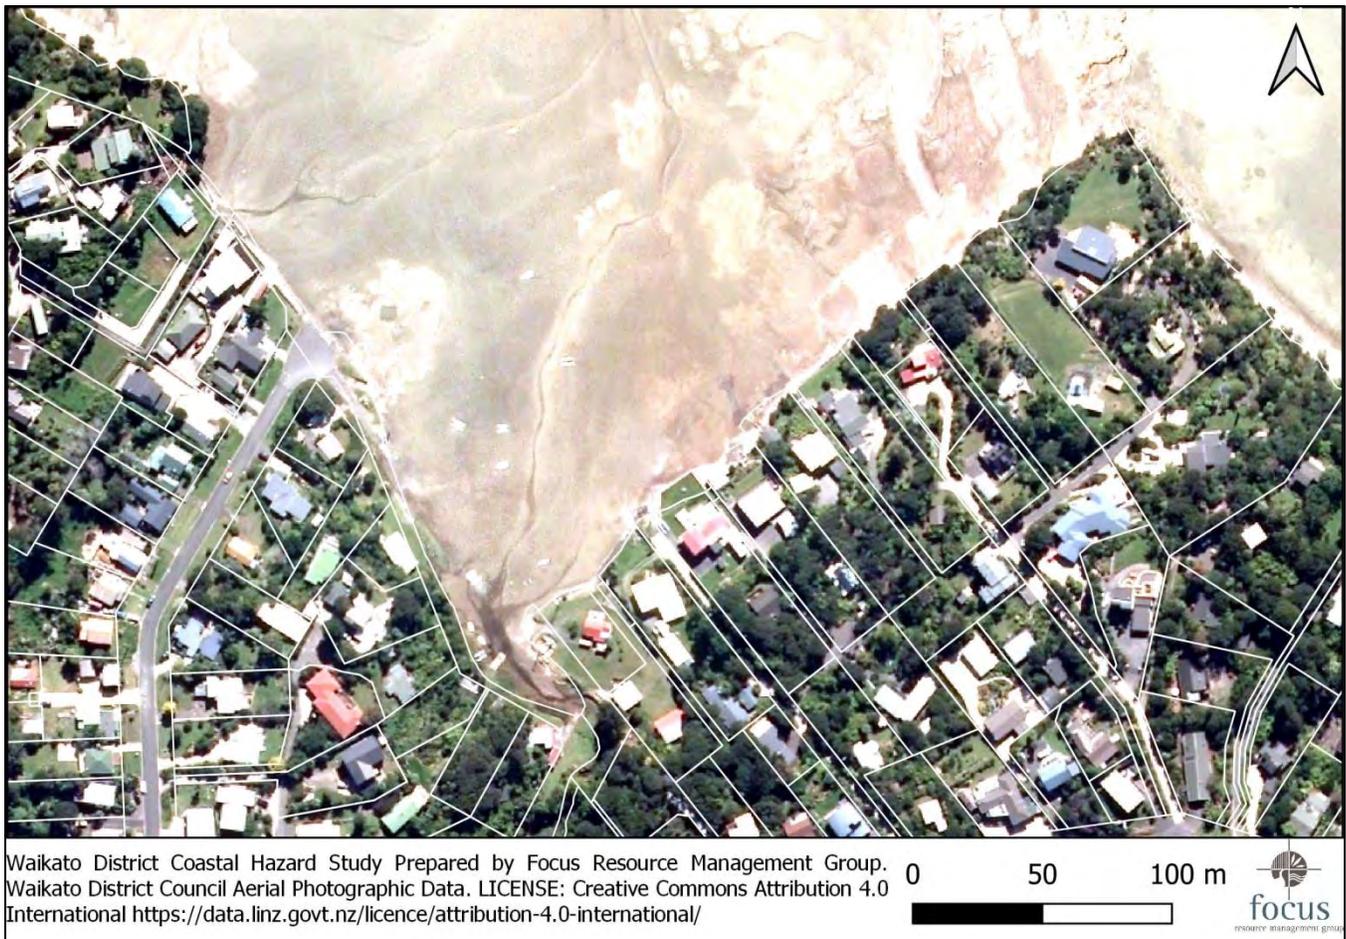
Figure 45: Property boundaries at Lorenzen Bay, showing the variation in seaward boundary location associated with different title dates, and illustrating localised reclamation.

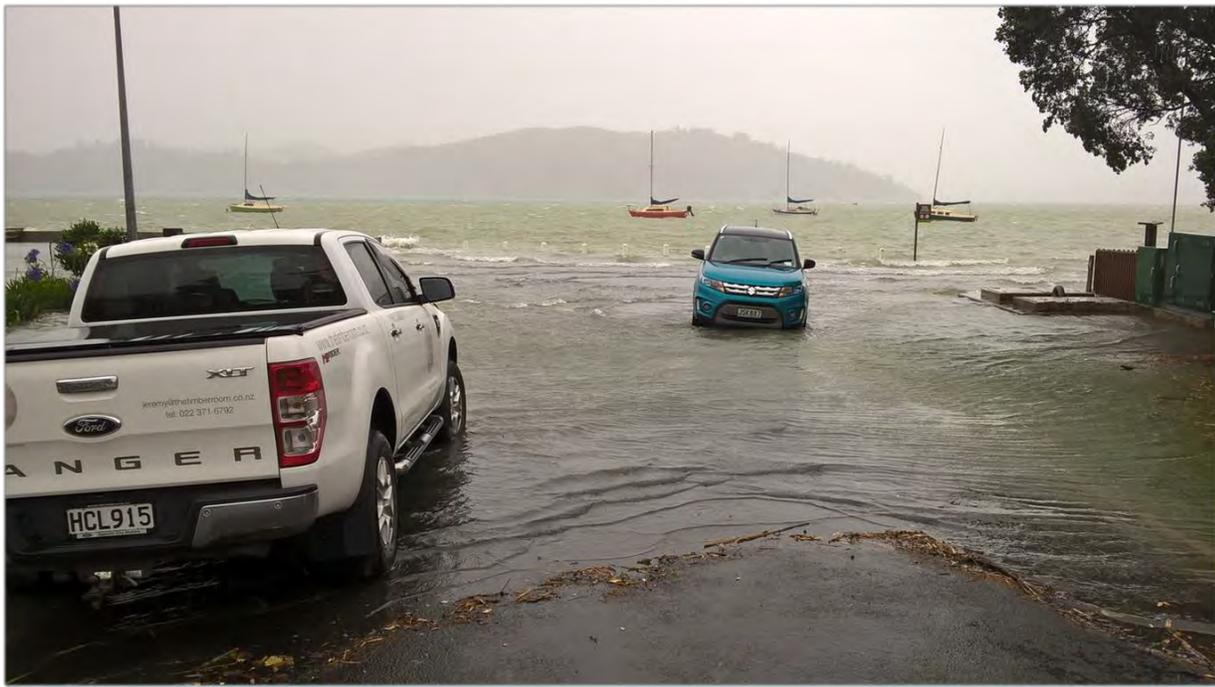
Figure 46: Flooding at the end of Lorenzen Bay Road in 2018.

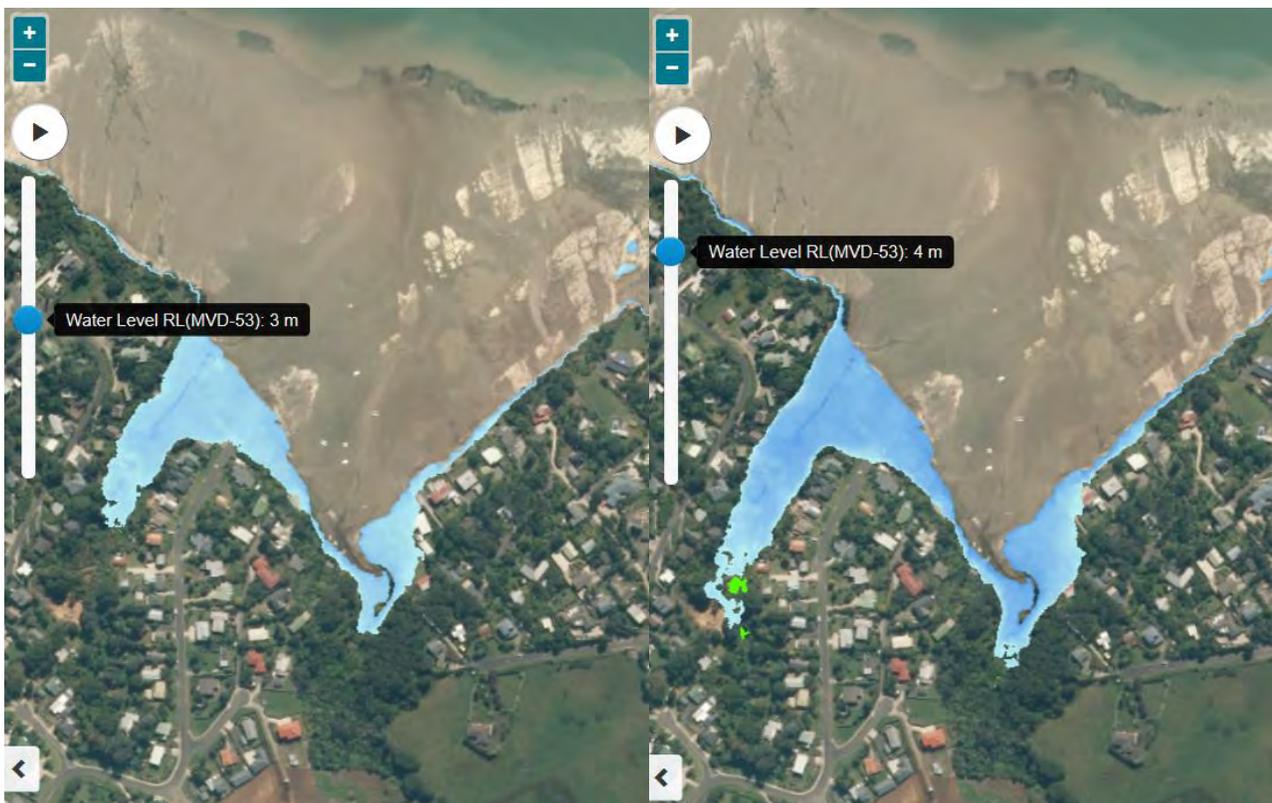
Figure 47: Broad area at risk from coastal inundation with current sea level (left) and with 1.0 m of sea level rise (right). Waikato Regional Council Coastal Inundation Tool (<http://coastalinundation.waikatoregion.govt.nz/>).

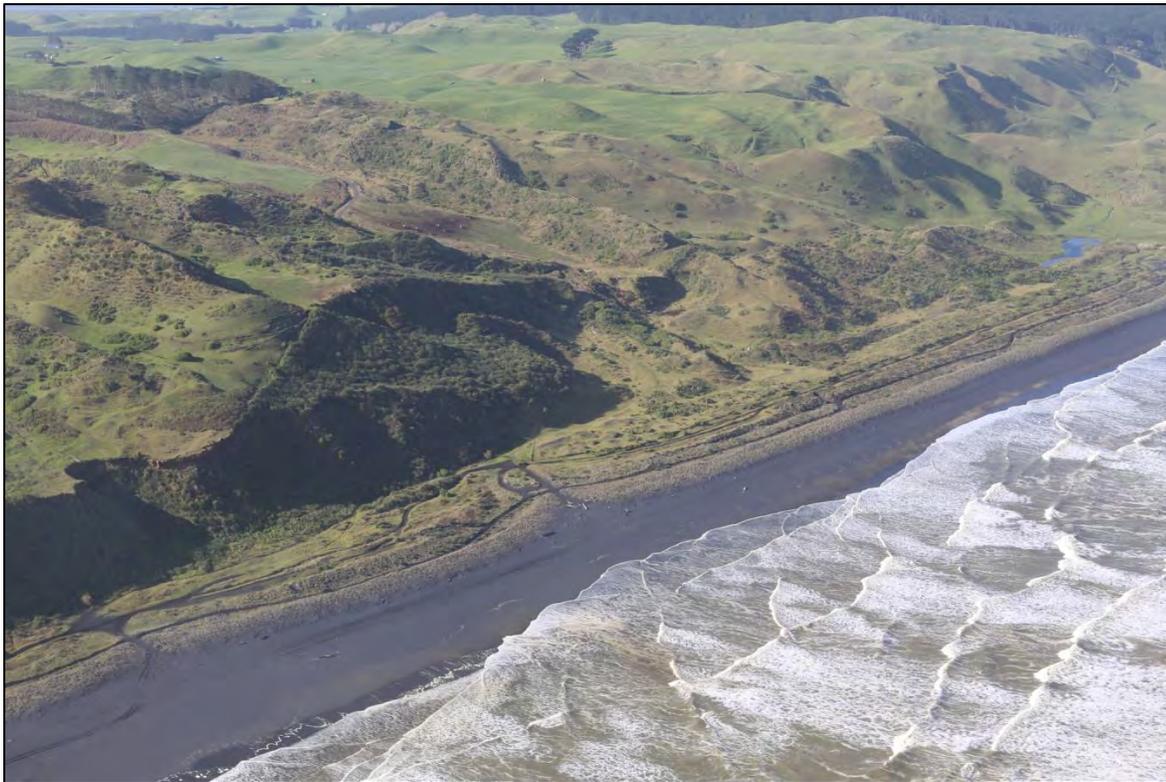
Figure 52: Shoreline north of Port Waikato. Old sea cliffs are protected from wave attack by dunes.

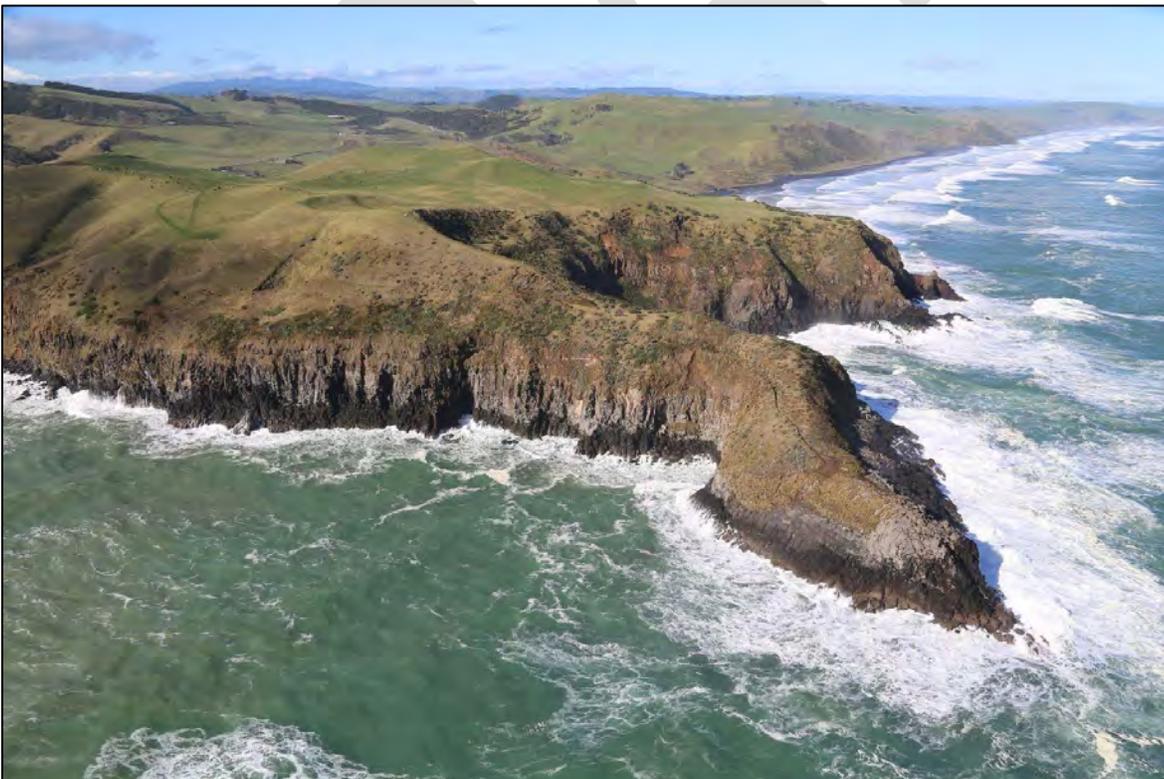
Figure 54: Hard basaltic cliffs at the base of Mt Karioi.

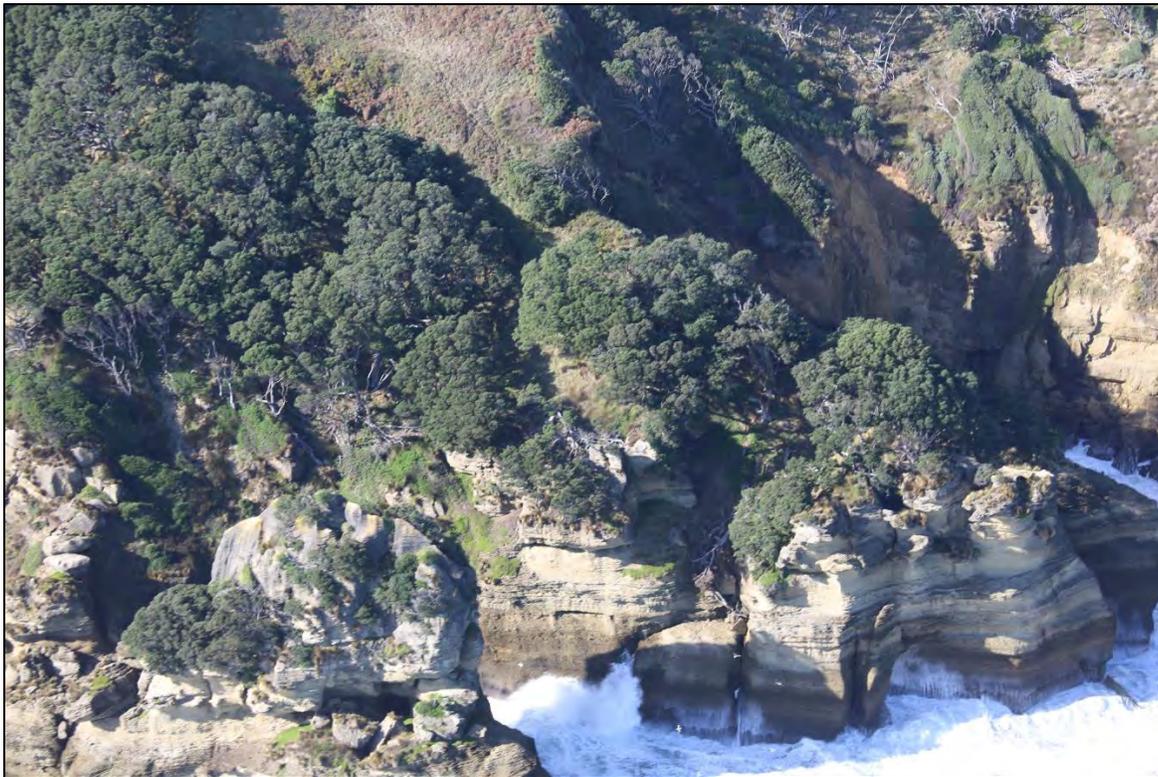
Figure 55: Tertiary aged limestones of the Te Kuiti Group (north of Aotea Harbour).

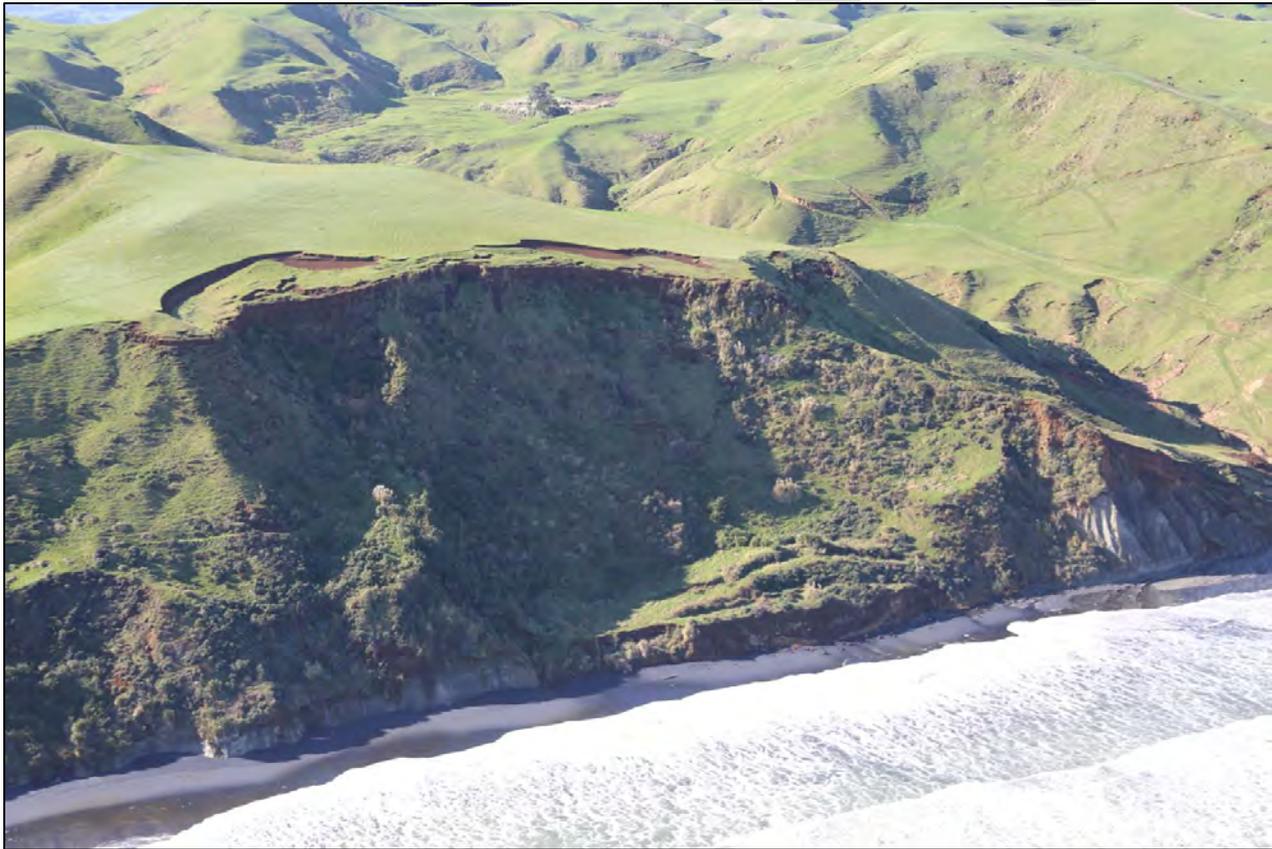
Figure 56: Land instability between Port Waikato and Raglan.

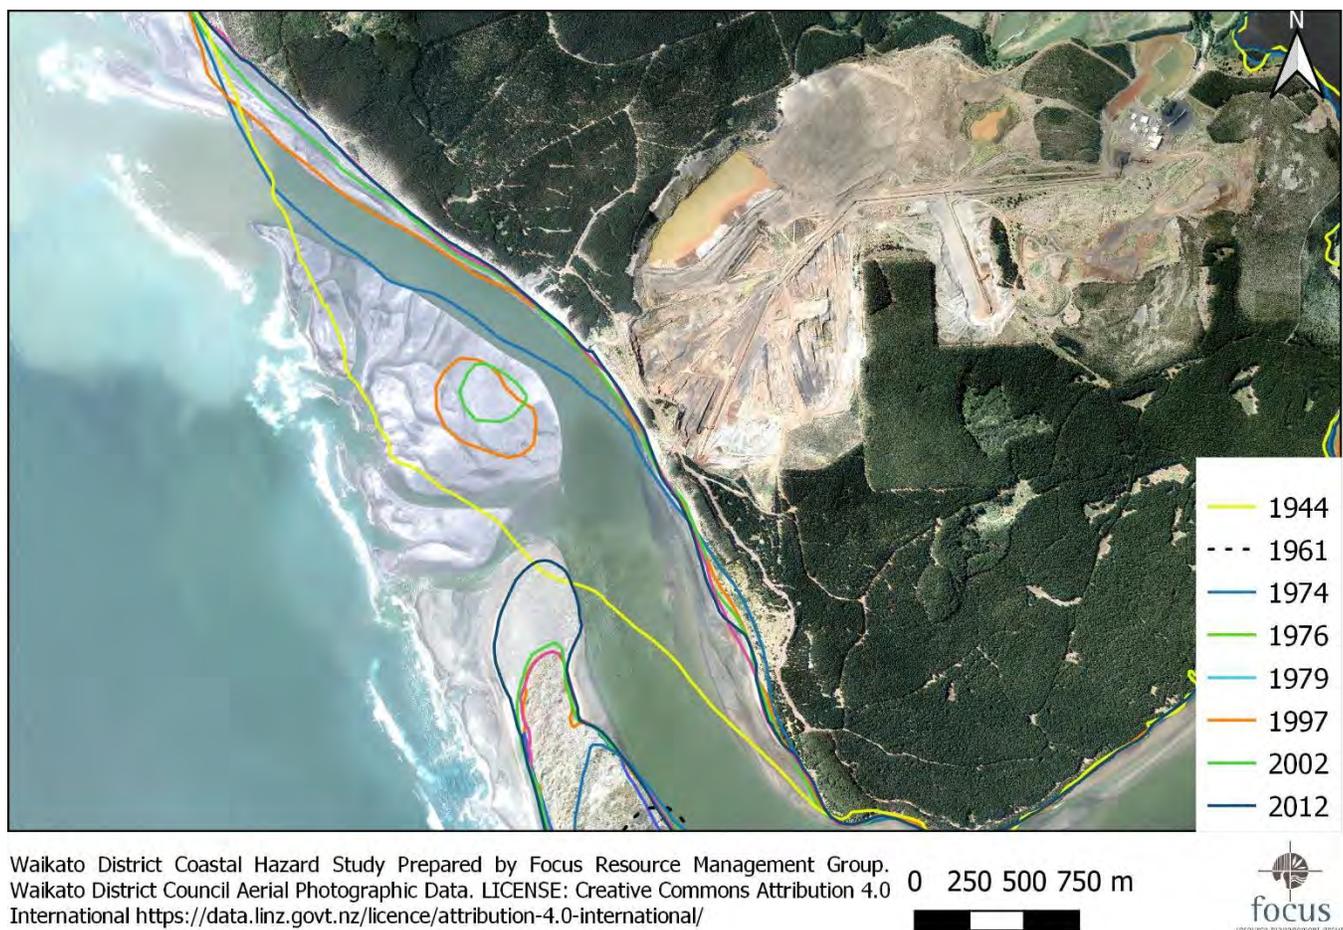
Figure 57: Historical shoreline change north of the Waikato River mouth.

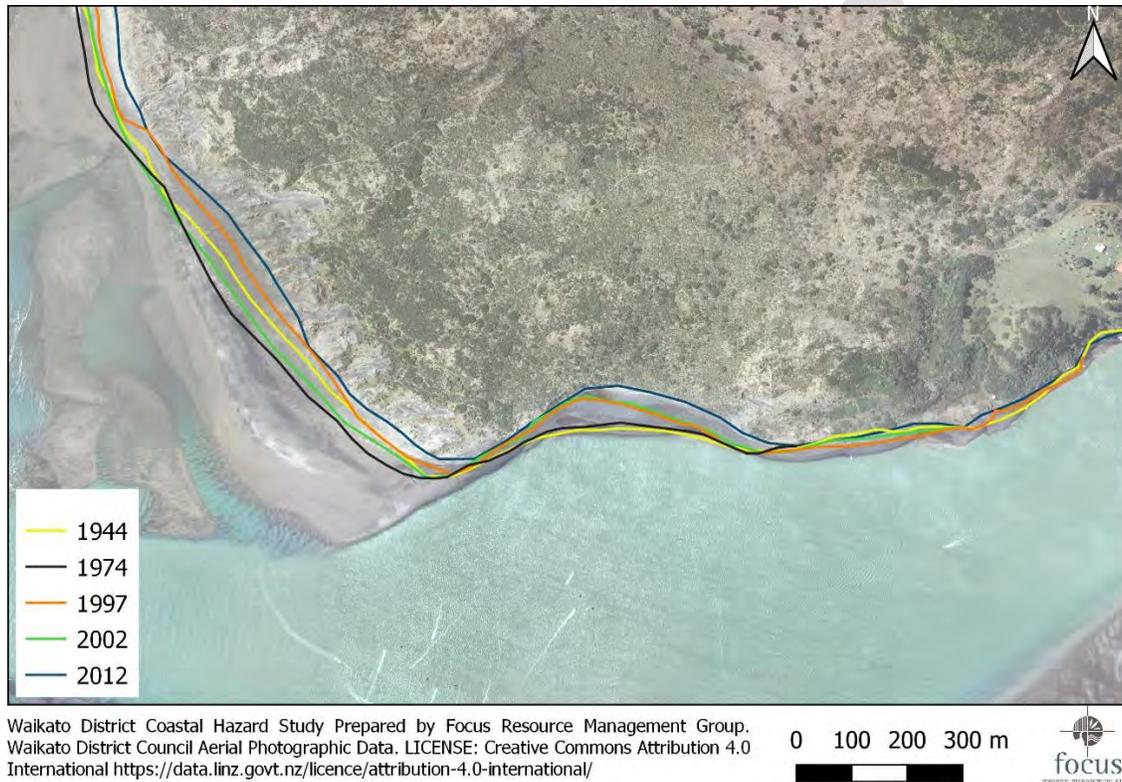
Figure 58: Shoreline change on northern shore of Raglan Harbour entrance.

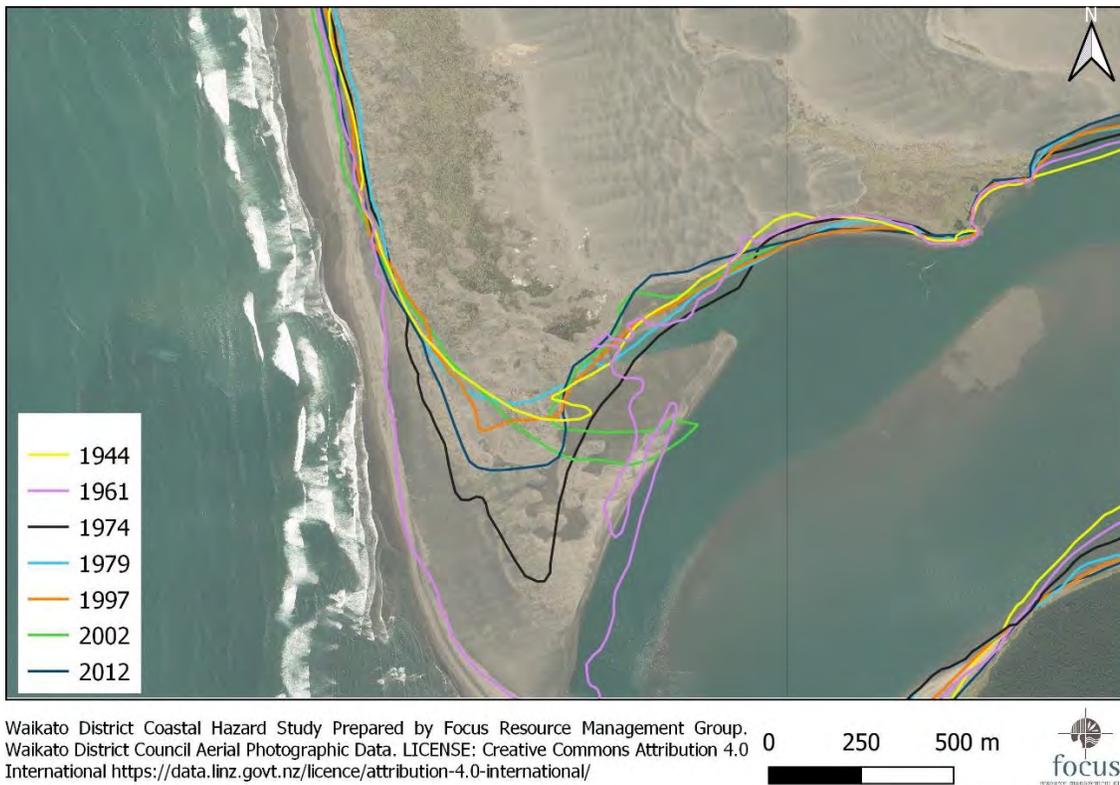
Figure 59: Shoreline change north of Aotea Harbour entrance.

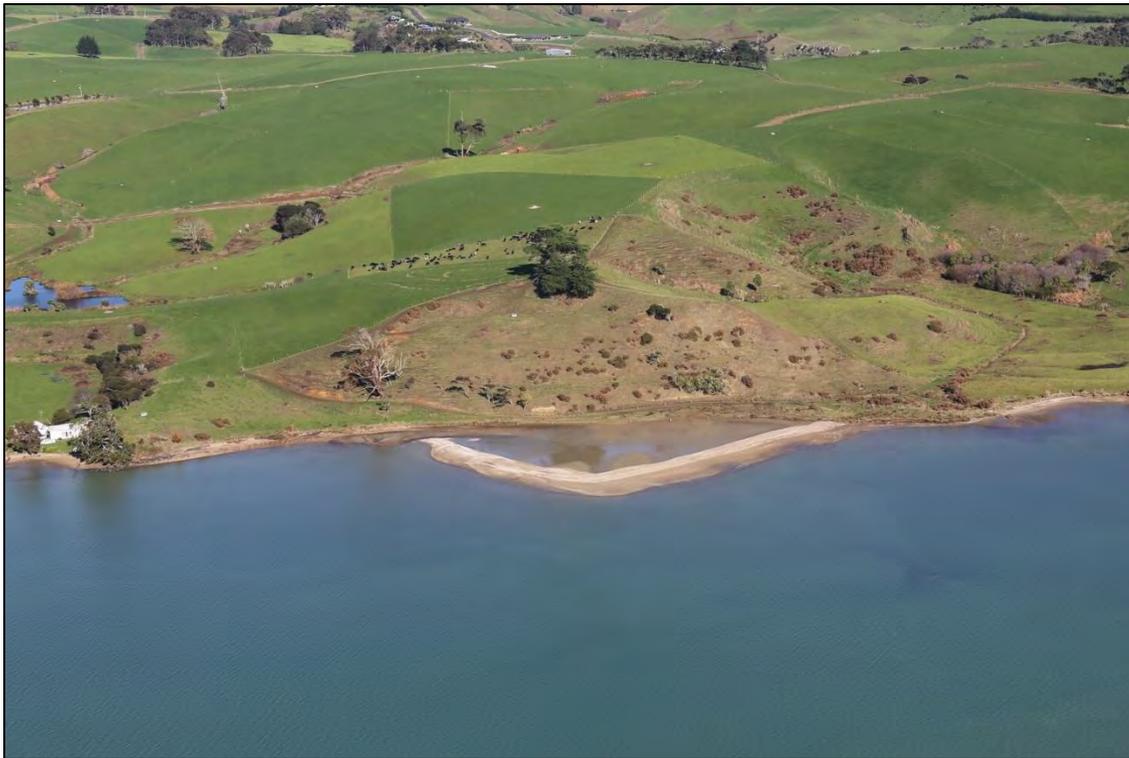
Figure 61: Chenier ridge on the southern shore of Raglan Harbour.

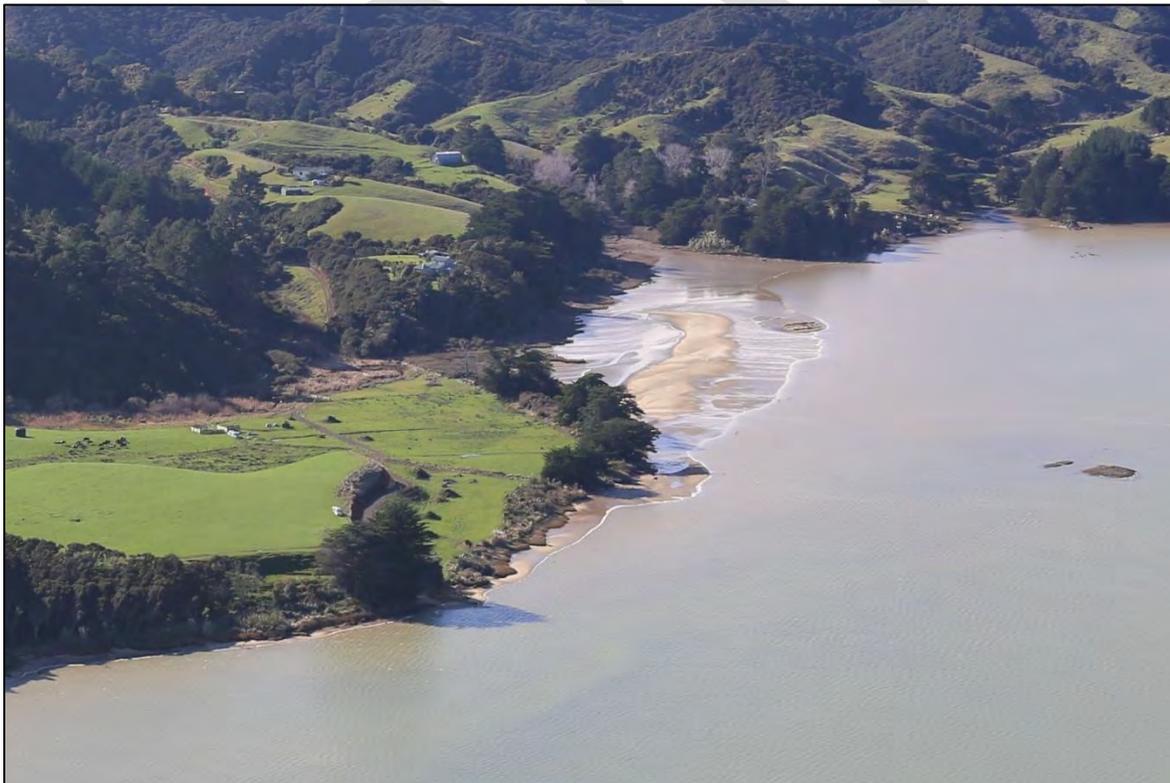
Figure 62: Chenier feature in Aotea Harbour.
