WAIKATO DISTRICT COUNCIL COASTAL HAZARDS

Waikato District Coastal Hazard Assessment

**PREPARED FOR WAIKATO DISTRICT COUNCIL
BY MEMBERS OF FOCUS RESOURCE MANAGEMENT GROUP:**

FOCUS, 2019: Waikato District Coastal Hazard Assessment. Prepared for Waikato District Council by the Focus Resource Management Group. Focus Report No. 19/130.

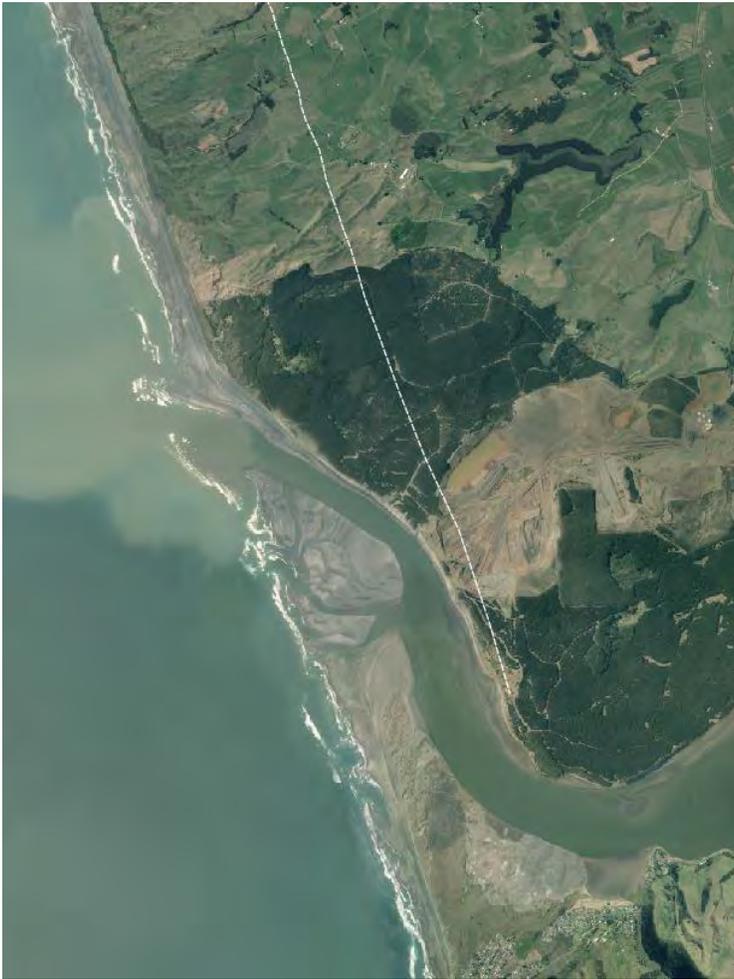
Figure 63: Broad illustration of the approximate location of the recommended coastal sensitivity zone boundary (DRAFT).
